**Heritage Overlay No.:** 072  
**Citation No.:** 193  
**Place:** House, 2 Exford Road

**Other Names of Place:** N/A  
**Location:** 2 Exford Road, Melton South  
**Critical Dates:** Originally constructed c.1929-1930; Relocated and rebuilt on current site: 1939-1940.  
**Existing Heritage Listings:** None  
**Recommended Level of Significance:** LOCAL

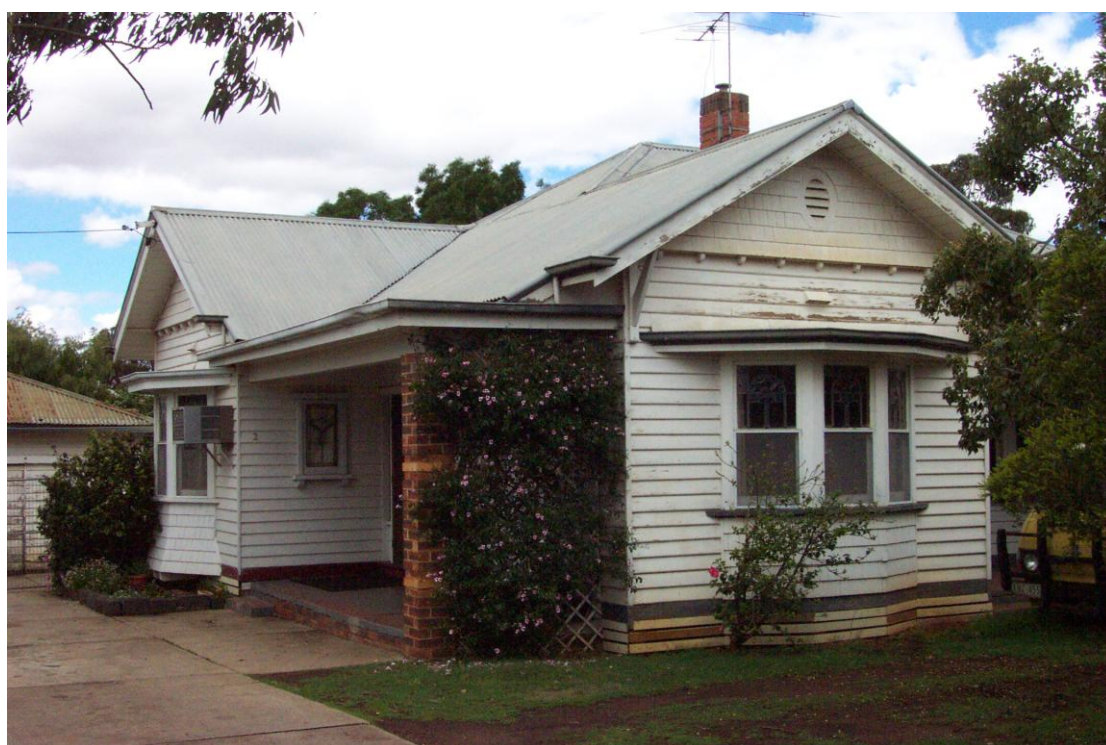
The asymmetrical, single storey, horizontal timber weatherboard, interwar Bungalow styled house is characterised by a hipped roof form that traverses the site, together with gable roof forms that project at the front and side (towards the rear) that are linked by a flat roofed porch. These roof forms are clad in unpainted galvanised corrugated steel. An early face brick chimney with a soldier course top adorns the roofline. Wide overhangs are features of the eaves, as are the timber brackets that support the projecting gable ends.

Early features of the design include the projecting flat roofed faceted bay windows under the projecting gables. These bays have timber framed double hung windows. There are also other early timber framed double hung windows elsewhere on the building. Another feature is the face brick corner pier that supports the flat roofed porch, near the front of the house.

Other early features include the timber shingling, small timber brackets and oval timber ventilation openings in the gable ends.
