Heritage Overlay **089**
Citation No.: **237**
Place: **House, ‘Balmoral Farm’**

Other Names of Place: McIntosh Property
Location: 2120-2224 Melton Highway, Melton.
Critical Dates: c.1914
Existing Heritage Listings: None
Recommended Level of Significance: LOCAL

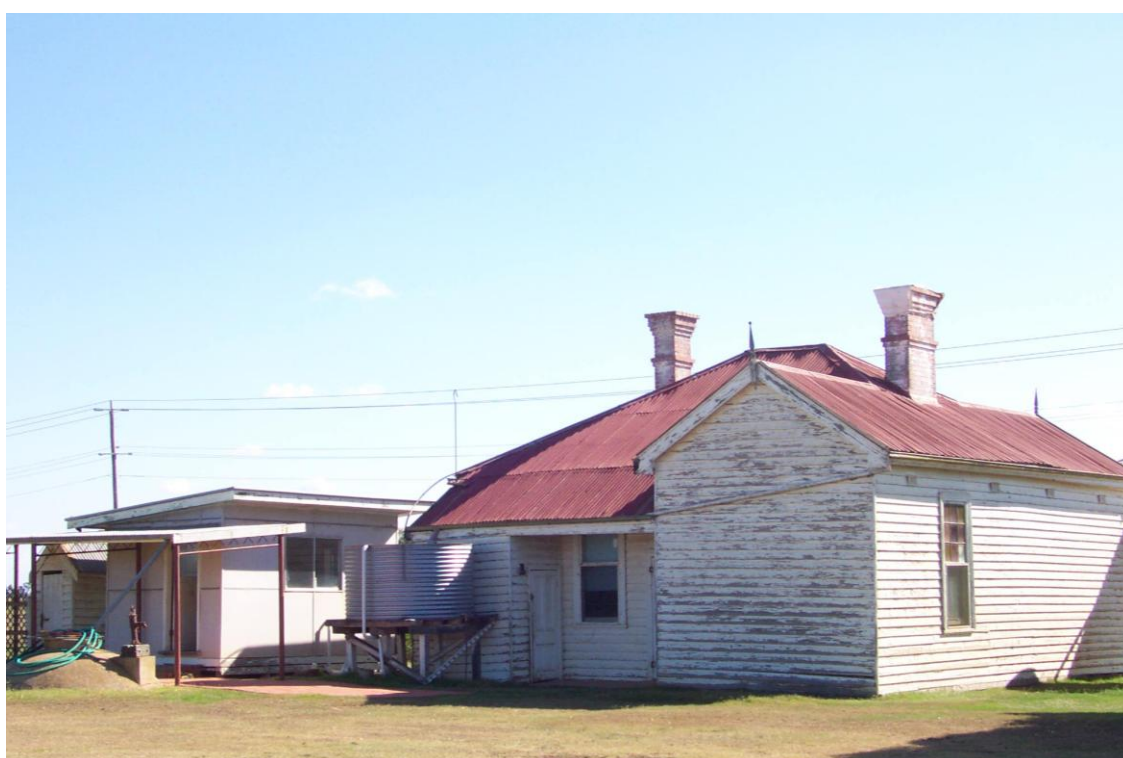
The asymmetrical, single storey, horizontal timber weatherboard, Federation styled house is characterised by a recessed hipped roof form, together with a gable that projects at one side and a returned verandah formed under the main roof. These roof forms are clad in deep red painted and lapped galvanised corrugated steel. Two early partially painted red brick chimneys with multi-corbelled tops adorn the roofline. Modest overhangs are features of the eaves.

Other early features of the design include the timber framed double hung windows (some with nine paned upper sashes), timber framed doorway, and the turned timber finials on the gable ends.

The three-dimensional context and setting of the house is severely interrupted by the introduced flat roof carport at the side-rear, and an introduced house linked with a walkway at the front. Although these represent an intrusion on the original building, the essential Federation design qualities – including forms, construction and some detailing – have been retained.

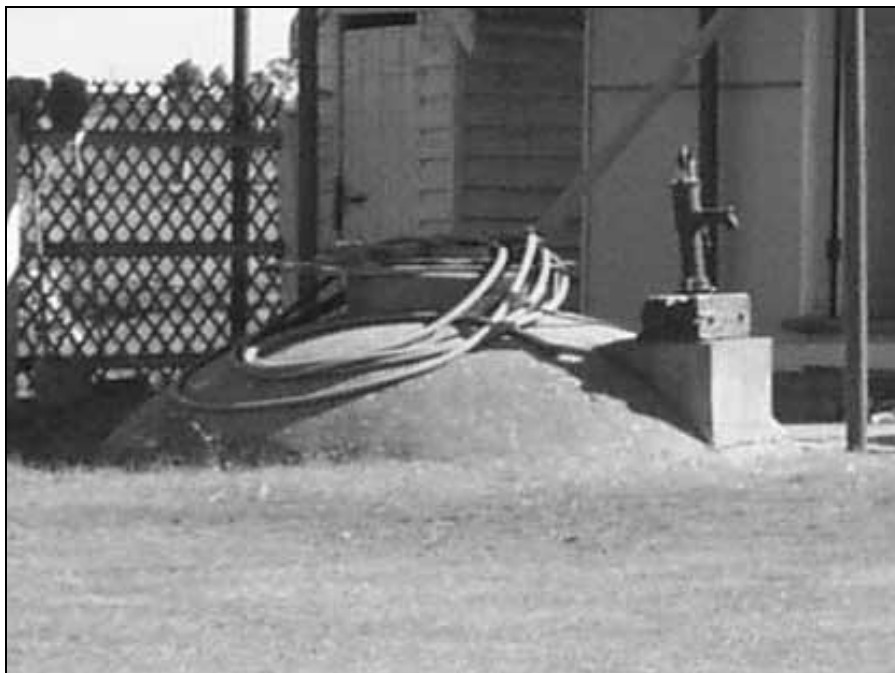
Towards the rear of the site is also an early domical rendered brick underground water tank. These tanks are a typical part of nineteenth and early twentieth century rural properties in Melton and more widely in Victoria, and illustrate a form of water collection and infrastructure no longer practised. The design of the tank appears to be a variation of early nineteenth century

brick lined underground tank design published in J.C. Loudon's *Encyclopaedia of Agriculture* in 1826, but widely employed in Australia only from the 1860s. It has a low segmental rather than high hemispherical dome.

Underground Tanks:- In terms of underground tanks, this is one of quite a number of such tanks remaining in the Shire. A minority of these (not including this one) are publicly visible, being situated at the front of a property near a road. Significantly, this is one of only four known tanks (identified in Stage One of the Heritage Study) to retain its early handpump. The others are:-

Domed cement rendered brick underground tank, with iron handpump.

- An archaeological survey of the tank has the potential to provide further information regarding the evolution of tank construction, water management, and domestic lifestyles in the dry Melton Plains area, and is desirable.
