| <b>Heritage Overlay</b> | <b>095</b> |
| <b>Citation No.:</b> | <b>252</b> |
| <b>Place:</b> | <b>Former Robinson House Tank, The Bullock Track</b> |

| <b>Location:</b> | 122-142 The Bullock Track, Melton West |

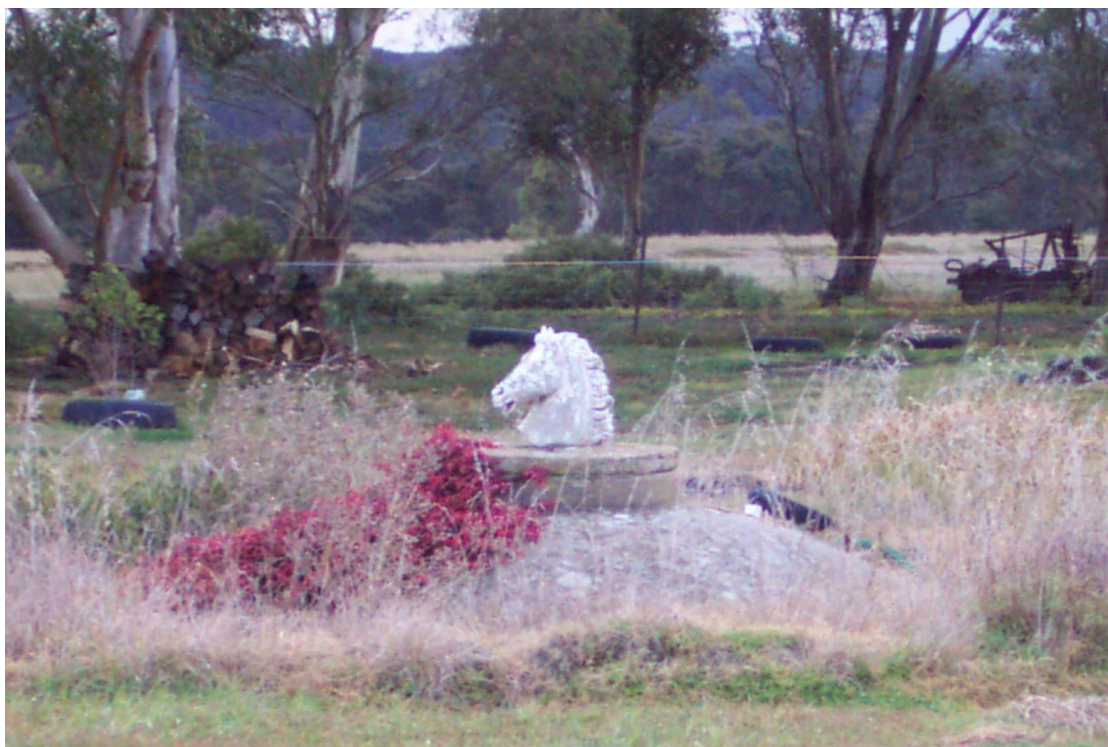
The underground tank is situated at 122-142 The Bullock Track, on the north side. It is situated where the road bends slightly south, meaning that the tank is directly in front of vehicles travelling west along The Bullock Track, and is thus one of the most prominent underground tank in the Shire.

Although commonly called 'wells', such structures are almost always underground tanks, or cisterns, used to store water run off from the roofs of a nearby house or farm outbuildings. The water in this tank came from the original stone and brick building that was situated just to its north. The place comprises a concrete dome with concrete lid, over a brick tank, with a concrete render. This is a typical type of underground tank in the Shire, probably dating from the late nineteenth or early twentieth century. Unusually, it had no hand or powered pump: the cold water was pulled up in a bucket tied to a rope. Currently it is overgrown with a flowering prostrate plant, and wild grass. A cast horse's head placed on top of the tank gives it a certain prominence, but detracts a little from its integrity. Its segmental dome is consistent with it having been constructed in the late nineteenth century.

Appears Fair from the road.

Substantially Intact.

Recommended for inclusion in the Melton Planning Scheme.

- A preliminary archaeological survey of the tank, with other similar tanks in the area, has the potential to provide further information and contribute to an understanding of the evolution of tank construction, water management, and domestic lifestyles in the dry Melton Plains area and is desirable.
