Heritage Overlay No.: 117
Citation No.: 438
Place: ‘Bonnie Doone’, 339-365 Tarletons Road

Other Names of Place: ‘Bonnie Doon’
Location: 339-365 Tarletons Road, Plumpton
Critical Dates: Construction: 1906
Existing Heritage Listings: None
Recommended Level of Significance: LOCAL

Statement of Significance:

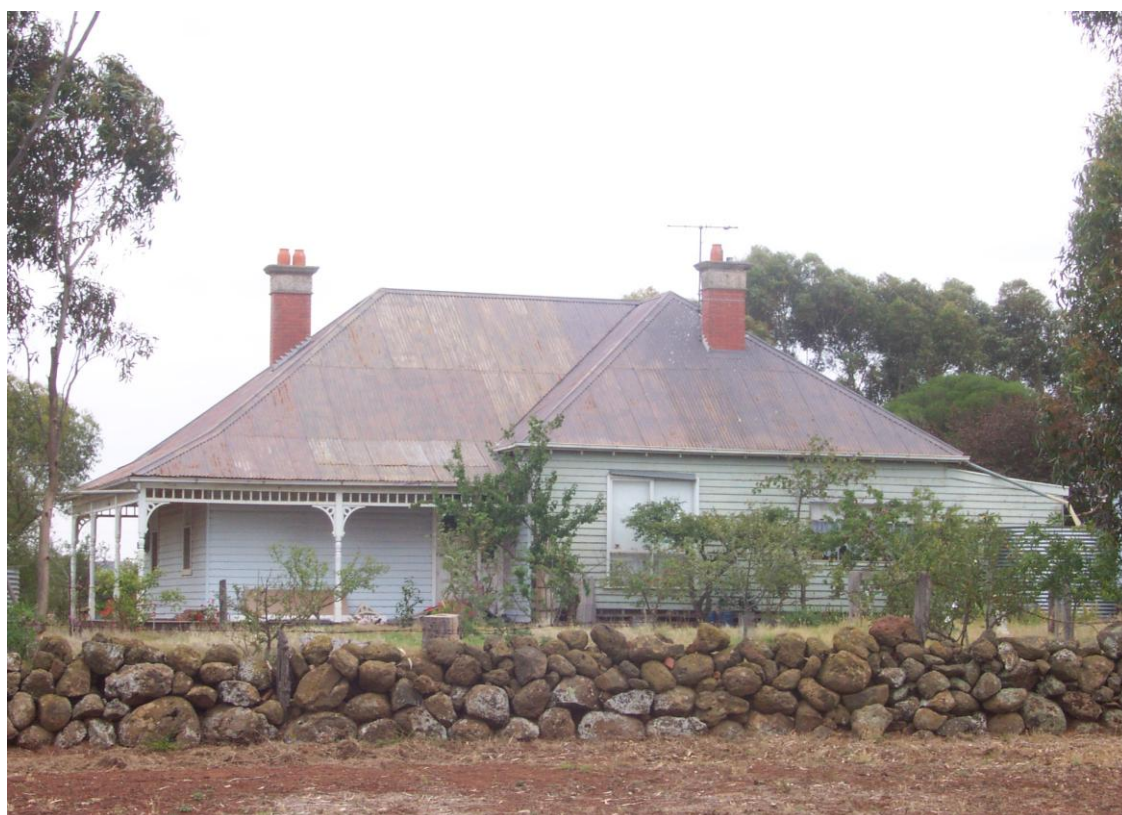
Bonnie Doone, 339-365 Tarletons Road, Rockbank, has a rural setting and consists of a timber house, galvanised steel outbuilding, dry stone walls and underground tank.

The asymmetrical, single storey, horizontal timber weatherboard, Federation styled house is characterised by steeply pitched hipped roof forms, together with a broken back return verandah. These roof forms are clad in galvanised corrugated steel. Two early red brick chimneys with rendered and projecting tops and terra cotta pots adorn the roofline. Modest overhangs and exposed timber rafters are features of the eaves.

An early feature of the design is the return verandah, which has recently been extended to the north side of the house. It is supported by turned timber posts with decorative brackets and timber fretwork valance, and has a timber floor. Other early features of the design of the house is the timber framed doorway with timber door, sidelight and highlight, and the fact that the house is orientated to face the original track which ran along the south-west side of the house.
