Heritage Inventory No: H	6	2 3 -	0	3 2	4
--------------------------	---	-------	---	-----	---

# **Heritage Inventory Site Card**

1. Place			
Name Harp of Erin Hotel, Burru	mbeet		
Other/former names	,,,,,,,,,,,,,,,,,,,,,,,,,,,,,,,,,,,,,,,		
Current site description			
Stone structural features, mounds and directly north of the Western Highway area of almost 2,500 m² that is located Above-ground structural remains consbasalt/bluestone. The outline of a rect from satellite photographs.	, 1.5 km west d on the basa sist of linear a	of Burrumbeet. The fe It plain north of Lake B nd rectilinear arrangen	atures span an urrumbeet. nents of squared

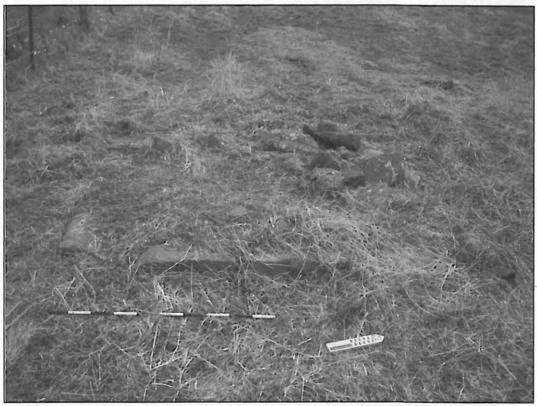
Fig. 5: Feature A: square shaped feature formed by dressed basalt blocks (P. Kucera, 15/9/11)

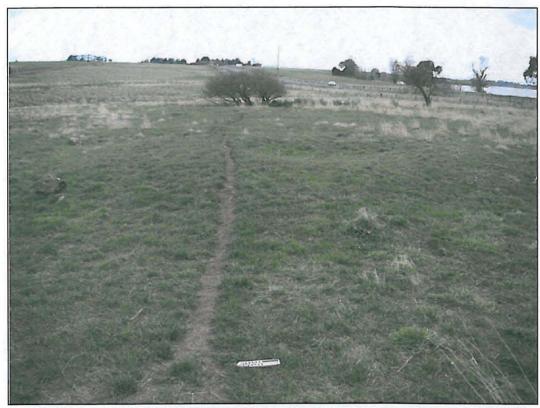
Fig.7: Feature C: circular mound and depressions with associated basalt building stone, facing east (P. Kucera, 15/9/11)

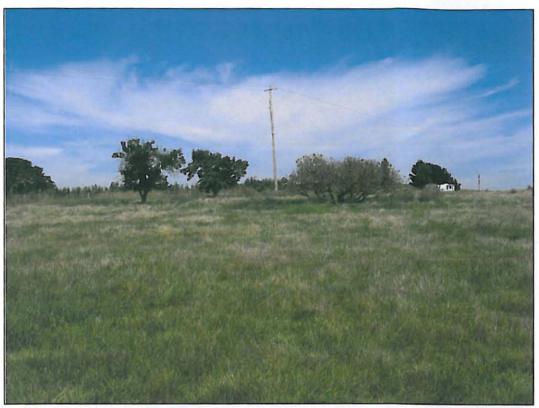
Fig. 8: View of the Harp of Erin Hotel site showing apple and mulberry trees, facing southwest (W. Anderson, 25/2/11)

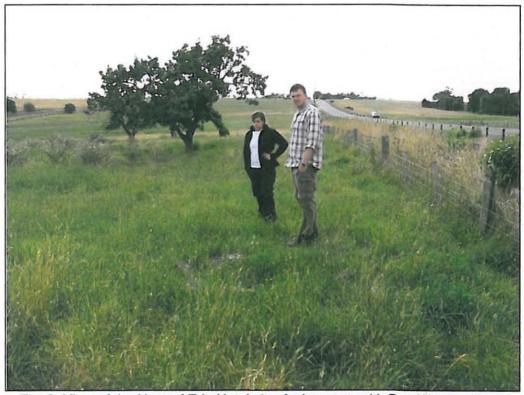
Fig. 9: View of the Harp of Erin Hotel site, facing east, with Ben Watson (r) and Siobhan Privitera (I). Ben is standing beside Feature A, showing its proximity to the current highway (W. Anderson, 25/2/11)

Road works: the proposed duplication of the Western Highway will impact upon the site, as the northern carriageway is planned to pass through the southern side of the site and almost the whole site will be within the construction zone.
