This sheet should be read in conjunction with Graeme Butler & Associates, *Geelong City Urban Conservation Study*, Vol. 1-5, 1991

244 Moorabool Street

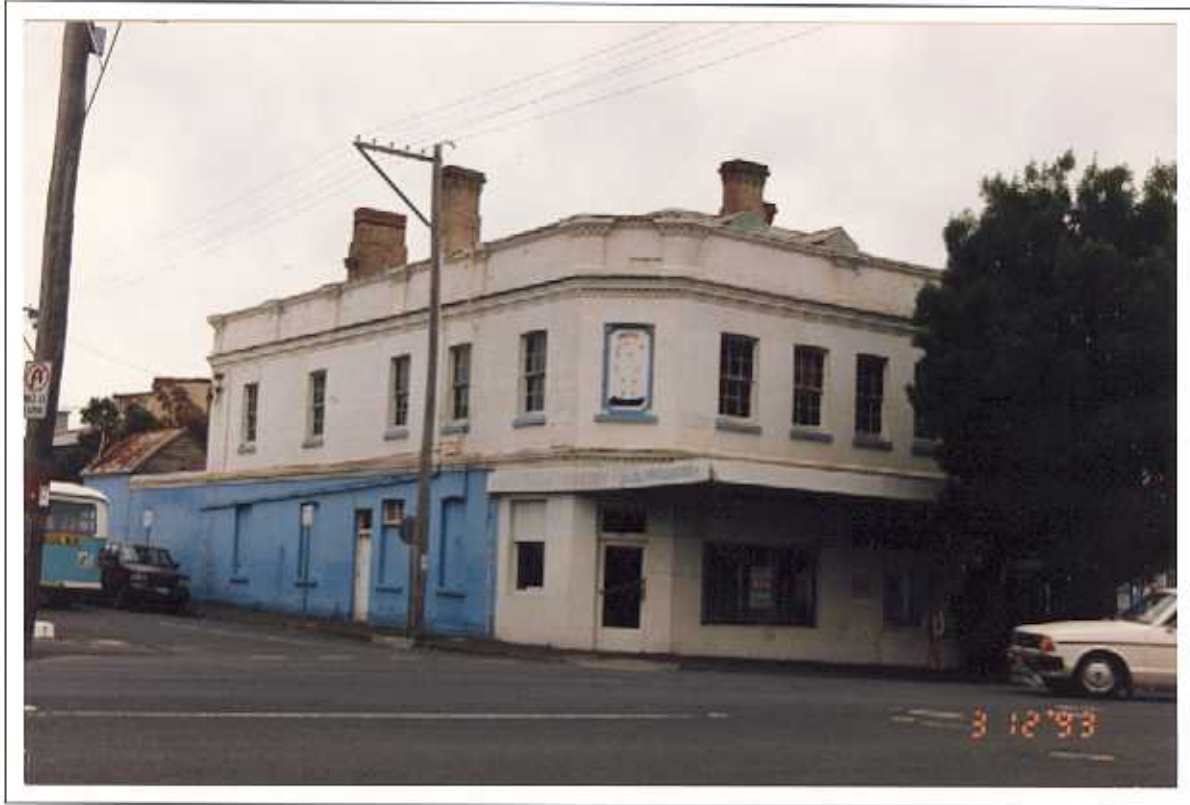
244 Moorabool Street is a double storey Early Victorian building which has been altered at ground level and a new verandah added to the east side. The building is semi-detached and features an unusually decorated brick parapet facade with brick corbelling to mark the ground and first floors and the top of the parapet. The irregular spacings of parapet pilasters with the windows below suggests that the parapet may be a later addition. The first floor has double hung sash windows with twelve panes and substantially intact joinery. The ground floor windows have been bricked in on the south facade although their form is clearly apparent, and on the east facade have been replaced with larger openings. The building retains its corner entry focus and appears to have small clerestory roof lights. The timber and brick outbuilding and adjacent walls of 'Geelong Blues' brickwork are significant original features of the site. The survival of outbuildings is relatively rare in commercial centres. Removal of the paintwork in a gentle manner would expose handmade bricks and greatly enhance the presentation of the property.
