This sheet should be read in conjunction with Graeme Butler & Associates, *Geelong City Urban Conservation Study*, Vol. 1-5, 1991.

## 73 Ormond Road

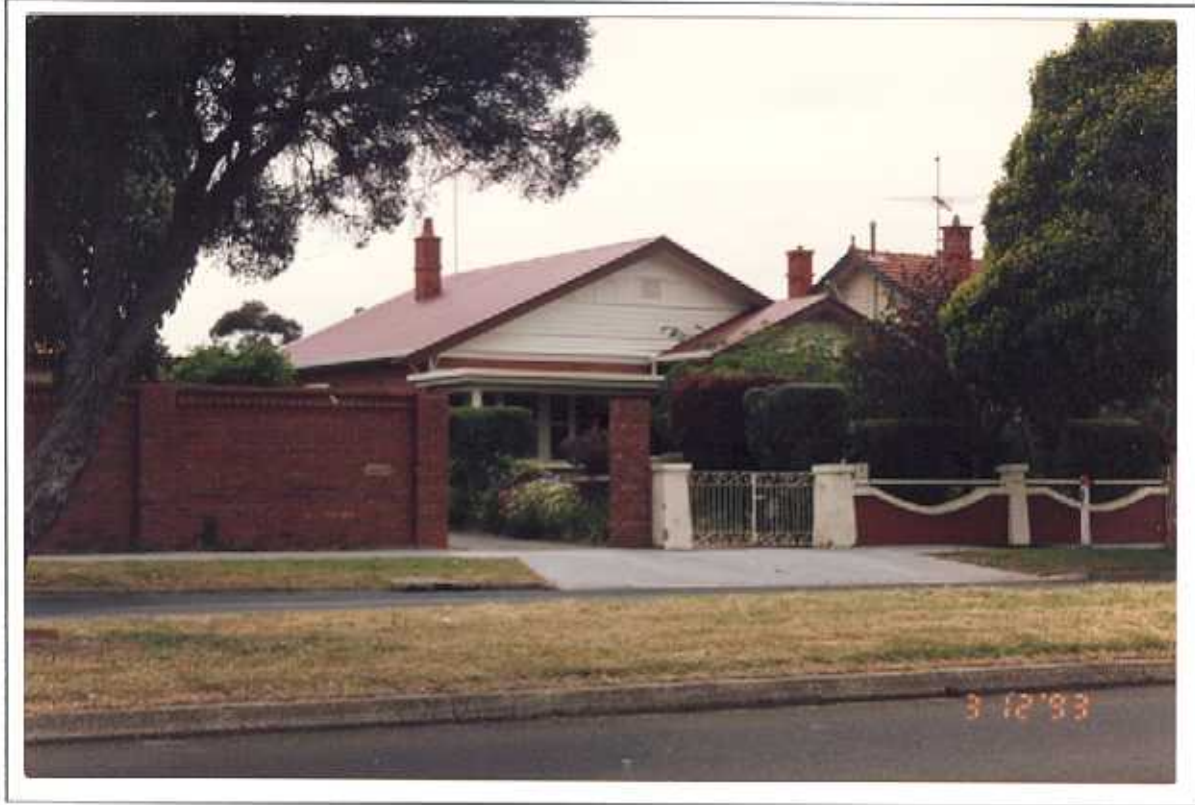
73 Ormond Road is a typical brick Bungalow residence which has undergone alterations. It has a notable brick and render fence. The asymmetrical double fronted facade features a prominent gable set in front of a larger gable form, with a flat verandah entrance porch. The entrance is altered, however the original sidelight still exists. The gable infills have a half timbered effect, imitation timber wall shingles, stucco, and wide barge boards. The openings are double hung sash windows with lead light glass. The corrugated iron roof has been recently reclad. A tall brick chimney with mouldings and terracotta pots protrudes from the roof. The fence at the front of the site has thick rendered piers and a swag like brick with render capping infill between the piers and tie rods.

73 Ormond Road has architectural significance at a local level. The building is a representative example of a brick Bungalow residence which is reasonably intact retaining characteristic siting, form and details, including the prominent gable, casement windows, and infill panels. In particular the brick and render front fence is notable as an example of Bungalow fencing with a high degree of integrity which contributes to this residential streetscape.
