# BELMONT HERITAGE REPORT (INDIVIDUAL CITATIONS) (FORMERLY PART OF THE GREATER GEELONG OUTER AREAS HERITAGE STUDY STAGE 2)

<p><b>Existing Use/Type</b> Suburban Residential</p> <p><b>Survey Date</b> 17/04/1998</p> <p><b>Cons Man Plan</b> </p> <p><b>Recorded By</b> David Rowe</p>	<p><b>Key Dates</b> Original 1914-15</p> <p><b>Major Changes</b> </p> <p><b>Precinct Name</b> Belmont Heights</p>	<p><b>Site Address</b> Street/Site Name Peary Street</p> <p><b>No.</b> 2</p> <p><b>Town/Suburb</b> Belmont</p> <p><b>Postcode</b> 3216</p> <p><b>Current Site Name</b> House</p>	<b>A D M I N I S T R A T I V E  S H E E T</b>

Site Address	No.	Street/Site Name	Town/Suburb	Postcode
	2	Peary Street	Belmont	3216
			Site Name	House

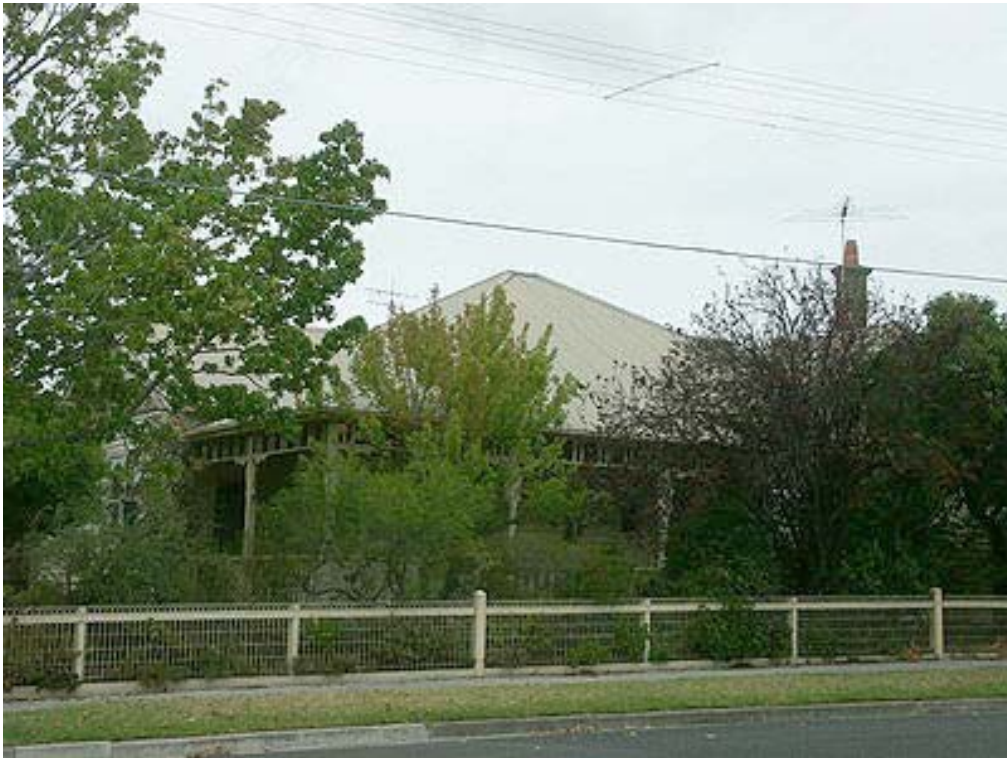
The single storey weatherboard Federation styled house is characterised by a dominant galvanised corrugated iron hipped roof with a projecting minor attic gable on the diagonal of the north-east corner. A tall chimney with terra cotta pot adorns the roof top. A return verandah wraps around the corner of the house, under the broken backed roof section of the main hipped roof form. This type of roof arrangement recalls the early Colonial Georgian homesteads of the early 1800s in Australia, whereby the roof acted as a protective measure against the hot sun.

The timber framed windows are grouped in banks of threes under the verandah of the front elevation. They appear to be oriented on the diagonal. These casement windows may have leadlight upper lights.

The verandah is supported by early decorative timber columns, with worked timber brackets and a fretwork valance forming the other decorative features of the design.
