**BELMONT HERITAGE REPORT (INDIVIDUAL CITATIONS)
(FORMERLY PART OF THE GREATER GEELONG OUTER AREAS HERITAGE STUDY STAGE 2)**

ADMINISTRATIVE SHEET

<p>Existing Use/Type Suburban Residential</p>	<p>Key Dates Original 1913-14</p>	<p>Site Address Street/Site Name No. 2 Church Street</p>
<p>Survey Date 17/04/1998</p>	<p>Cons Man Plan []</p>	<p>Town/Suburb Belmont</p>
<p>Major Changes 1972</p>		<p>Postcode 3216</p>
<p>Recorded By David Rowe</p>		<p>Current Site Name House</p>
<p>Precinct Name []</p>

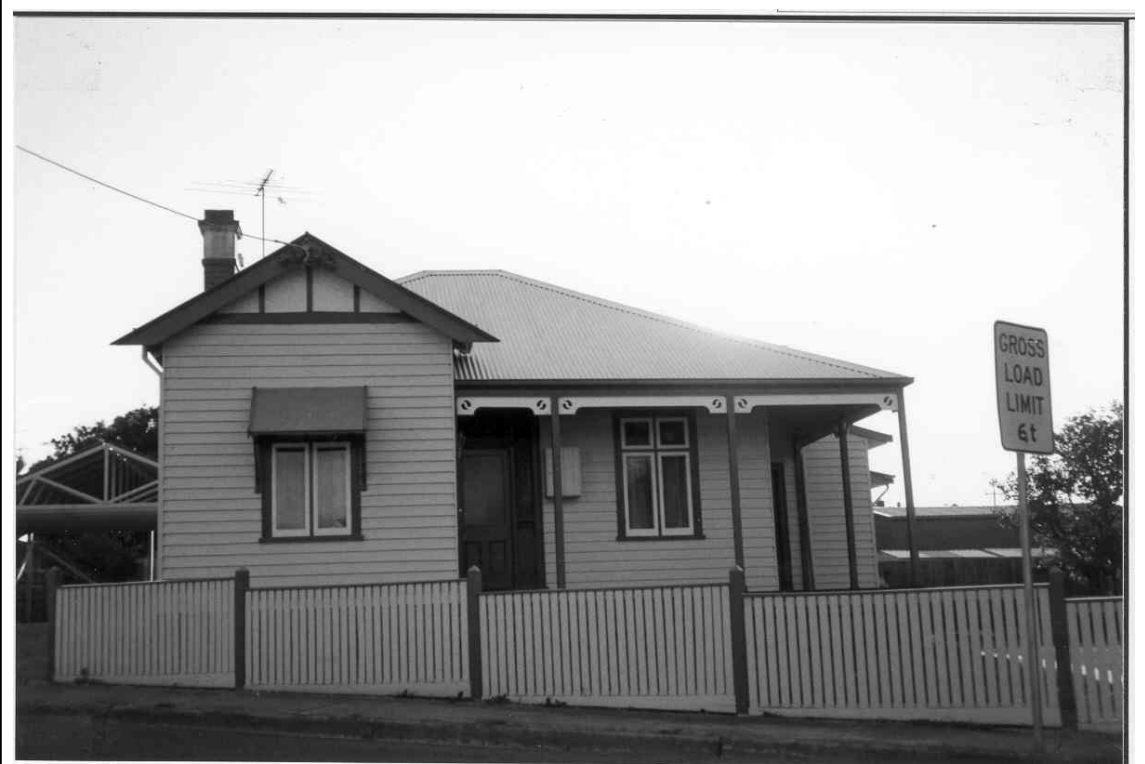
Site Address	No.	Street/Site Name	Town/Suburb	Postcode
	2	Church Street	Belmont	3216
		Site Name	House	
Description				
<p>This site at 2 Church Street is set on a substantial allotment, with considerable side setbacks and a typical front setback. These setbacks are shown on the 1989 GWST Plan of Drainage.³ The front is bound by an appropriate capped timber picket fence, approximately 1300mm high.</p> <p>The asymmetrical, single storey, weatherboard Edwardian style house is characterised by a dominant, rear hipped roof with a return verandah and a projecting gable towards the street frontage. These roof forms are clad in galvanised corrugated iron? An early, tall brick and rendered and corbelled chimney adorns the roofline. The early timber framed casement windows with highlights are arranged in pairs on the street facade. The window under the gable has an early? window hood over and is supported by worked timber brackets. The front timber panelled door and sidelight also appears to be early, although altered.</p> <p>The return verandah is a feature of the design, however it is supported by recent columns, possibly with a recent timber fretwork valance.</p> <p>Early decorative features of the design include the gable infill (stucco work and battening).</p>
