**BELMONT HERITAGE REPORT (INDIVIDUAL CITATIONS)**  
**(FORMERLY PART OF THE GREATER GEELONG OUTER AREAS HERITAGE STUDY STAGE 2)**

<p><b>Existing Use/Type</b> Suburban Residential</p>	<p><b>Key Dates</b> Original 1928-29</p>	<p><b>Site Address</b> Street/Site Name No. 19 Herd Road</p>
<p><b>Survey Date</b> 21/04/1998</p>	<p><b>Cons Man Plan</b> [ ]</p>	<p><b>Town/Suburb</b> Belmont</p>
<p><b>Major Changes</b></p>		<p><b>Postcode</b> 3216</p>
<p><b>Recorded By</b> David Rowe</p>		<p><b>Current Site Name</b> House</p>
<p><b>Precinct Name</b> [ ]</p>

<b>Site Address</b>	<b>No.</b>	<b>Street/Site Name</b>	<b>Town/Suburb</b>	<b>Postcode</b>
	19	Herd Road	Belmont	3216
			<b>Site Name</b>	House

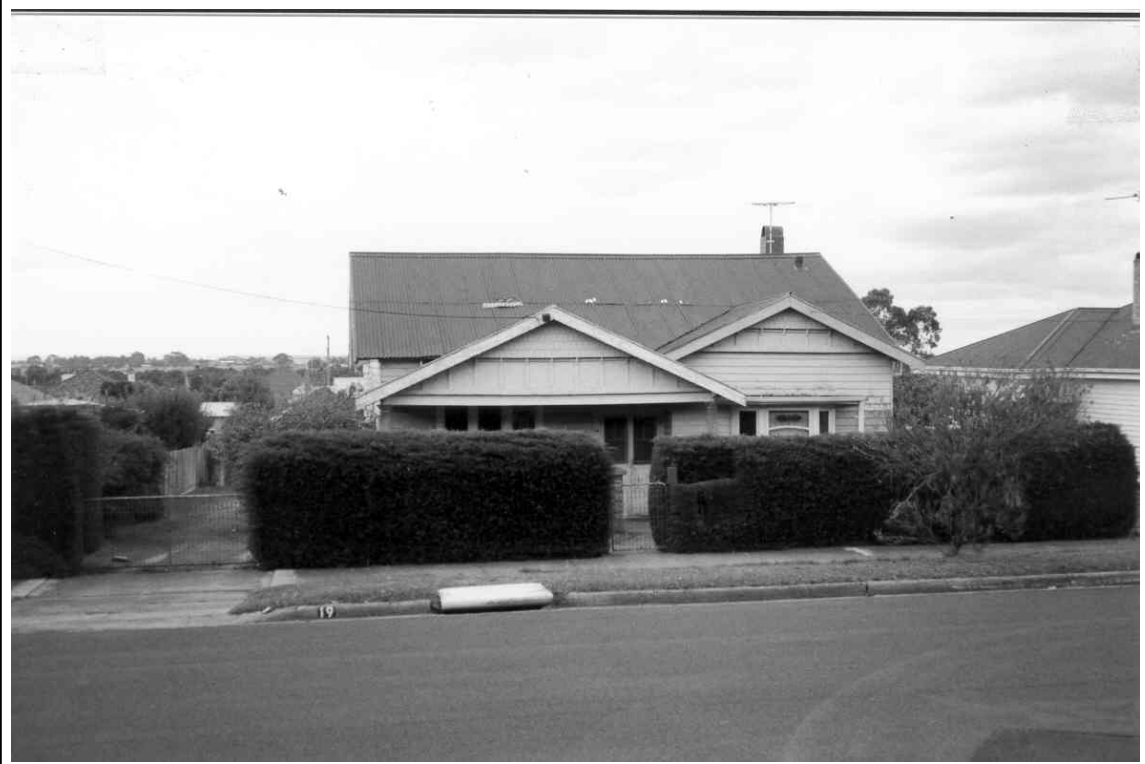
The asymmetrical, single storey, weatherboard interwar Californian Bungalow is characterised by a gable roof form that traverses the site, together with a minor gable and verandah gable that project towards the street frontage. These roof forms are clad in painted, lapped galvanised corrugated iron. An early brick chimney adorns the roofline. Wide overhangs are a feature of the eaves. The early timber framed double hung windows are arranged as a horizontal bank of three under the verandah and as a projecting flat roofed bay (with a central fixed light denoted by a bowed sash). The front timber and glazed doors may also be early.

A feature of the design is the projecting verandah gable. It is supported by early, square, fluted, concrete Doric columns which in turn are supported by face brick piers with concrete cappings.

Apart from these verandah elements, early decorative features of the design include the window leadlighting and the gable infill (brackets, stucco work, battening and shingling).
