**BELMONT HERITAGE REPORT (INDIVIDUAL CITATIONS)
(FORMERLY PART OF THE GREATER GEELONG OUTER AREAS HERITAGE STUDY STAGE 2)**

Existing Use/Type Suburban Residential		Key Dates Original 1913-14		Site Address Street/Site Name No. 195 Roslyn Road	
Survey Date 20/04/1998	Cons Man Plan	Major Changes		Town/Suburb Belmont	Postcode 3216
Recorded By David Rowe		Precinct Name	Current Site Name House

Site Address	No.	Street/Site Name	Town/Suburb	Postcode
	195	Roslyn Road	Belmont	3216
	Site Name		House

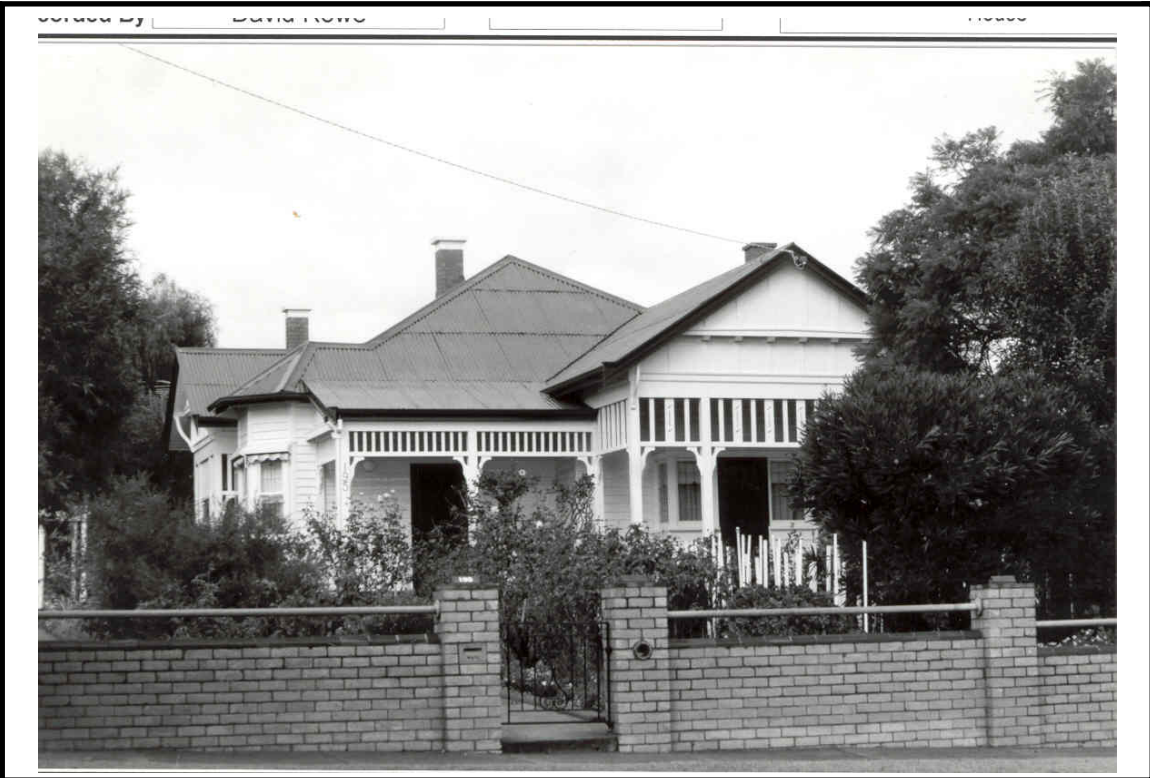
The single storey, asymmetrical, horizontal weatherboard, Federation styled house is characterised by a picturesque arrangement of roof forms, including a central recessed hipped roof, together with projecting minor gables, skillion verandah and window bay. These roof forms are clad in early, painted and lapped galvanised corrugated iron. Three early, unpainted brick chimneys with rendered cappings adorn the roofline. Wide overhangs are a feature of the eaves. The early timber framed windows are fixed and double hung, and the front timber door appears to be early.

A feature of the design is the front verandah that spans across the whole of the street facade, under the projecting gable and skillion. It is supported by early square timber columns, worked timber brackets and distinctive timber fretwork valances. These features are continued at the side to the east, where other porches and verandahs are located. Another feature of the design is the bay window that projects towards the east.

Apart from the verandah elements, early decorative features of the design include the worked timber gable brackets and the gable infill (roughcast panelling, timber battening and small timber brackets).
