**BELMONT HERITAGE REPORT (INDIVIDUAL CITATIONS)
(FORMERLY PART OF THE GREATER GEELONG OUTER AREAS HERITAGE STUDY STAGE 2)**

| Existing Use/Type Suburban Residential | | Key Dates Original 1961 | | Site Address Street/Site Name No. 209 Roslyn Road | |

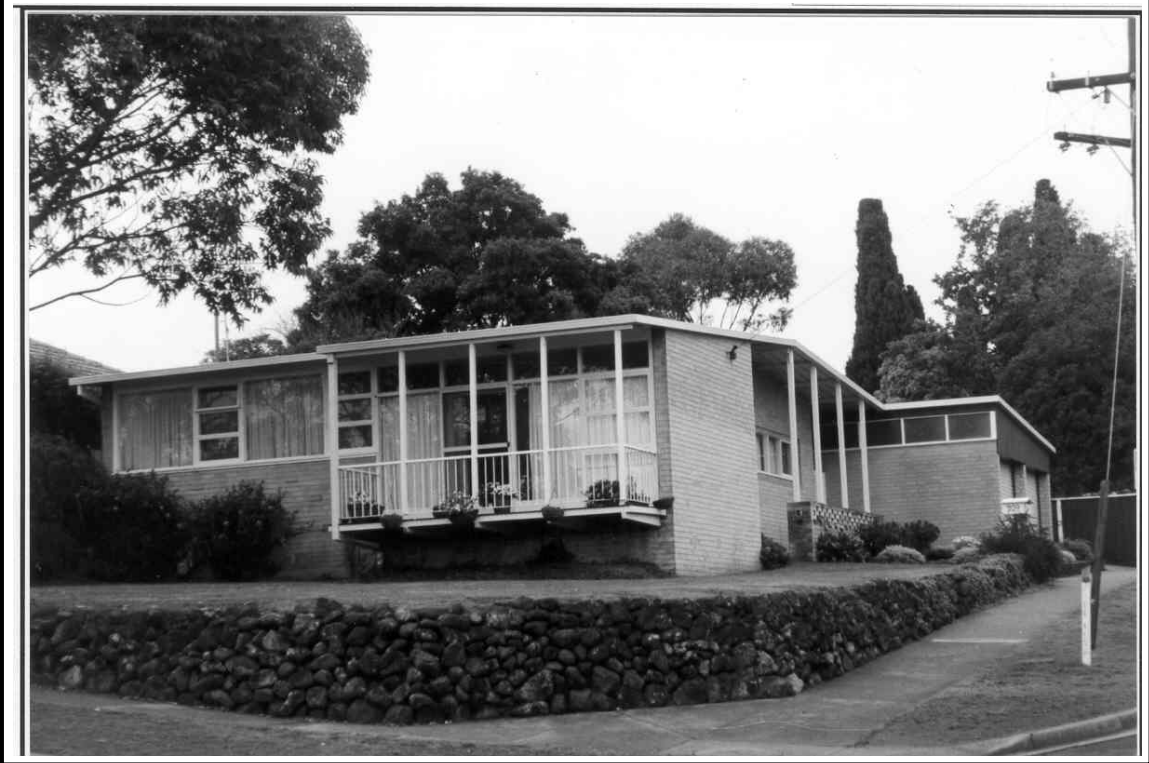
| Site Address | No. | Street/Site Name | Town/Suburb | Postcode |
|--|---|--|---|---|
| <p>The house at 209 Roslyn Road has a large front setback (approximately 6 metres), with smaller sidebacks (approximately 1 - 3 metres), with a driveway along the side at the rear. These setbacks are shown on the 1961 GWST Plan of Drainage.² The front is bound by a dry stone retaining and garden wall, approximately 1 metre high.</p> <p>The single storey, unpainted cement brick, Postwar Modern house is characterised by a shallow sloping gable roof form and skillion garage roof at the rear. These roof forms appear to be clad in galvanised iron decking. The house is also characterised by the protrusion and recession of spatial forms, together with the combination of very wide eaves forming verandahs.</p> <p>The facades of the house, typical of the postwar modern style, are also a geometrical essay of brick and sheets of glass subdivided into rectangles by early timber frames. Pivot windows and expansive glazed doors are other features.</p> <p>Another feature of the design are the verandahs. The verandah which projects towards the street frontage has a cantilevered floor and the roof is supported by plain square timber posts with a steel balustrade between. The side verandah is also supported by square timber posts which in turn are supported by an unpainted brick dwarf wall/balustrade that has a strong rectilinear pattern formed by the hollow spaces between the bricks.</p> | | | | |
