Name	Viewbank (ruin)	Reference in 1998 Marong Study	SU2
Address	2856 Elmore-Raywood Road , north-east of intersection with Ludemans Road, Raywood ¹	Map reference	VicRoads 44 F2
Building type	Timber ruin, presumed to be a food store	Survey date	August 2010
Date of construction	After 1882	Recommendation	Include in the Schedule to the Heritage Overlay
Significance	The log ruin is of local historical and technological significance.

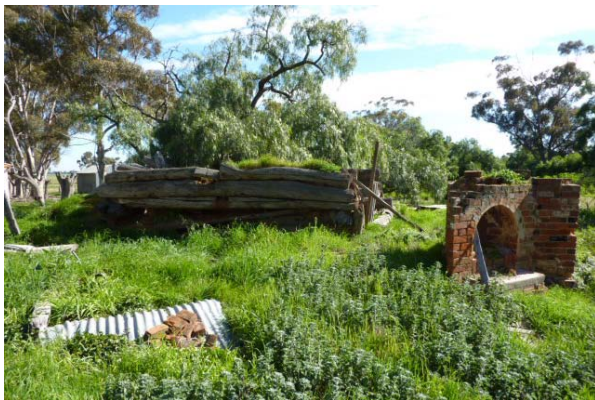
Left: South side of the former store, with the fireplace of the former house at right. Right: The entry to the former larder (east face).

The collapsed log structure at *Viewbank*, a property on the north side of the Elmore-Raywood Road at Summerfield, is of massive construction, and comprises double thickness logs walls with the cavities filled with earth. There is a rammed earth embankment at the rear (west). The logs have chocked corners fixed with iron pins. The corner posts have U shaped terminations accommodating cross beams. There is evidence of notches cut for a cross beam to carry the roof in the centre of both sides. The remnant roof structure comprises beams oriented east-west. It is possible that the roof was pugged with earth as a sealant. No evidence survives of the original entry.

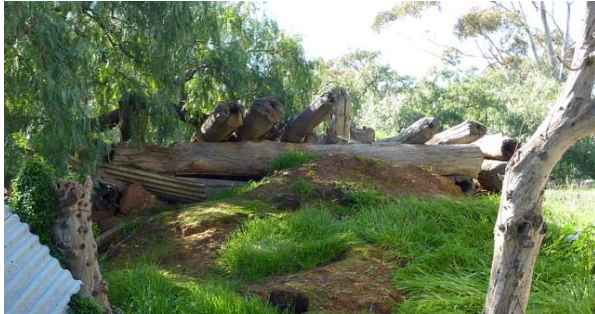
Left: Embanked earth at the rear of former food store. Right: Detail of south face.
