Former Melville's Grain Store at 11-17 Colebrook Street, Brunswick.

## CONSERVATION MANAGEMENT PLAN

Final Document: (Issued) 6 July, 2012

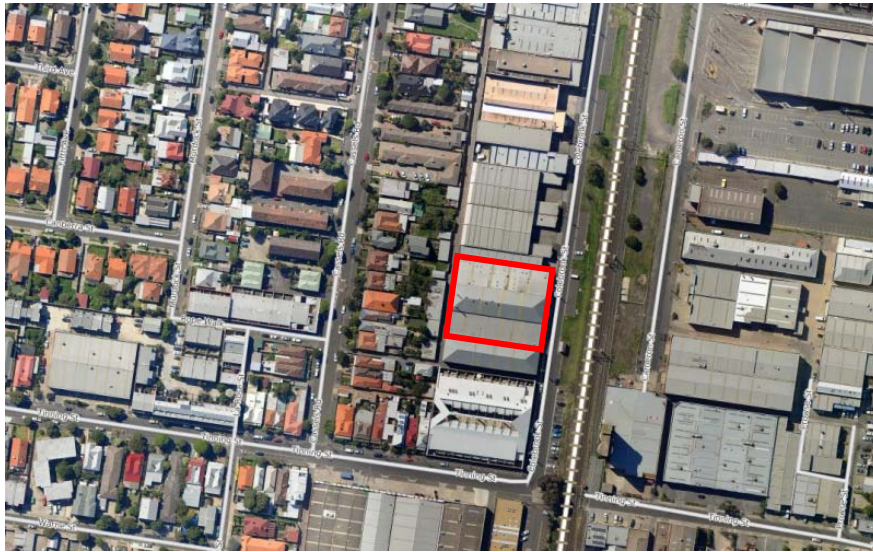
Fig 1: Subject site outlined in red.  
Source: Nearmap, accessed 3/7/12

Shed 4 is situated at 1-17 Colebrook Street, Brunswick (Melway Ref: 29G5.), adjacent to the Upfield railway line just north of Anstey Station. The subject site forms the northern part of a complex of three bluestone buildings at 1-17 Colebrook Street, known as *Former Melville's Grain Store* (FMGS), and forms part of the land included in Certificate of Titles Vol. 2165 Folio 889 and Vol 1951 Folio 633. The site is indicated in figure 1 below.

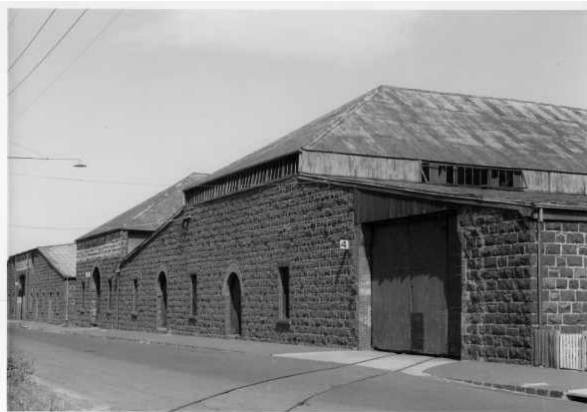
Fig 3: Oblique view and main elevation of Shed 4 in the foreground.  
Source: State Library Victoria. Id: jc012269, date 1964.

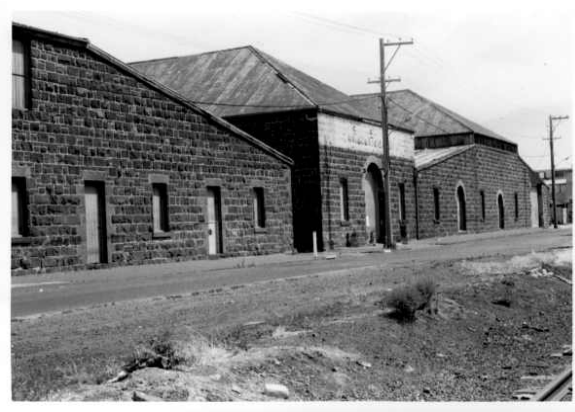
Fig 4: From left to right: Shed 2, 3 and 4.  
Source: State Library Victoria. Id: jc002685, date 1985.

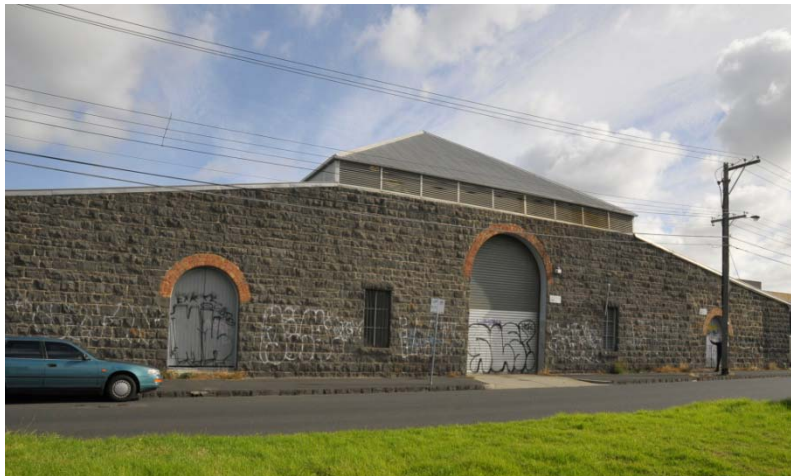
**Fig 5:** Principal (east) elevation from railway track.  
**Source:** Trethowan, April 2012

The eastern elevation of the building forms the principal facade. This elevation comprises of four entry points and two windows. The doorways range in size from a single leaf through to the large roller shuttered opening that extends to approx 6m in height. The majority of the doorways are trimmed with red-brick semi-circular arches and squared bluestone reveals. With the exception of the roller shutter, the doors are of a timber ledge and brace type. The two rectangular window openings, either side of the main central door, have bluestone lintels, sills and squared reveals. Both windows are divided into six equally sized panes of glass and comprise later fabric. One window retains its metal security bars. To the north end of the east elevation there is evidence of an earlier opening having been filled it. The opening, due to the train tracks in the roadway, was clearly the access point for the arrival and departure of goods from the train line. The arched doorway in this location is evidently later than the original openings. Later louvered wall cladding links the bluestone wall with the main hipped roof. The skillion roof covering overlaps timber bargeboards to both side wings of the building.

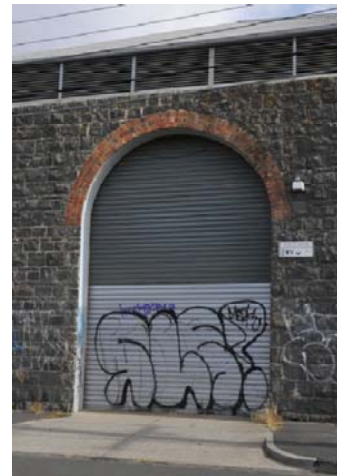
**Fig 6:** Central doorway, post 1985, with graffiti to the roller shutter door and stonework.  
**Source:** Trethowan, April 2012

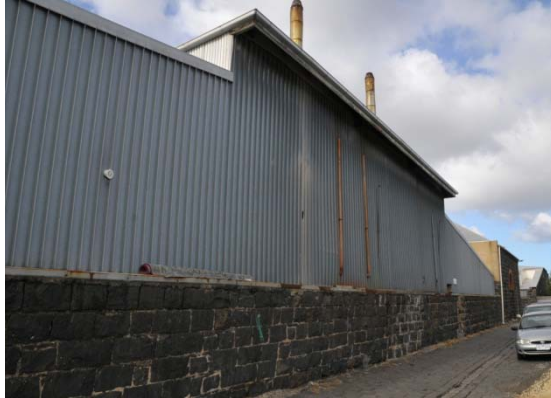
The western wall, which backs onto a bluestone laneway, consists of an original bluestone wall that is currently at approx 1.5m high. Two single leaf doorways have been later formed in the stonework at each end of the wall and both have a concrete step up into the building. A metal capping has been cemented to the top of the wall, and it is from this point that the later standing seam metal wall cladding begins and continues up to the eaves.

Fig 7: Rear (west) elevation from laneway looking south.  
Source: Trethowan, April 2012.

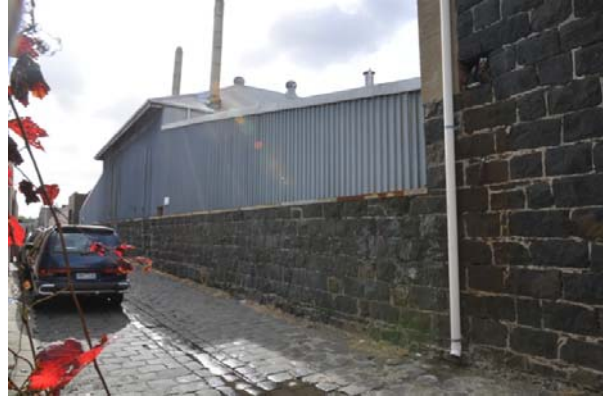
Fig 8: Rear (west) elevation from laneway looking north.  
Source: Trethowan, April 2012.

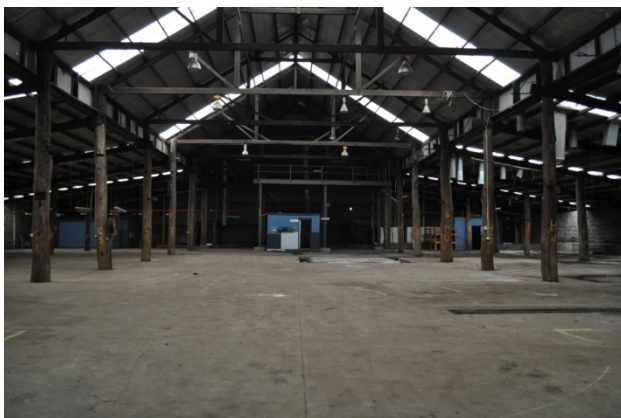
Internally the building is basically one vast space with existing remnant equipment from its former use to the west end and a number of single storey stand alone structures; offices, stores, toilets and reception areas, to the east (Fig's 9 and 10).

Fig 9: Internal view looking west.  
Source: Trethowan, June 2012.

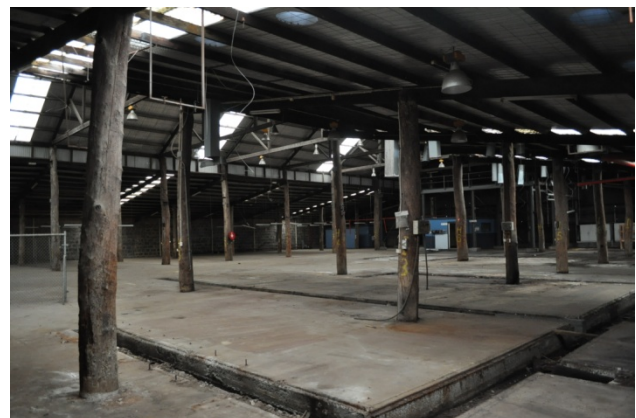
Fig 10: Internal view looking southwest.  
Source: Trethowan, June 2012.

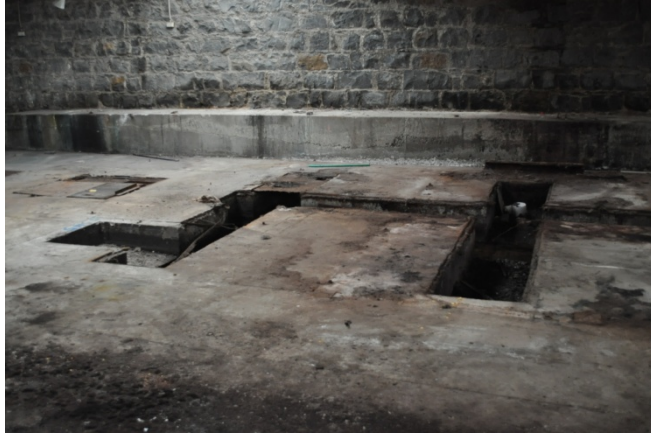
The interior has a concrete slab floor which includes a series of channels and pits (Fig 11). Some tiled floor coverings have been used at the eastern end (Fig 11). Concrete has also been used to provide an extensive up-stand that runs along the base of the western wall and partially along the northern wall (Fig 11). Further concrete pads have been inserted to support a steel framed platform, part of the former use of the building. A concrete ramp to the east end permits the main transition from street level to internal floor level.

**Fig 11:** Channels, pits and concrete up stand located in the north east corner.

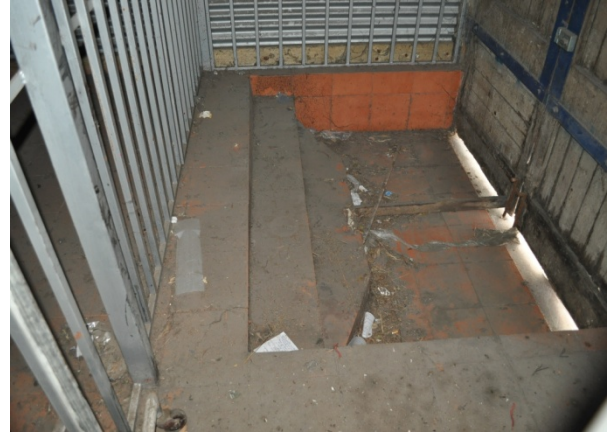
**Fig 12:** Pedestrian steps showing the transition from street level to the FFL of the internal concrete floor.

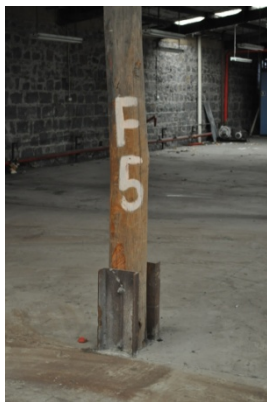
Four rows of large tree trunks, running east – west, project out of the concrete floor and provide the main structural support to the roof structure (Fig's 9 and 10). Some trunks have been replaced, while some have received additional strengthening to the base (Fig 13). Evidence of earlier, likely bluestone, pad stones are sometimes visible at the base of the trunks (Fig 14) and one pad has been replaced with a brick pier. The shorter outer rows of trunks support the timber rafters (Fig 17) to the skillion roof, while the taller inner rows support the timber trusses that hold up the hipped roof. Joints between these members are crude and bolts tie the two members together (Fig 16). A number of the trunks have been used to provide additional support to the independent structures and are showing signs of decay, particularly to the base (Fig 15).

**Fig 13:** Timber post showing additional steel bracing.  
**Source:** Trethowan, June 2012.

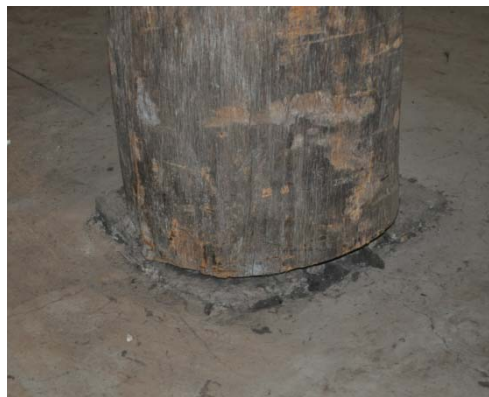
**Fig 14:** Base of timber post on bluestone post.  
**Source:** Trethowan, June 2012.

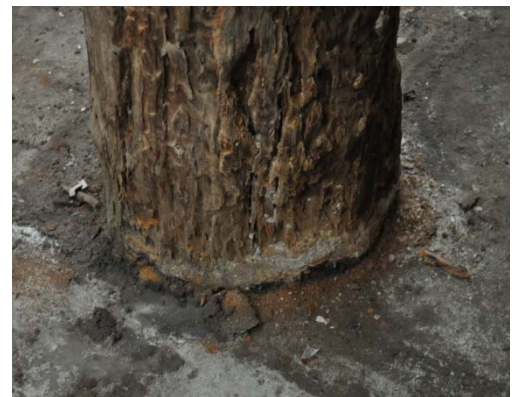
**Fig 15:** Base of timber post showing signs of decay.  
**Source:** Trethowan, June 2012.

Overall Shed 4 presents in good condition. The roof and its structure show no signs of decay and no visible leaks were detected. However, some of the bluestone walls are showing signs of damp; possibly from defective downpipes and gutter system or rising damp. Some cracking has also been detected in the north-east corner. The street elevations have undergone a degree of vandalism through graffiti. Internally a number of the supporting tree trunks have been replaced, damaged and/or been given additional structural bracing. Some trunks are also showing signs of decay, especially at the base.

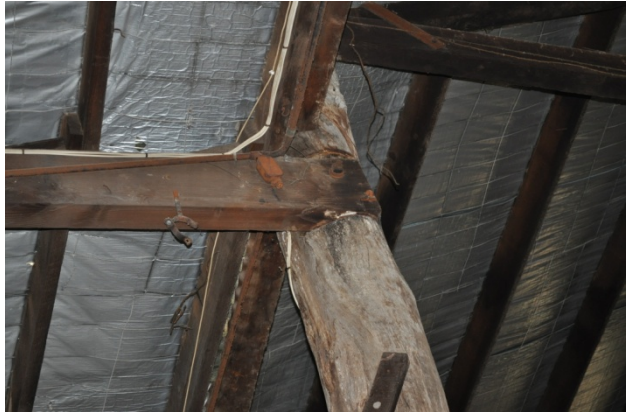
**Fig 16:** Detail of the crude joint between the timber post and the rafter.

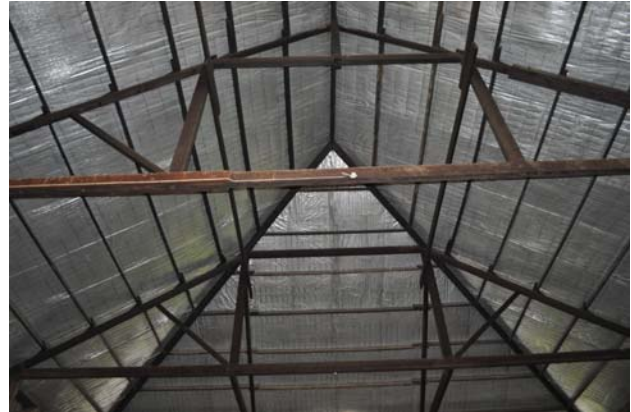
**Fig 17:** Timber trusses beneath the hipped roof.

The underside of the roof covering is visible and identifies a modern 'thermo foil' type roof insulation that indicates the current roof covering is a replacement (Fig 17).

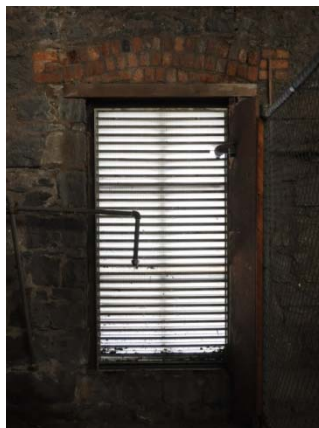
**Fig 18:** Internal view of the brick arch.

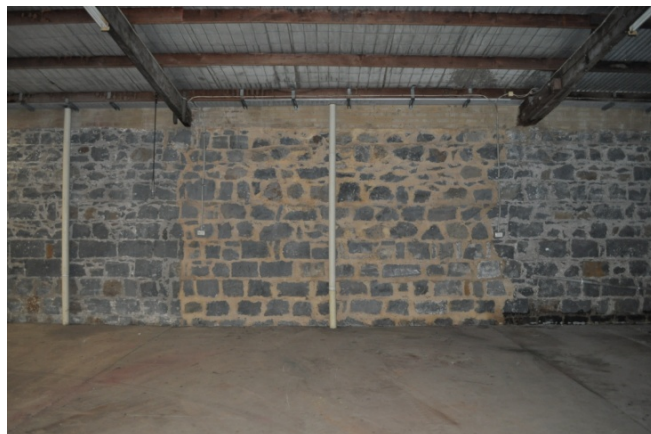
All internal faces of the bluestone walls remain untreated i.e. no paint layer, plaster or internal linings (Fig 19). The internal face of the principal facade shows the brick arches to the windows and doors. A further timber lintel, below the brick arch, is also visible to the windows (Fig 18). On the top of the southern wall the later 'bagged' brickwork is evident and encloses the ends of the rafters. Evidence of alteration / repair, and possible patches of damp (Fig 20) is seen on the southern and northern walls. Plastic internal downpipes are also in existence to drain the roof to a assumed ground water drain.

**Fig 19:** Internal face of the southern wall that identifies an alteration, the unadorned stonework and the bagged brickwork to the top of the wall.

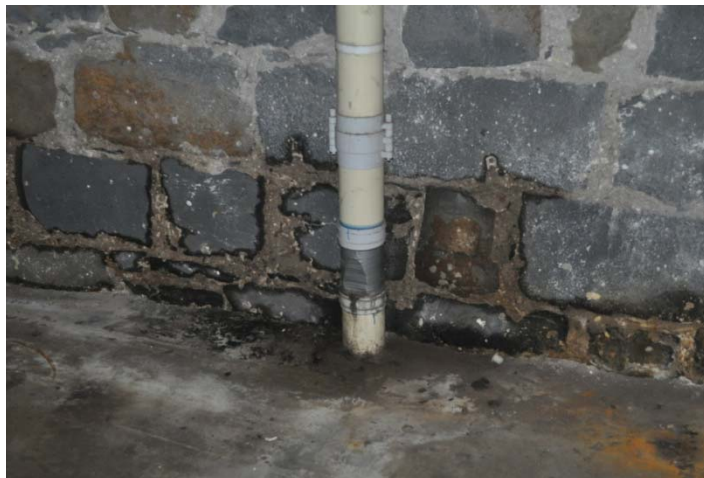
**Fig 20:** Evidence of damp in the southern wall. Damaged plastic pipe is probably the cause.

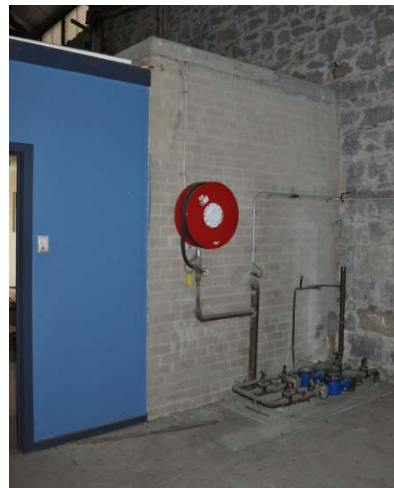
Further masonry structures are located in the southeast corner which houses an electrical substation (Fig 21), and forms enclosures to the rear access points.

**Fig 21:** Masonry structure that houses the electrical substation in the southeastern corner.

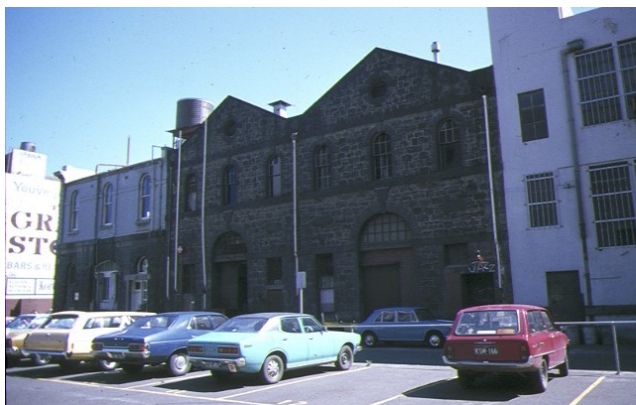
Many large bluestone warehouses exist in the Central Business District (CBD) and were constructed between 1850s and 1870s. Often sited for easy access to the dock area, the large imposing buildings range from two to five storeys, with extensive basements and/or attached offices. The large size of the buildings reflected their use as storage for all types of goods, and it appears that only a handful had a specific use, i.e. the storage of wool. Architecturally these buildings commonly adopted a classical appearance and many were designed in the Renaissance Revival style. As most of these city warehouses were considered prestigious, they were often designed by prominent architects such as Leonard Terry (Former Levicks & Piper Wholesale Ironmongers Warehouse (HO431)) and John Gill (516-526 Bourke Street (HO104)).

**Fig 24:** Former Levicks & Piper Wholesale Ironmongers Warehouse (HO431).  
**Source:** Victorian Heritage Register Database, accessed 2/7/12.

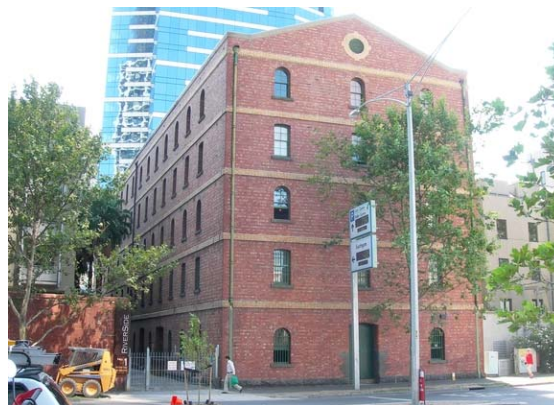
**Fig 25:** Jones's Bond Store (HO828).  
**Source:** Victorian Heritage Register Database, accessed 2/7/12.

Outside the CBD in other dock areas like Southbank, the warehouses / stores retained their classical architectural style and large size but were generally constructed of red brick with cream brick detailing; as seen in the Jones's Bond Store (HO828). Moving further away from the dock area, research determined that bluestone was again adopted but this time on a much smaller scale like the single storey building at 41 Madden Grove, Richmond (HO275). Although on a smaller scale it is noted that this particular example still retains the classical architectural style.
