**OLD MELBOURNE GAOL
CHAPEL & ENTRANCE
BUILDINGS**

*"RMIT HISTORIC
LEGAL PRECINCT"*

CONSERVATION PLAN

September 1998

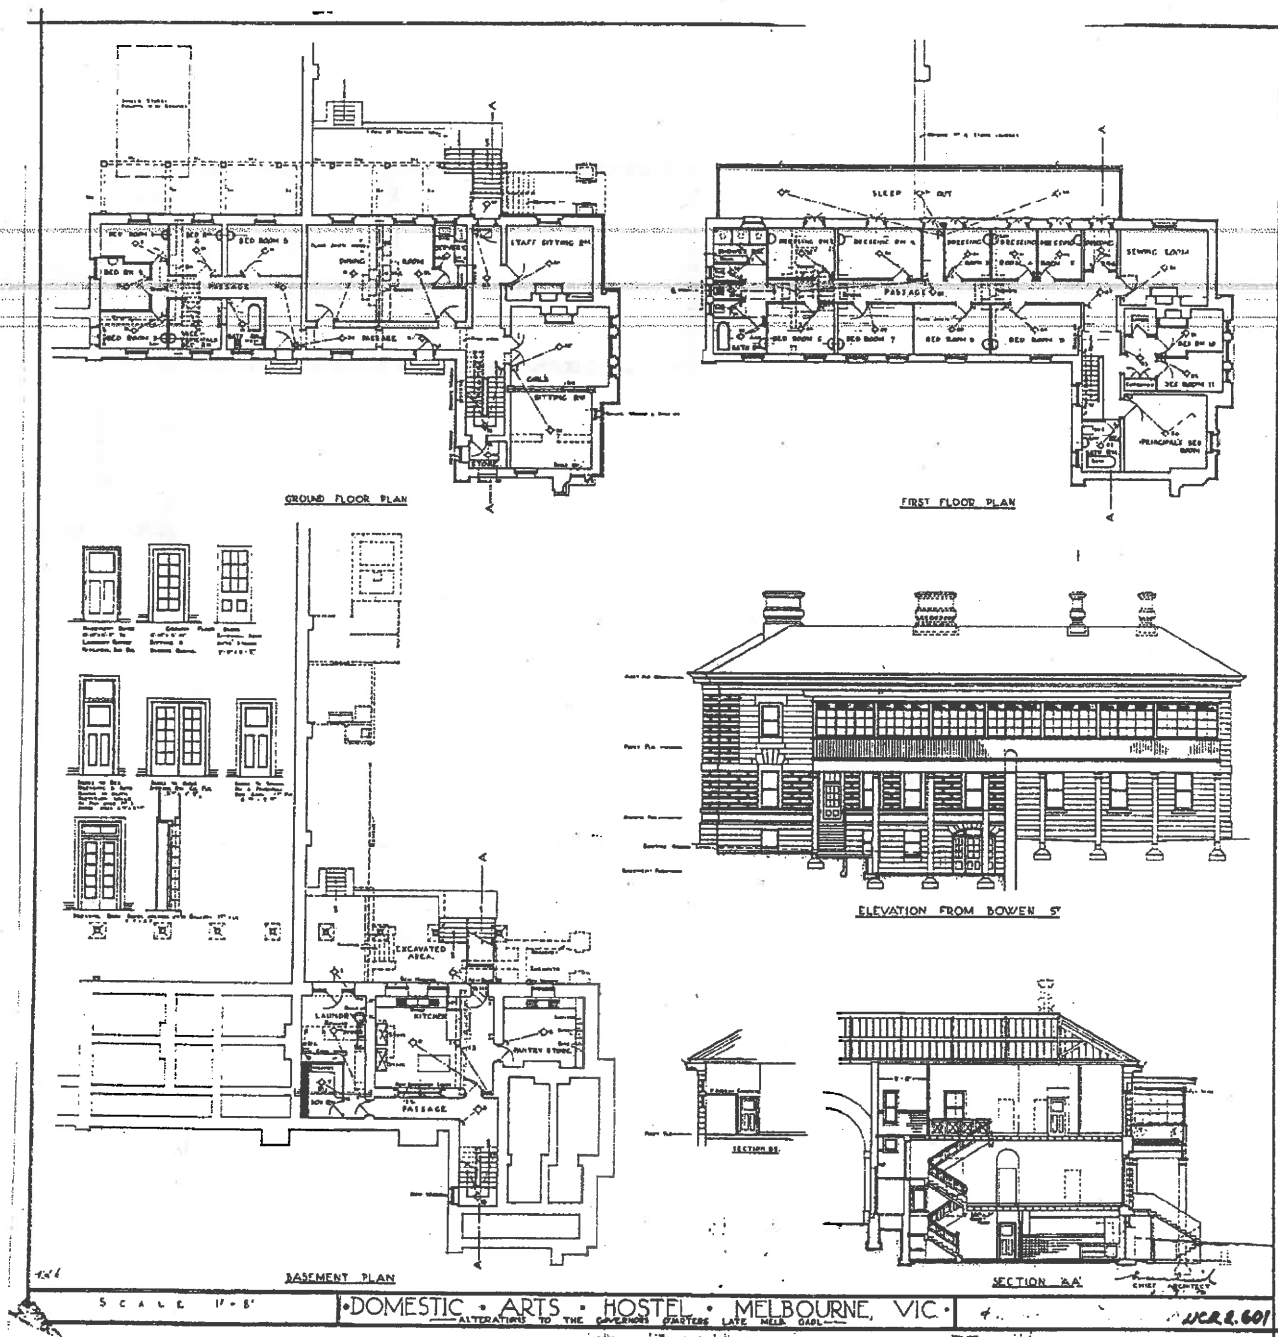
Figure 9 "Domestic Arts Hostel Melbourne" Alterations to the West Wing, 1926

Part of the original timber floor construction on the eastern side of the West Wing, on both the ground and first floors, was replaced by a concrete floor during the remodelling of 1926. (see Figure 9) The area was altered to accommodate a new concrete stair and resulted in three concrete landings

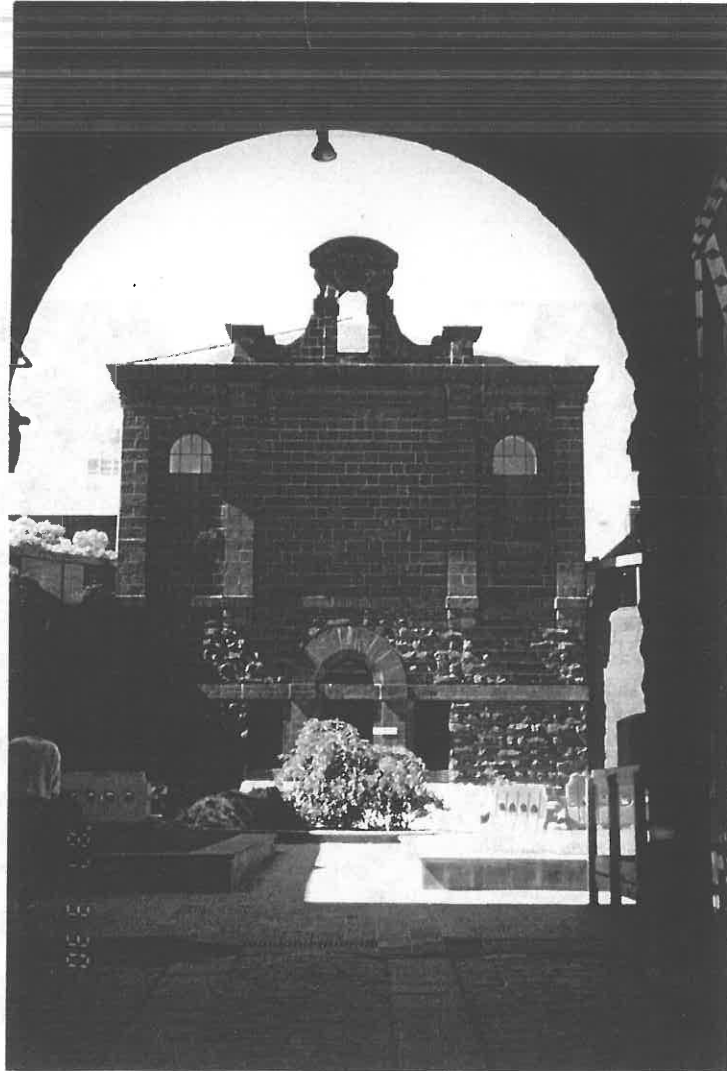
Photo 1 North Elevation of the Chapel Building

The stone along all three facades of the Chapel Building are in excellent condition. Some re-pointing is required.

Immediate (0-2 years)	Approximate Costs
EAST FACADE	
- re-point bluestone wall	\$13,260.00
- replace one downpipe and re-paint	\$150.00
- re-paint windows	\$2,400.00
NORTH FACADE	
- re-point bluestone walls	\$340.00
- re-paint door and windows	\$600.00
- repair crack in stone threshold	\$60.00

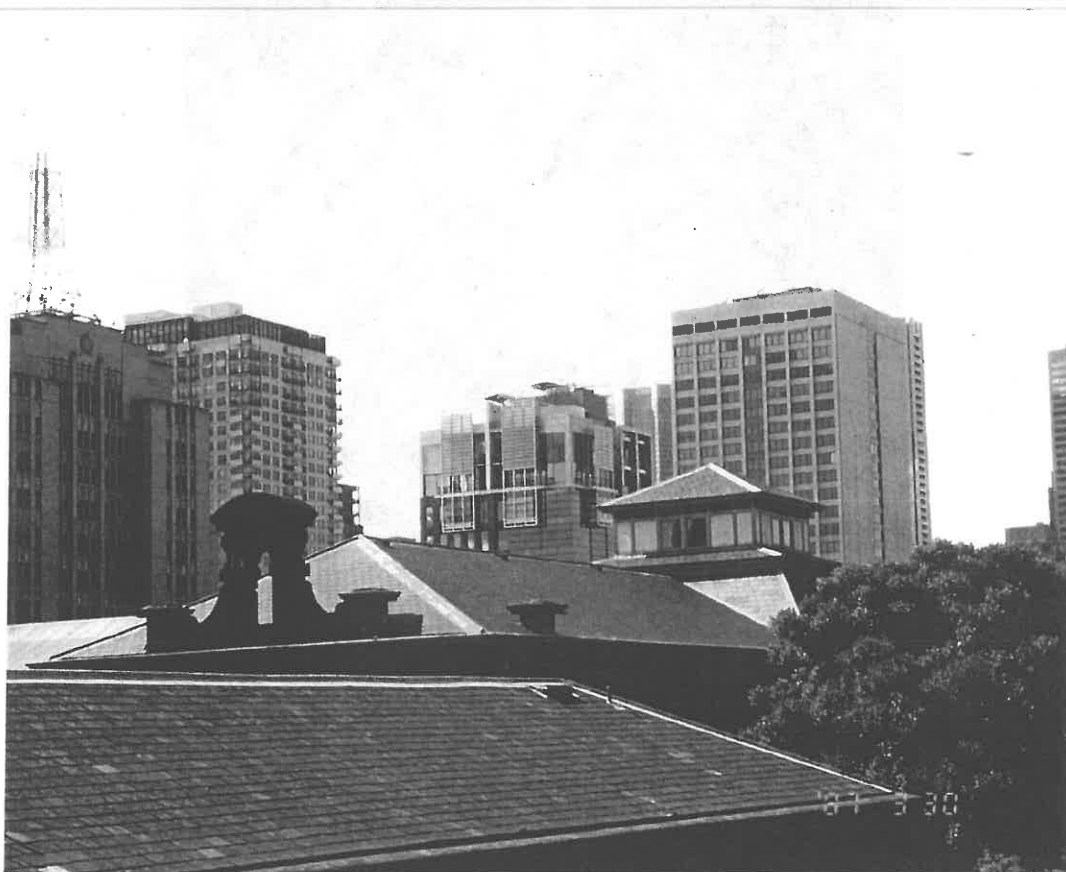
Photo 4 North-west view of the roof of the Chapel Building

The roof covering the Gaol Chapel Building is slate with either galvanised or copper gutters and downpipes. Most of the slate roofing and drainage material are either showing failure or rusting. Most of the slate will have to be

Works to the slate roof will need to be undertaken within the next two years. When this work is organised, all of the slate needs to be removed, some of the slate will be salvaged and cleaned the rest will need to be replaced with new or re-claimed slate. Sarking and new battens will need to be allowed for, and the slate re-nailed/nailed in place.

Almost all of the roof plumbing will need to be replaced using ogee type galvanised steel gutters and round section galvanised steel downpipes. Painting of all roof plumbing should be considered.

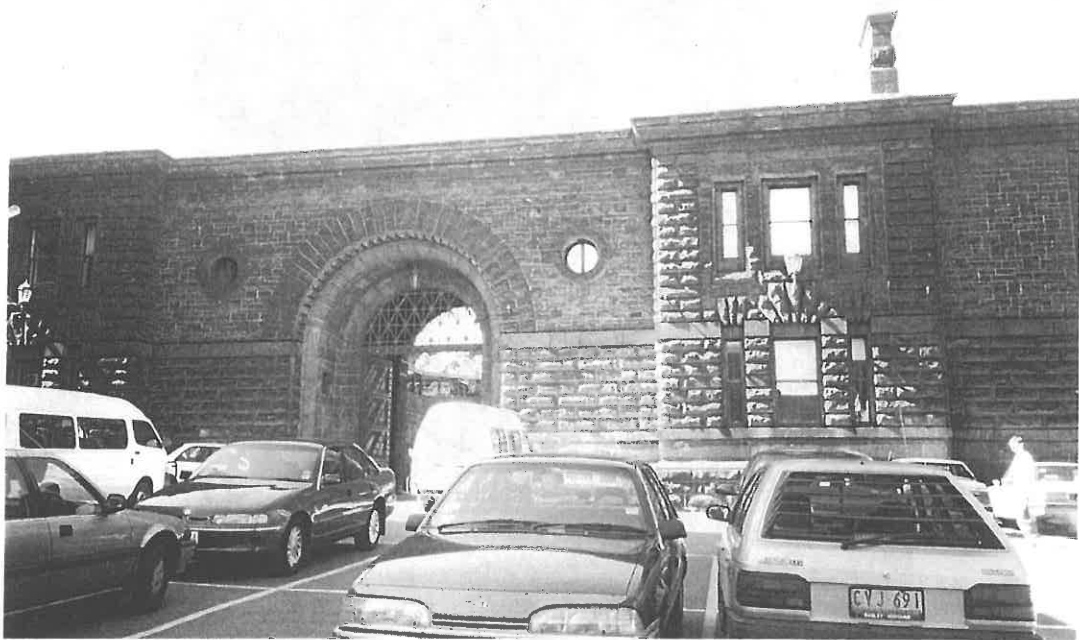
Photo 10 North Elevation of the Administration/Entrance Buildings

The stone of the west, east, north and south facades of the Administration/Entrance Buildings (including the two joining walkways to the Chapel Building) are in relative good condition. Some cleaning, indent repairs and tuck-pointing to the bluestone walls is required.

Clean the bluestone, complete indent repair as noted in the priority works list and tuck-pointing of all facades and the walkway walls as soon as practicable.

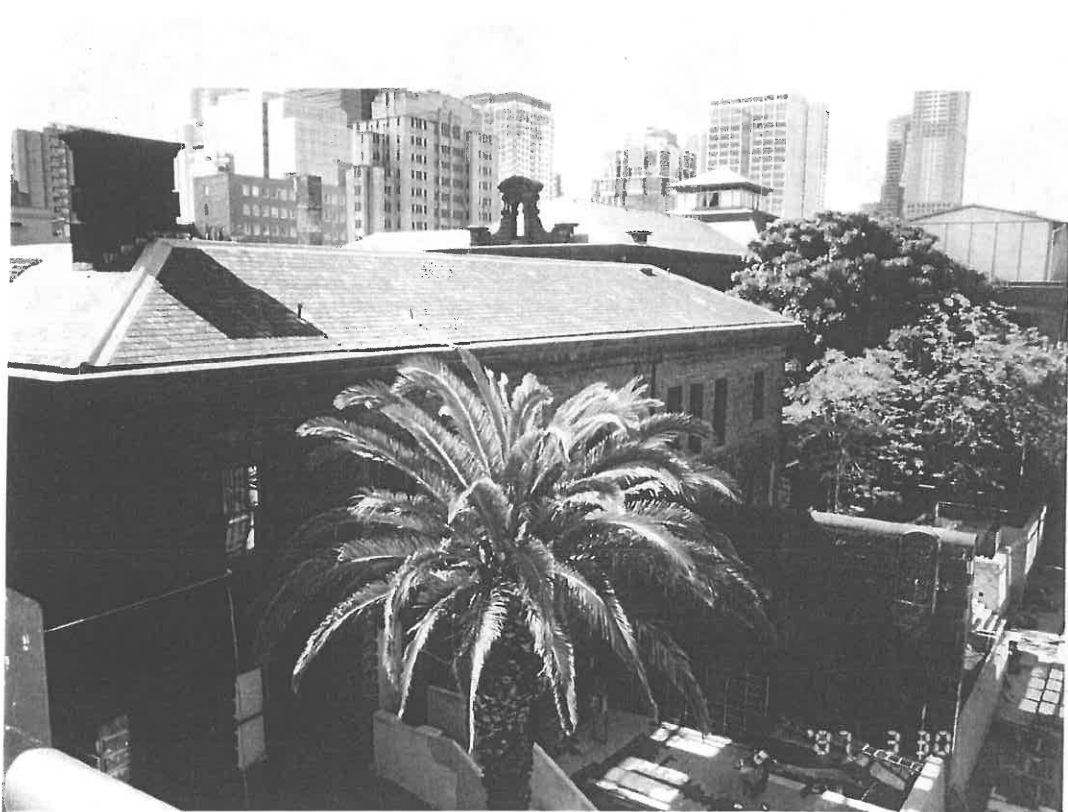
Photo 14 Roof of the West Wing

The roofs covering the Administration/Entrance are corrugated galvanised steel above the verandahs and slate roofing above the main buildings. Most of the roofing and drainage material are either showing failure or rusting. Most of the slate will have to be removed and re-nailed to ensure that no further leaks occur inside the buildings.

Works to the slate roof will need to be undertaken within the next two years. When this work is organised, all of the slate needs to be removed, some of the slate will be salvaged and cleaned the rest will need to be replaced with new or re-claimed slate. Sarking and new battens will need to be allowed for, and the slate re-nailed/nailed in place.

Almost all of the roof plumbing will need to be replaced using ogee type galvanised steel gutters and round section galvanised steel downpipes. Painting of all roof plumbing should be considered.

Immediate (0-2 years)	Approximate Costs
<u>WEST WING (INCLUDING PART OF THE ARCHED ENTRANCE)</u>	
ROOF (refer to photo 14)	
- replace all box gutters	\$8,100.00
- replace 70% of slate	\$56,000.00
- remove slates and battens, relay slates (re-used) and replace battens	\$48,000.00
- provide sarking	\$7,200.00
- replace all ridge cappings	\$5,100.00
- replace flashings	\$480.00
- replace valley gutters	\$2,700.00
- re-point stonework along the eaves line	\$2,380.00
<u>EAST WING (INCLUDING PART OF THE ARCHED ENTRANCE)</u>	
ROOF (refer to photo 13)	
- replace a small amount of slate	\$4,400.00
- replace all box gutters and eaves gutters	\$16,200.00
<u>GENERAL</u>	
Inspection of all stormwater drainage with video system	\$1,000.00
