## STAMFORD PARK, ROWVILLE CONSERVATION MANAGEMENT PLAN

Reviewed and updated

Final Report  
June 2013

Prepared for  
Knox City Council

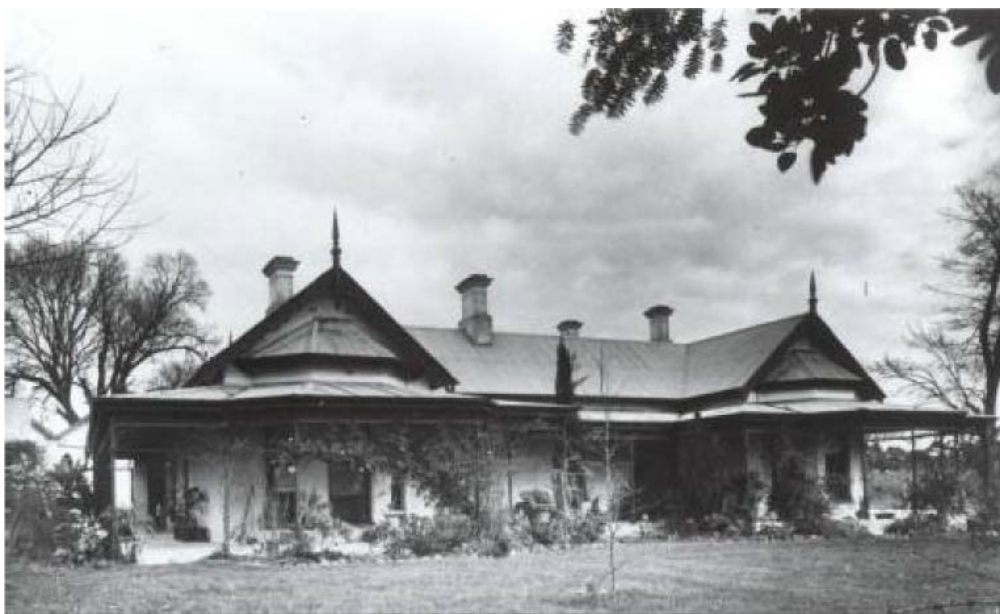
*Figure 1 - Stamford Park Homestead. (Source: Knox Historical Society)*

The homestead itself consisted of the single-storeyed main house, containing eight principal rooms, with a detached kitchen wing. Internally, floors were of New Zealand Kauri, there were ceiling roses throughout and the slate fireplaces were painted in imitation of marble (Allom Lovell 2002)<sup>5</sup>.

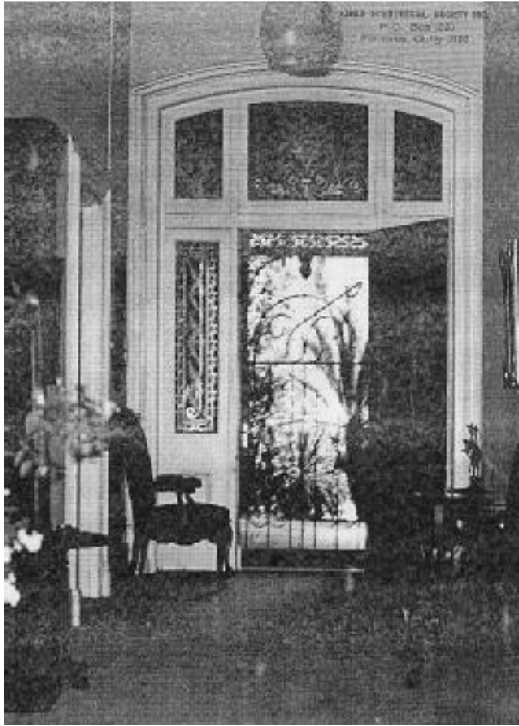
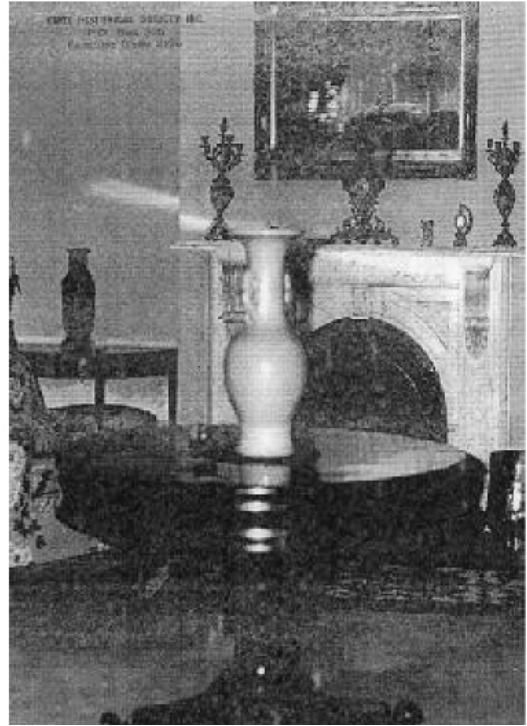
*Figure 2 - Main entrance hall (left) and drawing room with original fireplace (right). (Source: Knox Historical Society)*

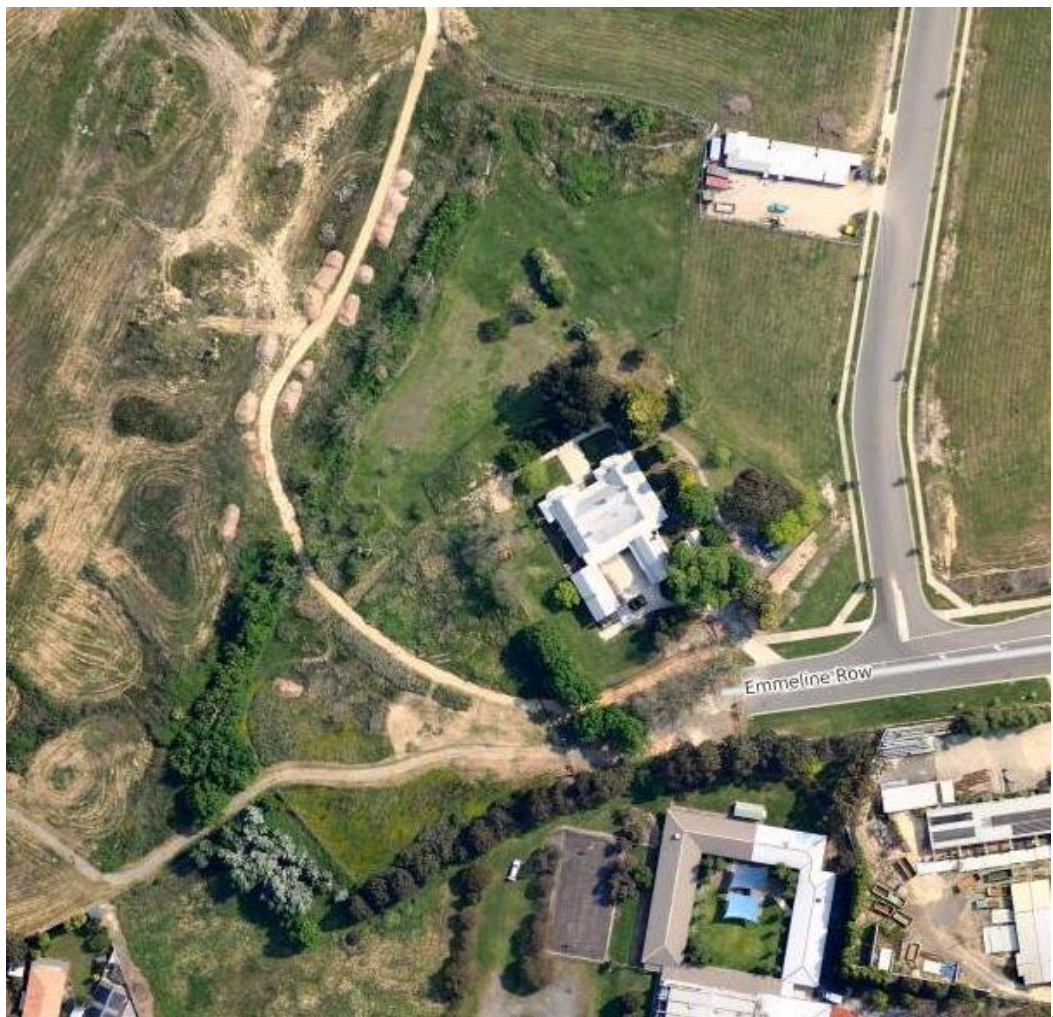
Figure 4 - Aerial view of Stamford Park in 2012. (Source: nearmap.com)

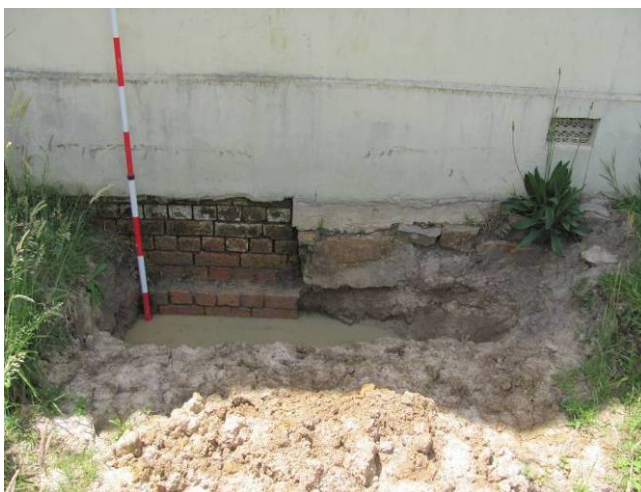
Figure 5 - Trench excavated against the south-western wall of the main house, showing the different foundations beneath Rooms 10 (left) and 11 (right). (Source: Context 2012)

In June 2009 an archaeological trench was excavated against the outside face of the house's western wall, in order to identify a possible change in building construction between rooms G10 and G11 (DIG International 2009). The 2m by 2.5m trench was aligned with the wall dividing the two, which also coincides with a vertical crack in the external render of the exterior wall surface – itself an indication of an abutment between two different constructions.

The trench exposed two different foundations. The foundation to the south (the structure comprising Room G11) was found to be 'slightly wider', comprising rough uneven stone blocks bonded with mortar with a keystone at the northern edge. It is abutted by the northern foundation (Room G10) which is therefore of a later date. The northern foundation comprises mortar bonded brick laid as alternate header and stretchers which had been constructed within a narrow brick-wide trench (c. 20cm). The trench appears to have been deepened since the 2009 excavation, and the foundation of Room G11 can be seen to be approximately 0.5m in depth. That for Room G10 extends deeper, to a depth which could not be determined from examination of the trench (as it was flooded at the time of survey) but it can be seen to be corbelled, widening by a brick's width below the earlier foundation.

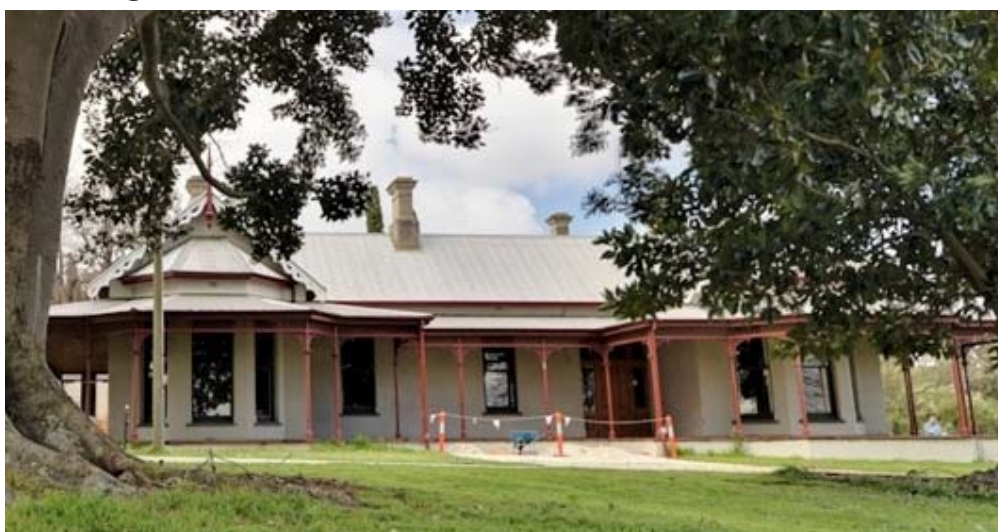
*Figure 6 - The front of the house from the north west. (Source: Peter Kavan)*

Whilst the overall form and detailing of the exterior of the main house closely resembles that shown on historical photos, much of the timber fabric of the fascias, veranda beams, veranda flooring, bargeboards, finials, veranda posts, and all the roof plumbing has been replaced.

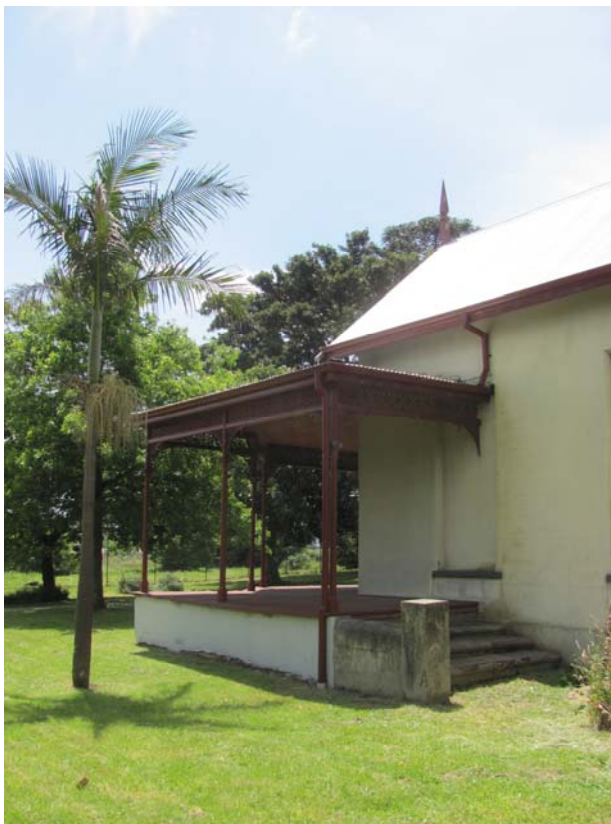
*Figure 7 – The west end of the veranda colliding with one of two blind windows (the other is to the right)*  
(Source: Context 2012)

The side (east and west) elevations are flat, each with an off-centre pair of windows towards the southern end. All windows to the veranda have projecting slate sills with chamfered edges, roll-moulded jambs and heads, and contain timber-framed double-hung sash windows. Windows to the west elevation, where the veranda stops, have sloped rendered sills, plain jambs and flat heads, and contain multi-paned timber-framed sash windows. These windows had narrow louvred timber shutters, since removed, although the original swivelling S-brackets still remain. There are two blind windows on the west elevation, and an unusual feature is that the veranda collides into the first of them. This makes the 'window' a less credible design element and points to a desire to satisfy a pre-conceived design, such as from a pattern-book.

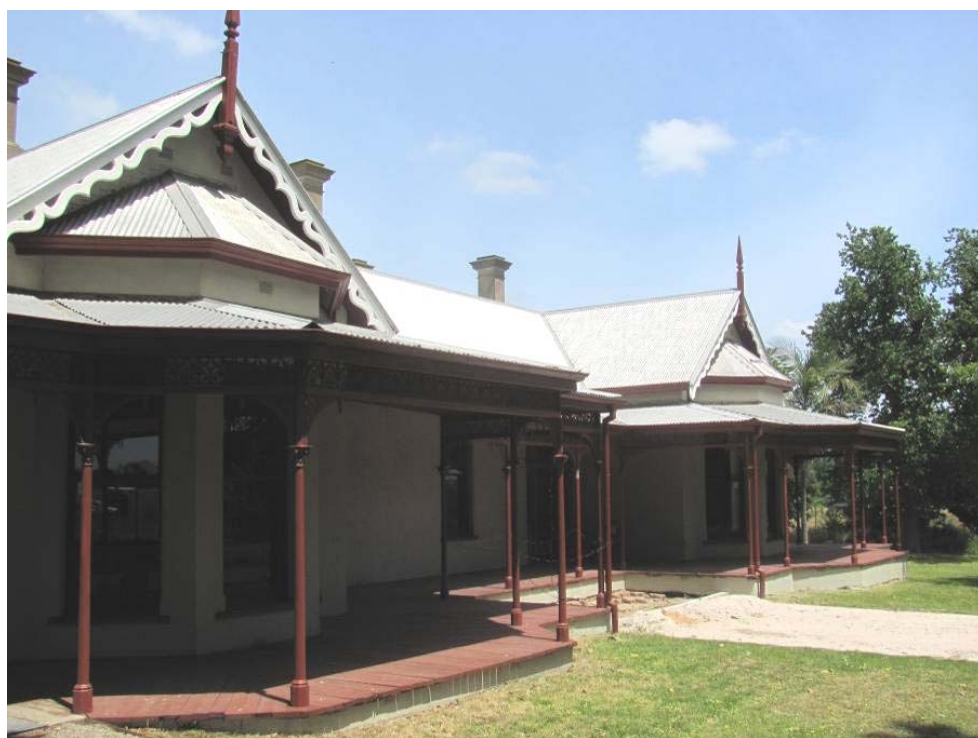
*Figure 8 - Front facade of the main house from the north, showing return veranda, bay windows and gable ends with decorative barge boards. (Source: Context 2012)*

The veranda floor is raised up on a rendered plinth with ceramic vents and remnants of a narrow band of herringbone brickwork (possibly a former spoon drain) along the base. The floor itself is of painted floorboards (not original) which run perpendicular to the outside wall of the house, with a small moulded timber skirting at the junction. At the end of the main veranda's western return is a small flight of granite steps with a rendered dwarf wall.

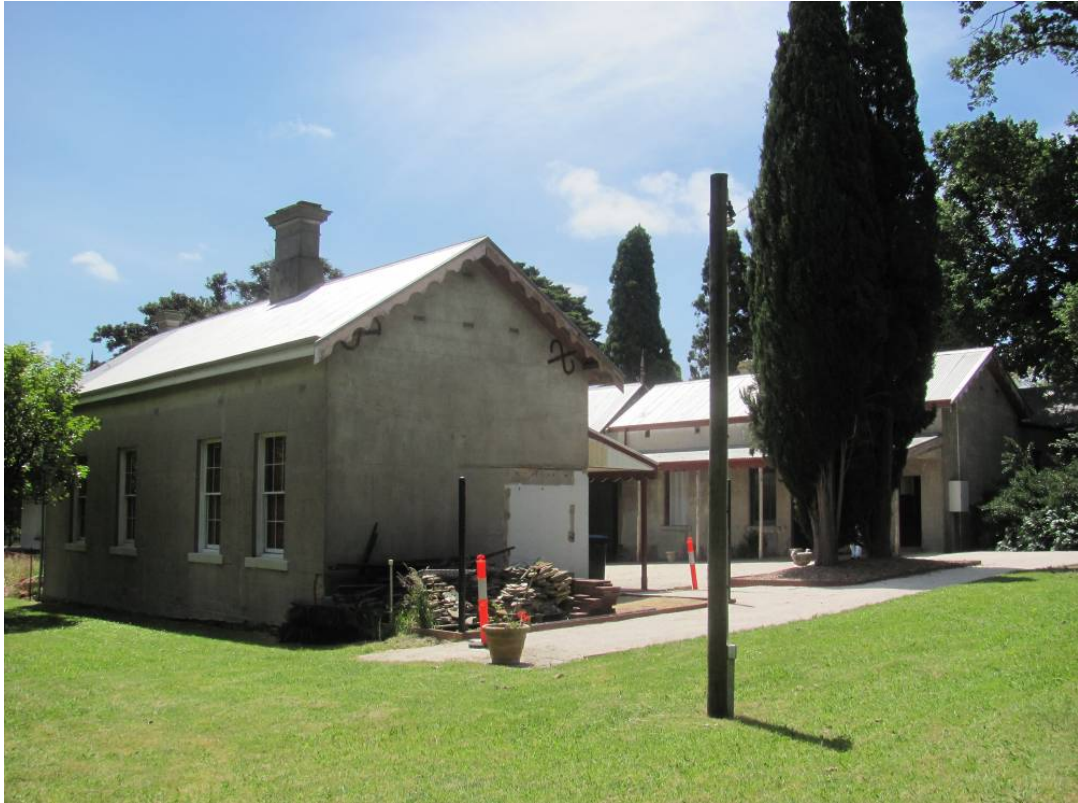
*Figure 9 - View from the southwest showing the two courtyard wings and the pair of Italian cypresses. The white patch on the facing wall shows the previous location of the now demolished WC (Source: Context 2012)*

The south-western wing is a single-storey rendered masonry building, rectangular in plan, with a gabled roof clad in corrugated galvanised steel and penetrated by a chimney at the ridge level. The north and south elevations are windowless, with a row of three metal grille vents near the roofline. The gable ends have scalloped timber bargeboards, and narrow eaves lined with beaded timber boards.

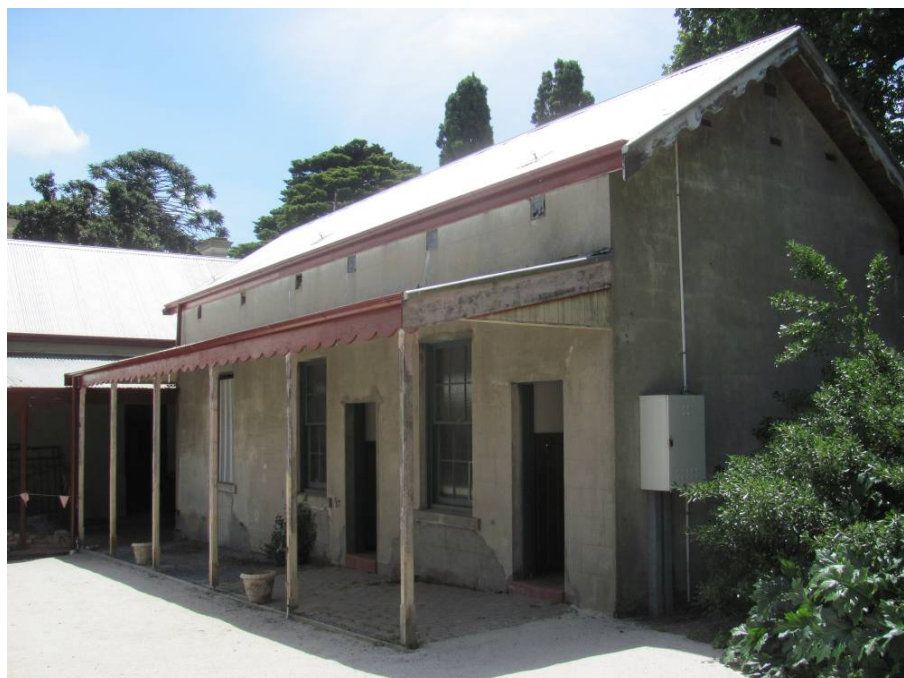
*Figure 10 - South eastern courtyard wing as viewed from the courtyard. The veranda has been reconstructed. (Source: Context 2012)*

The south-eastern wing is a single-storey rendered masonry building, rectangular in plan, with a hipped roof clad in corrugated galvanised steel. The south elevation is similar to the corresponding end elevations of the south-western wing; it has ruled ashlar walls, scalloped bargeboards to the gable end, and wire grille vents. The north elevation, abutting the veranda of the main house, is of ruled ashlar. It has a single doorway to the right side, considerably raised up above the ground line, with a timber threshold. It has a four-panel timber door with flush beaded mouldings and a wrought iron handle which is early, if not original.

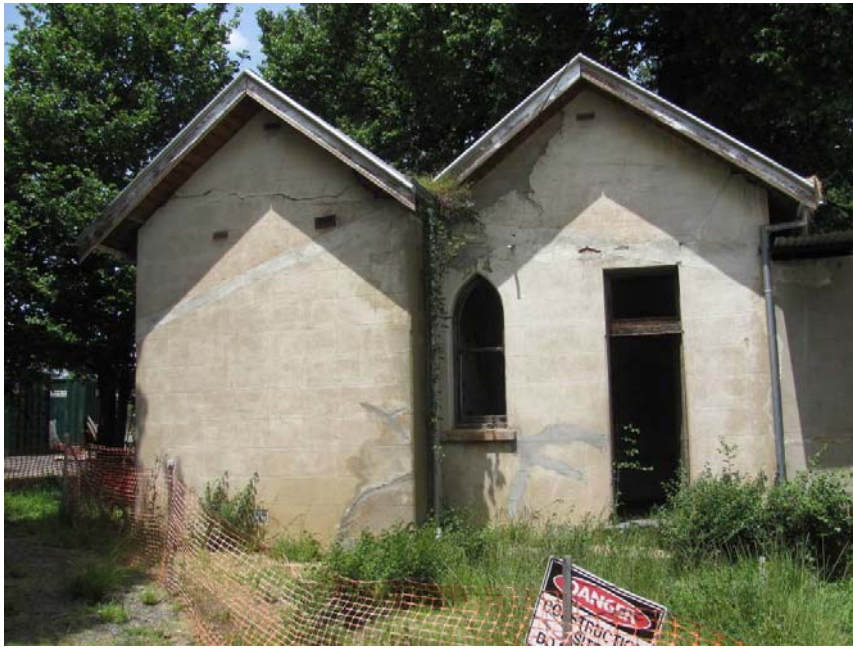
*Figure 11 - Outbuilding with store rooms to the left and cool store or dairy on the right. The laundry is at the extreme right of the photo. The evidence of the roofline of a former building is clearly marked in the render surface. (Source: Context 2012)*

The outbuilding is a small three-roomed building, of rendered masonry construction, with a ruled ashlar finish, and a double gabled roof clad in corrugated galvanised steel. It was originally freestanding, situated several metres from the eastern side of the south-eastern wing. At some point, the open space between the two buildings was infilled by the erection of a fourth room, thus creating a continuous and perpendicular attachment projecting from the south-eastern wing.

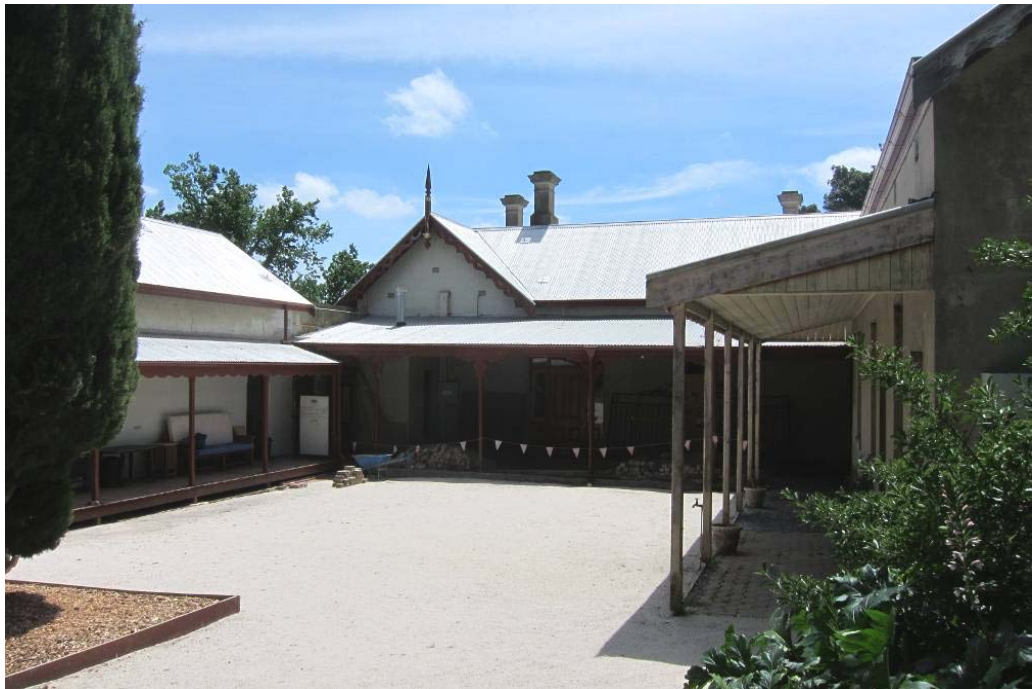
*Figure 12 - Courtyard surrounded by verandas of the main house (in the background), and south west and south east wings. (Source: Context 2012)*

The courtyard (or service yard) is a large gravel area, approximately square in plan. It is enclosed by the south frontage of the main house, and by the two rectangular wings which project from it. Photographs taken in the early 1990s indicate that there was a circular garden bed, with concrete edging, to the north end of the courtyard, and a similar square garden bed, containing a sundial or birdbath, to the south. A concrete pathway extended across the courtyard. All of these elements have since been removed, although portions of concrete path kerbing remain to the immediate south-west of the courtyard. There are a pair of Italian Cypress trees to the south edge of the courtyard.

The courtyard is an important element in the context of the house, being associated with the domestic operations of a nineteenth century homestead. It is intact in plan form, although some hard landscaping elements, namely garden beds and pathways, have been removed.

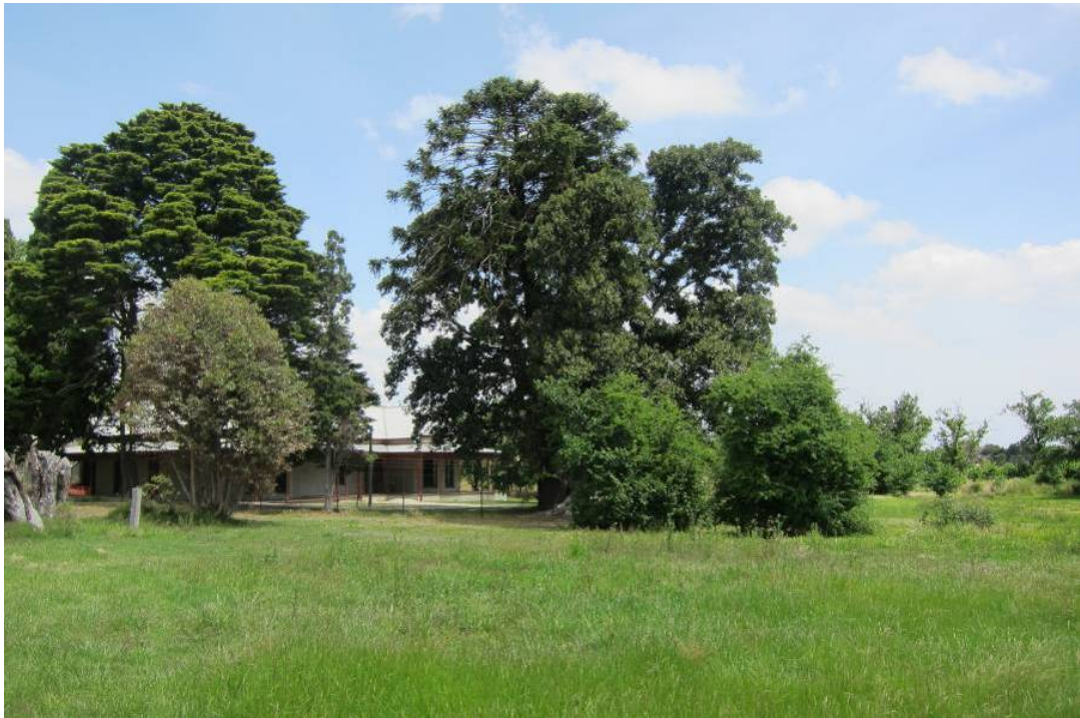
Figure 13 – Setting of *Cupressus*, *Araucaria* and Hawthorns to the north east corner of the garden.  
(Source: Context 2012)

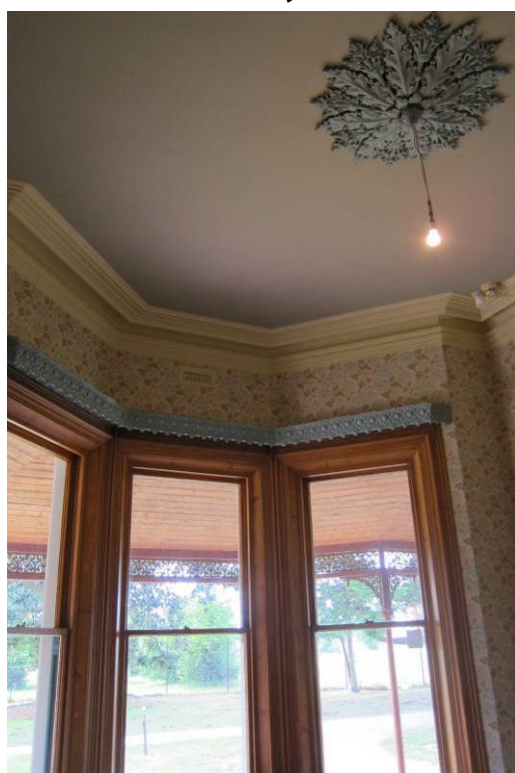
Figure 14 - Bay window of study showing wallpaper and paint colours. (Source Context 2012)

The former study is intact in plan form. Much of the internal fabric, notably the fireplace, wallpaper and other decorative finishes, are not original and date from the recent phase of restoration.

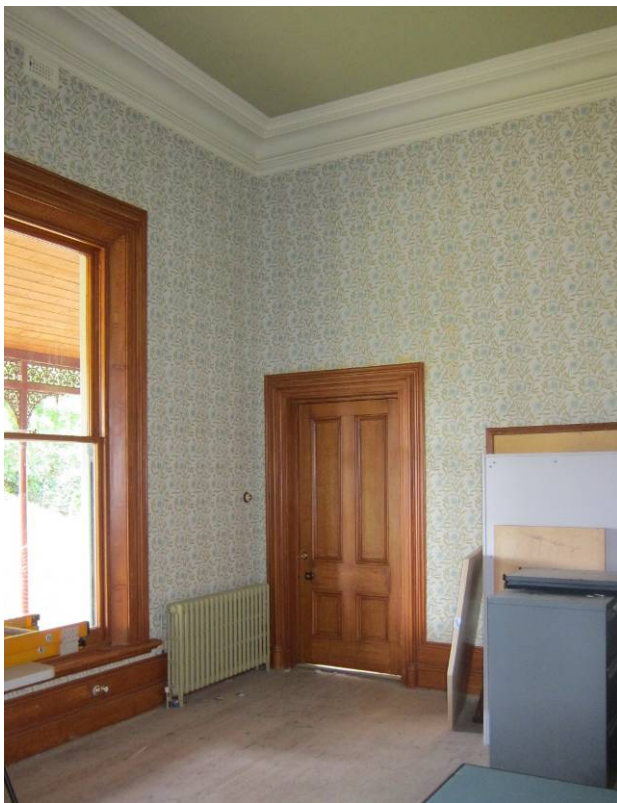
*Figure 15 - Dining room with door leading to the scullery. (Source: Context 2012)*

This room, with its separate external access to the kitchen wing, was the homestead's original dining room. The dining room is an elongated rectangular room with a fireplace at the north end and two windows along the east wall. An external door to the south opens onto the rear veranda, providing access to the nearby scullery and kitchen wing. An internal door, in the west wall, connects to the main corridor.

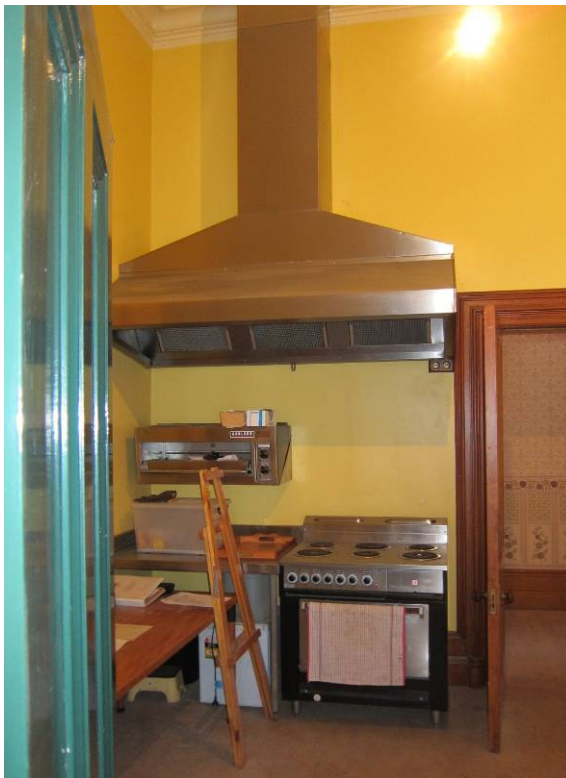
*Figure 16 – The kitchen has been fitted out with contemporary stove and cupboards. (Source: Context 2012)*

The timber floor is covered by modern vinyl flooring, and the hard-plastered walls are painted yellow. There are moulded timber architraves and skirtings, as elsewhere in the building, although much of the skirting has been concealed (or obliterated) by the new kitchen bench and cupboard units. Internal doors are similar to those elsewhere; the external door has a brass knob in place of the timber 'pumpkin' knob. The plaster ceiling has a simple coved and moulded cornice, although a portion along the north wall has been removed to facilitate the installation of the rangehood. It has a simple circular ceiling rose, from which is suspended a plain incandescent light fitting. As elsewhere, there are reproduction antique light switches and GPOs.

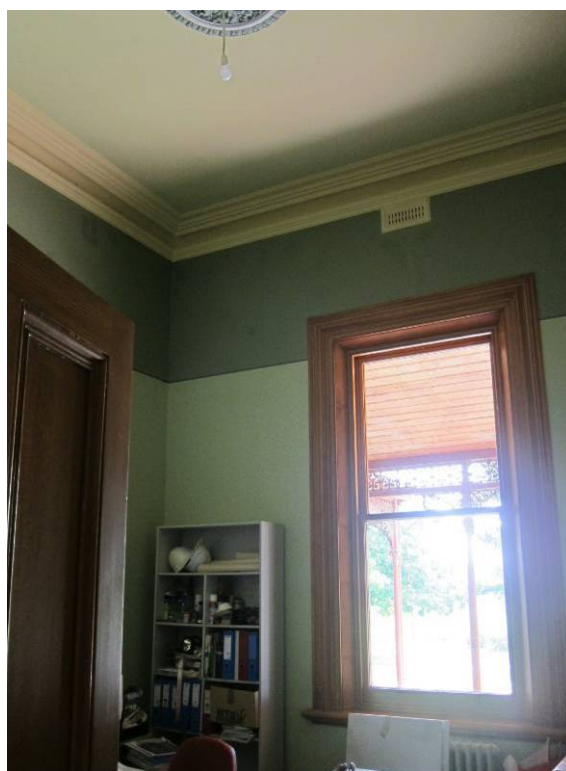
*Figure 17 - Former bedroom, now used as a site office. (Source: Context 2012)*

This room was originally a bedroom. There are moulded timber architraves and skirtings, identical to those elsewhere in the house. Doors have fingerplates and timber keyhole covers only to the side facing the hallway. A reproduction pendant luminaries comprises a brass ceiling-mounted rod with an opaque glass bell-shaped shade. To the east end of the hall is a ceiling-mounted alarm system, with a siren horn and sensor.

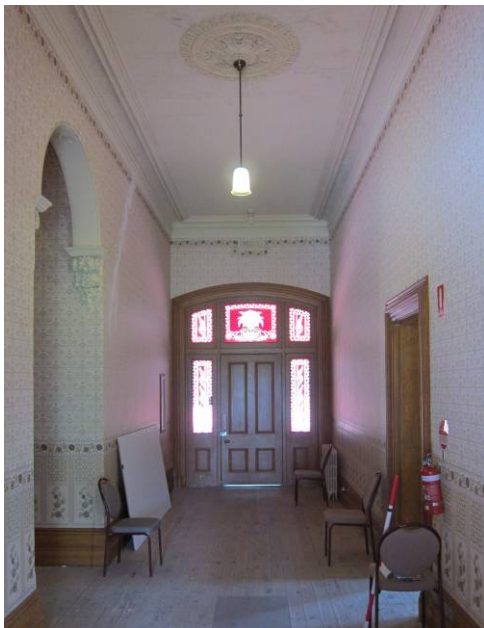
*Figure 18 - Main entry hall with reproduction wallpaper and ruby glass in doorcase. The secondary hallway leads off to the left. (Source: Context 2012)*

The entry hall is a wide rectangular space running north-south, with an external doorway at each end. A round-arched opening in the centre of the east wall connects to the east-west hallway, while two doors in the west wall provide access to the living room (Room G10) and the breakfast room (Room G1). The room has exposed timber floorboards, with an unpolished finish. The hard-plaster walls have reproduction wallpaper, with dado, filler and border, as for the east-west hallway. The wallpaper is evidently based on remnants of the original that were found during restoration. A small section of the original wallpaper has been preserved behind a timber-framed glass screen at the south end of the entry hall. There are moulded architraves and skirtings, as elsewhere. The plaster ceiling has a coved and moulded cornice and a circular medallion ceiling rose with lace-like ornament. There is a reproduction antique brass luminaire, identical to that in the adjacent hallway. Along the west wall, there are cast iron radiators at each end. The doors along the west wall are similar to those elsewhere in the house. There are wide doorcases at the north and south ends of the entry hall, each comprising a large grained timber door flanked by narrow sidelights containing etched red glass with a fern/bamboo motif. The tripartite fanlight has a segmental arched head, and contains fixed panes of etched red glass, with a design of floral garlands and arabesques.

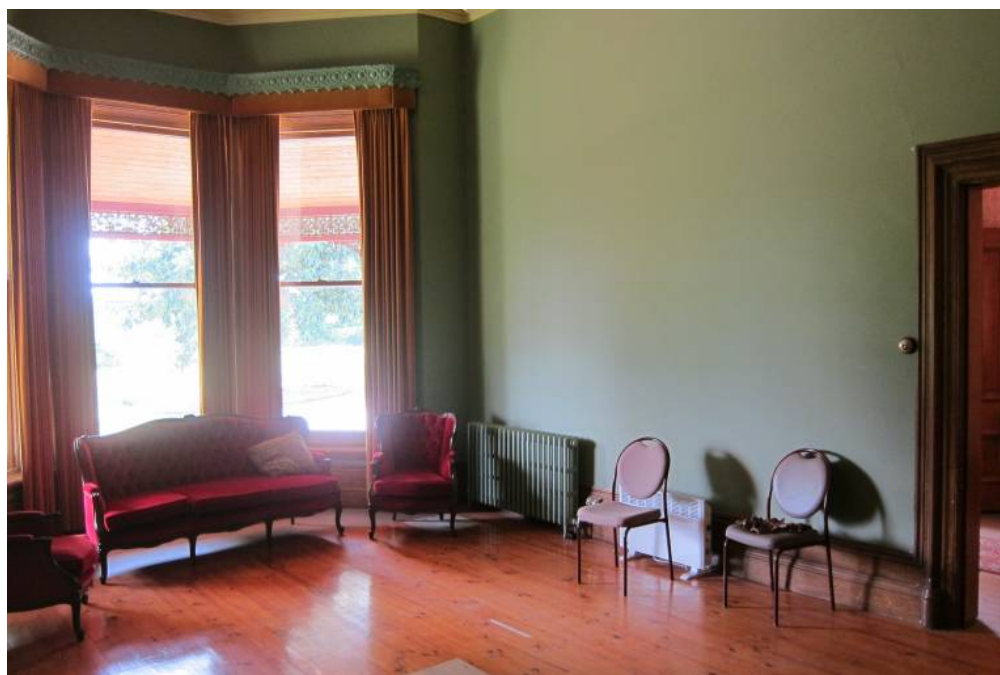
*Figure 19 - Former drawing room with bay window and new paint colours. (Source: Context 2012)*

The drawing room is a large rectangular space with a canted bay window at the north end and an open fireplace at the south end. A doorway, towards the south end of the east wall, opens off the main entry hall. The room has polished timber floorboards. The plaster ceiling is painted grey and has a particularly wide roved and moulded cornice, and a large ceiling rose with concentric rows of mouldings and filigree ornament. A pendant luminaire is suspended from the ceiling rose, with a brass rod and a white glass 'school-house' shade. The hard-plaster walls are painted olive green, and there are moulded timber skirtings architraves identical to that elsewhere in the house. The doorway has a grained four-panel timber door with flush mouldings; grained fingerplates to both sides, brass escutcheons, and timber 'pumpkin' door handles. The bay window, which has three huge timber-framed double-hung sashes, has splayed heads and reveal, and a continuous internal sill with bullnosed edge. There is a moulded timber pelmet, with floral/strapwork ornament, and heavy velvet drapes.

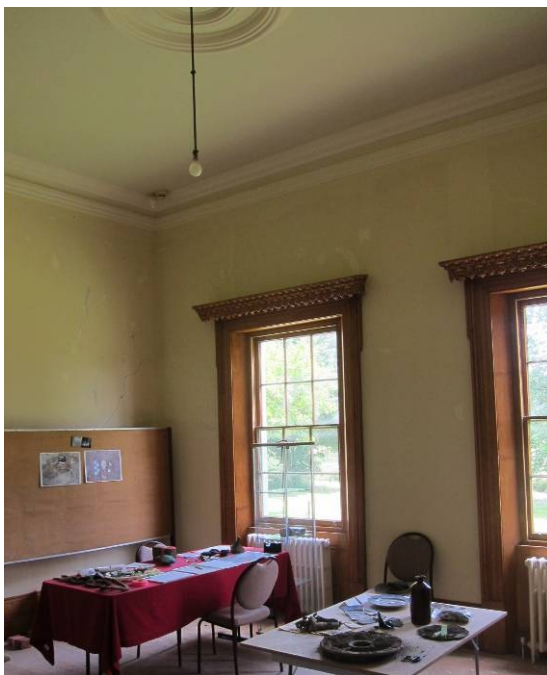
This space is rectangular in plan, with a symmetrical pair of window to the west wall, and a fireplace and doorway to the east wall. The presence of a fireplace on the east wall rather than on the north wall where it could have been conveniently backed up with the adjoining fireplace is additional evidence supporting this room as an earlier part of the building.

*Figure 20 - Room G11, now used to display finds from the archaeological investigations of the homestead. (Source: Context 2012)*

The room has exposed timber floorboards, with an unpolished finish. The cellar is located under part of the room.

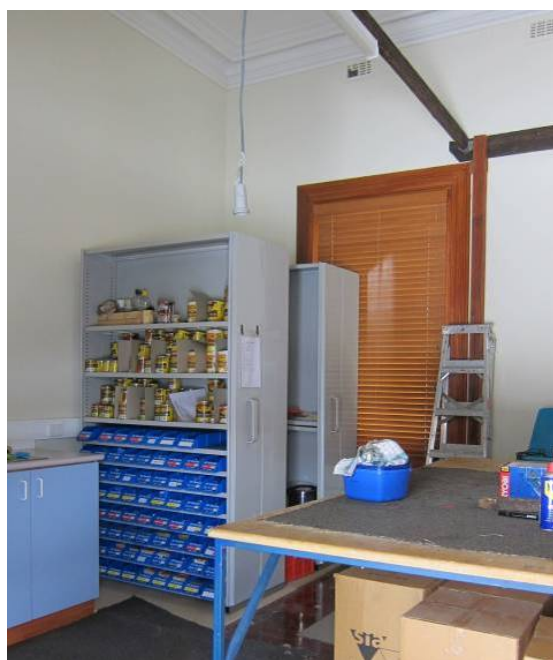
*Figure 21 - Room G13 fitted out as part of the men's shed. (Source: Context 2012)*

This room is an elongated rectangular space with a fireplace at the south end and a pair of windows along the west wall. A single doorway, at the north end of the east wall, permits access off the veranda. The floor is of exposed timber floorboards, with an unpolished finish. The plaster ceiling has a moulded and coved cornice, and a six-lobed plaster ceiling rose with fern-like foliated ornament.

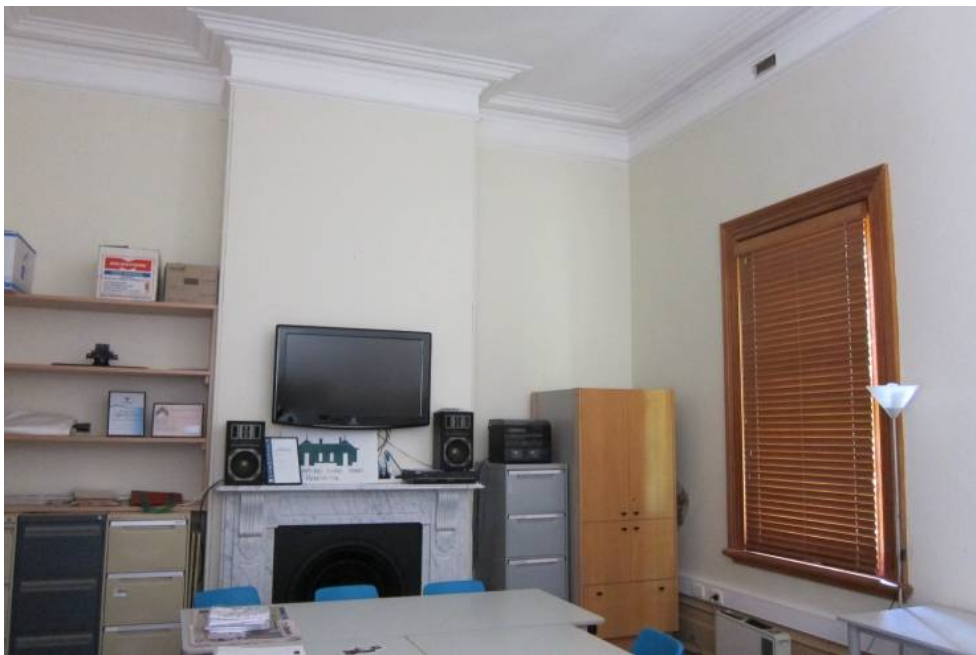
*Figure 22 - This room is now fitted out as part of the men's shed. (Source: Context 2012)*

The plaster ceiling has a moulded and coved cornice, and a small six-lobed plaster ceiling rose with acanthus ornament. The hard-plaster walls are painted, and have simple moulded timber skirtings (380mm deep) and architraves (15(mm deep), with a painted finish. The doorway contains a four-panel timber door with flush mouldings. The windows have multi-paned timber-framed double-hung sashes; both damaged and boarded internally with galvanised corrugated steel sheeting. The fireplace has a brick firebox and slate hearth, and the mantelpiece has been replaced. This room is intact in plan form, although some of its original fabric, such as the fireplace, has been removed and it is fitted out for the men's shed.

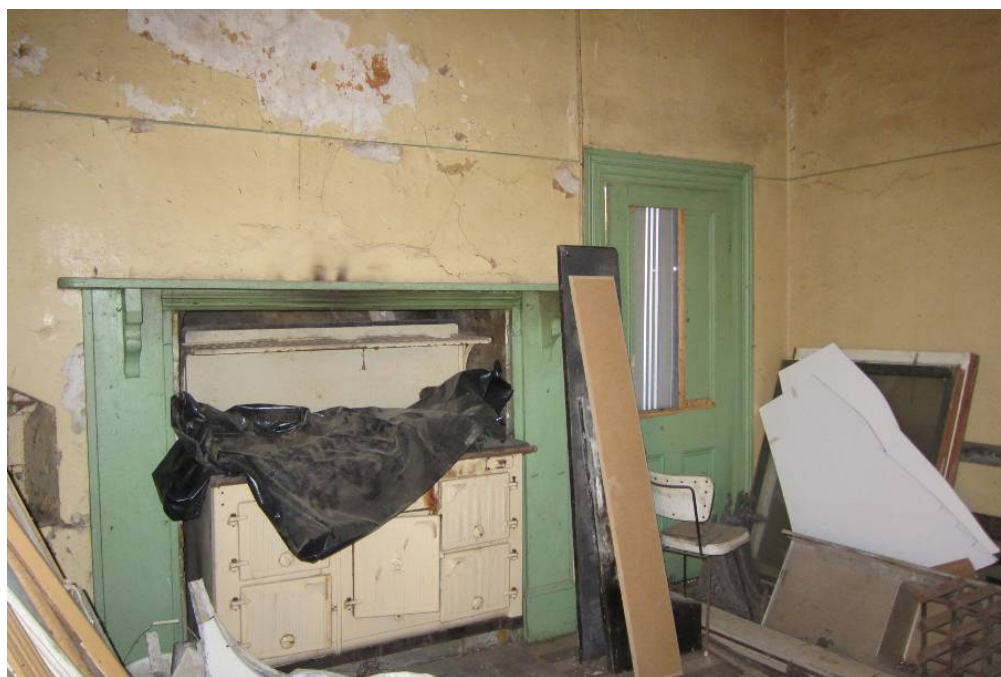
*Figure 23 - The kitchen stove and small oven is just visible to the left of the photo. The room now contains some building elements removed from other locations. (Source: Context 2012)*

This room was the homestead's early kitchen. The former kitchen is square in plan, with a window in the west wall, and external doorways in the north and east walls. There is a recessed stove alcove at the northern end of the east wall. The space has exposed timber floorboard, with an unpolished finish. The lath-and plaster ceiling is bisected by an exposed timber ceiling beam. The ceiling is square-set, and never had a ceiling rose.

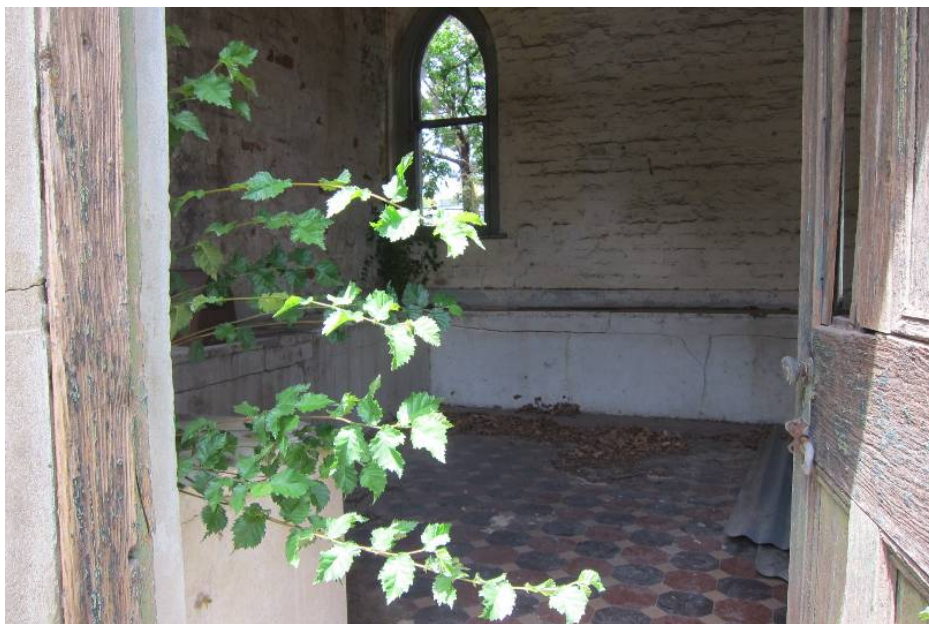
*Figure 24 - Cool store or dairy showing tiled floor and masonry benches. One of two pointed arch headed windows is visible in the background. (Source: Context 2012)*

The room is square in plan. It has a central doorway in the north wall, and pointed arch windows in the north and south walls, towards the extreme east edge of the space. There is evidence of a third window, larger and rectangular in form, in the west wall, although it has since been infilled with a single skin of brickwork. The room has walls of bagged and painted brickwork, and tessellated floor of octagonal and square tiles in buff, red and brown. The ceiling is lined with beaded timber boards; some are varnished and others, obviously modern replacements, are unpainted. There is a narrow timber scribe-profile cornice. The doorway has a four-panel timber door with flush mouldings and a copper doorknob. The pointed windows have timber-framed casement sashes, surmounted by a fixed sash fanlight to the apex of the arch. The latter are infilled with flywire. Windows have a projecting internal sill, and no architraves. The bricked-up window opening to the west has a timber lintel. To three sides of the room, there is a built-in bench-like structure of masonry construction, measuring 650mm high by 550mm wide. It has rendered sides and a white ceramic tiled top.

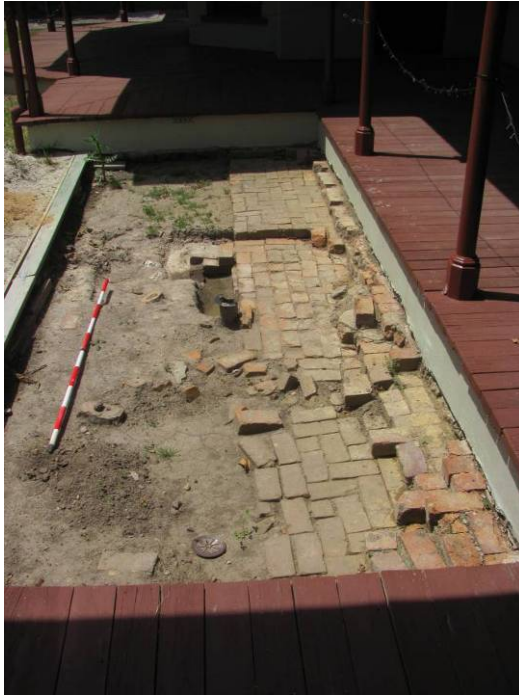
*Figure 25 - Recently excavated area to the north of the house, showing the brick platform with additional courses of brick to support the veranda. (Source: Context 2012)*

At the edge of the veranda itself, the flat surface is supplemented by an additional two courses of bricks in order to support the timbers bearing the veranda floor. As the lower surface extends beyond this veranda foundation, it would seem that it pre-dates the structure but was then utilised in its construction.

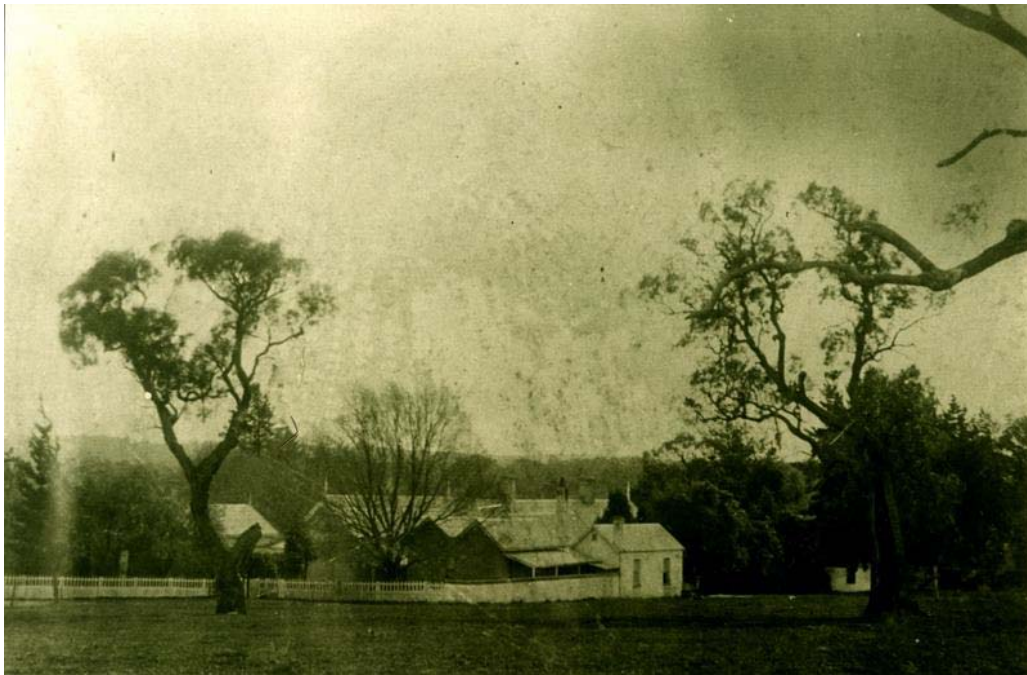
During the 2010 survey, the remains of a wall were found overgrown by trees and vegetation in line with the eastern garden boundary bank. Initially this was interpreted as the remains of a garden wall, but the excavation of a trench at this location uncovered a clear brick feature and together these can be seen to represent the remains of the building shown in the photograph.

*Figure 26 - A 19th century photo showing southern garden boundary (white fence), the building to the east of the south-eastern wing, which is no longer extant (centre right) and a circular building in the tree line (right of picture). (Source: DIG International 2008a)*

immediately to the north of Room G21, in Figure 26. It noted that a path has recently been constructed in that location to provide access from the eastern corner of the site, but it concluded that archaeological remains of this building should still survive.

A bank runs parallel to the south face of the south-east wing, 10m to its south between it and the garage site. This is likely to be remnant of the boundary line shown as a white picket fence in an undated late 19<sup>th</sup> Century photograph (DIG International 2011) (Figure 26).

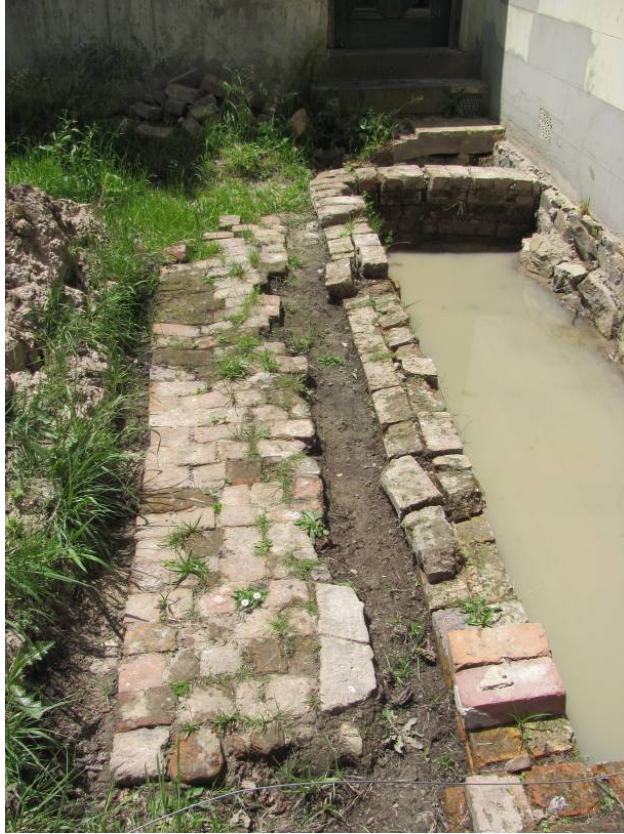
*Figure 27 - Rectangular foundation (flooded) against the north wall of the south-western wing, and the brick surface to its north. (Source: Context 2012)*

The rectangular brick wall has been interpreted as having supported a veranda in the same way as those identified around the courtyard (DIG International 2010). However the wall here is much more substantial and there is neither an entrance in this location nor any evidence of a veranda room along the upper wall. Furthermore, the interior of the feature has been excavated to beneath the level of the surrounding ground surface. Initial appearances are of an external stair to an in-filled cellar, similar to the extant example under Room G11, but the fact that it was holding water at the time of survey (and had been for some time – Peter Kavan pers. comm.) would seem to suggest otherwise. It would therefore seem more likely that it represents a foundation, perhaps for a sunken building such as a glass house.

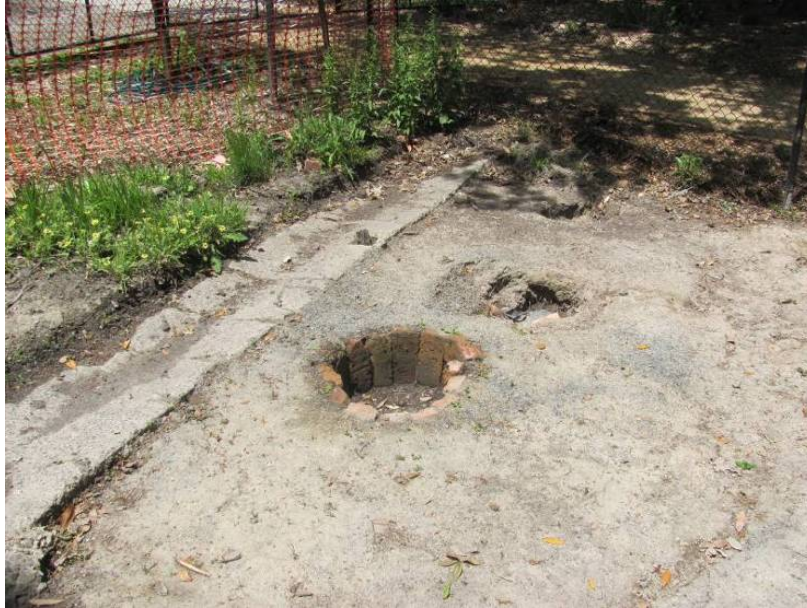
Figure 28 - Fire pits excavated in the footprint of the 1930s garage. (Source: Context 2012)

The garage's footprint was excavated during an archaeology open day at the homestead site in September 2012, revealing two fire pits at its eastern end and a scatter of domestic artefacts.

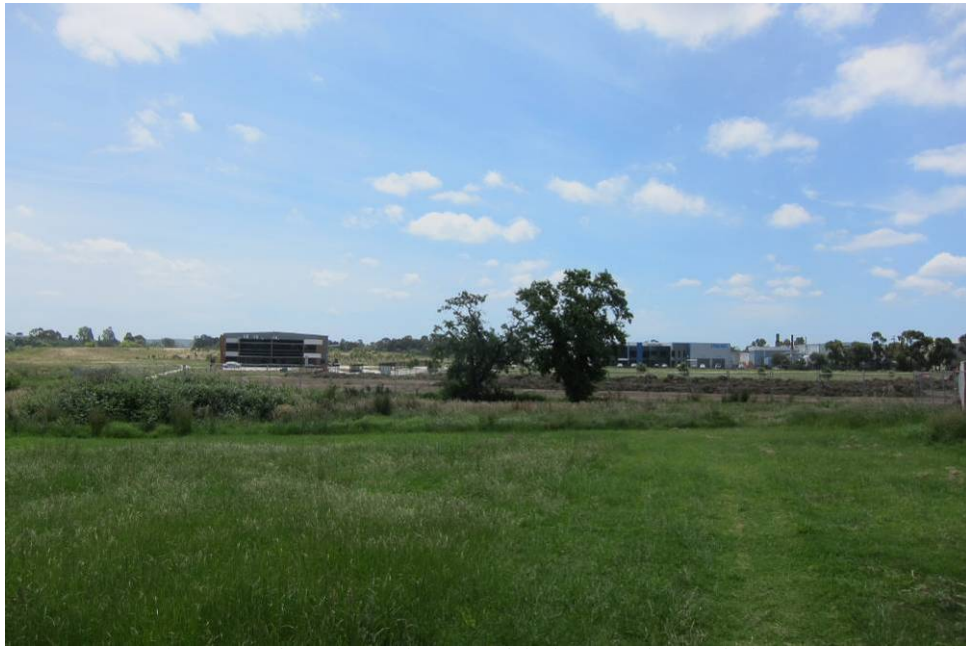
*Figure 29 - Looking north from the north corner of the homestead towards the two pear trees and the site of the agricultural features identified during the works of 2008 and 2009. (Source: Context 2012)*

In 2008 a non-invasive survey technique (resistivity) was employed in the area between the two pear trees, and this identified two 'suspect anomalies' (DIG International 2008b). In 2009 one of these features was excavated and found to be a posthole.

The features recorded in this area were together interpreted as possibly representing an earlier phase of agricultural settlement before the arrival of the Row family, or an early phase of their occupation before horse rearing became the main focus in the 1880s. These deposits could relate the cottage built by Edward and Frederick Row in 1864, or to the stable that burned down in 1900, but no structural remains seem to have been observed.

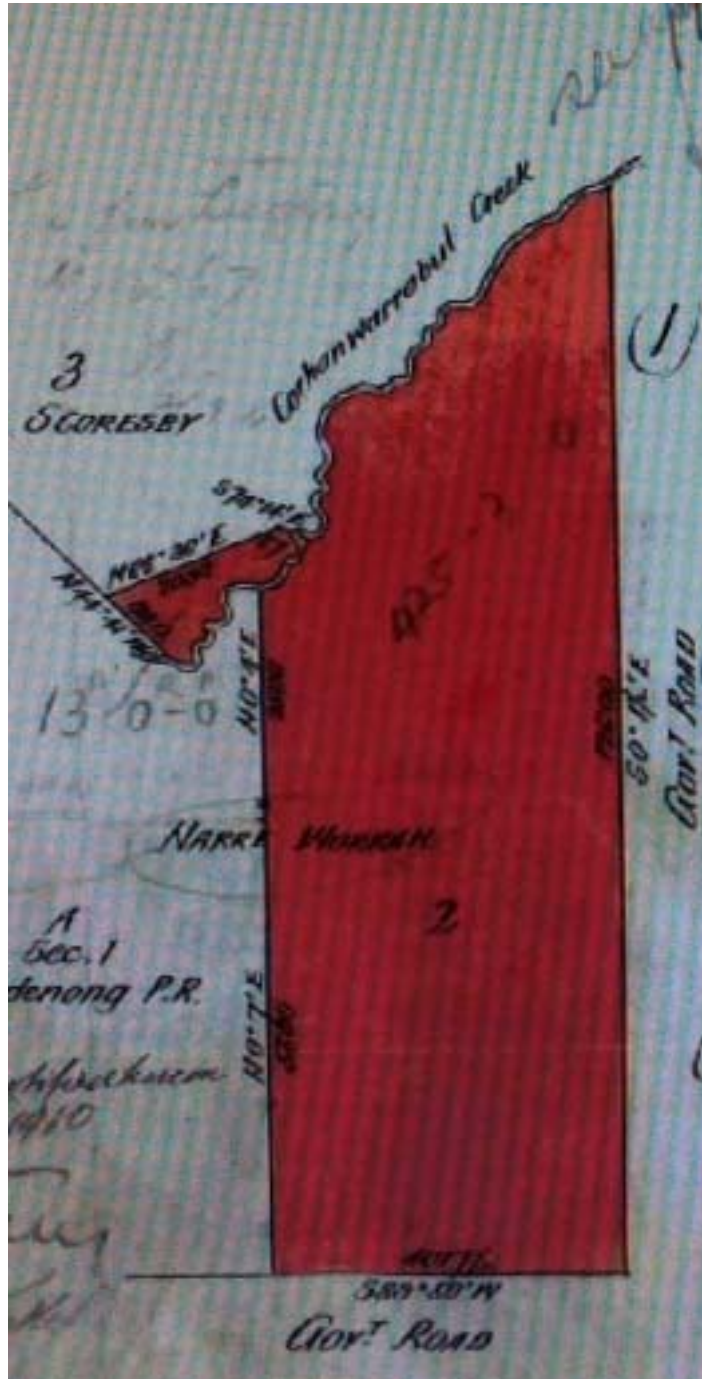
### Plan extracted from the Rows' 1907 Certificate of Title

Showing land to the north of Corhanwarrabul Creek, accessed at Land Victoria (V3211/F189).
