# Historical archaeological site card

Place name: Warrnambool Rifle Range

## 6. Current description of site

## 8. Analysis of site (interpretation)

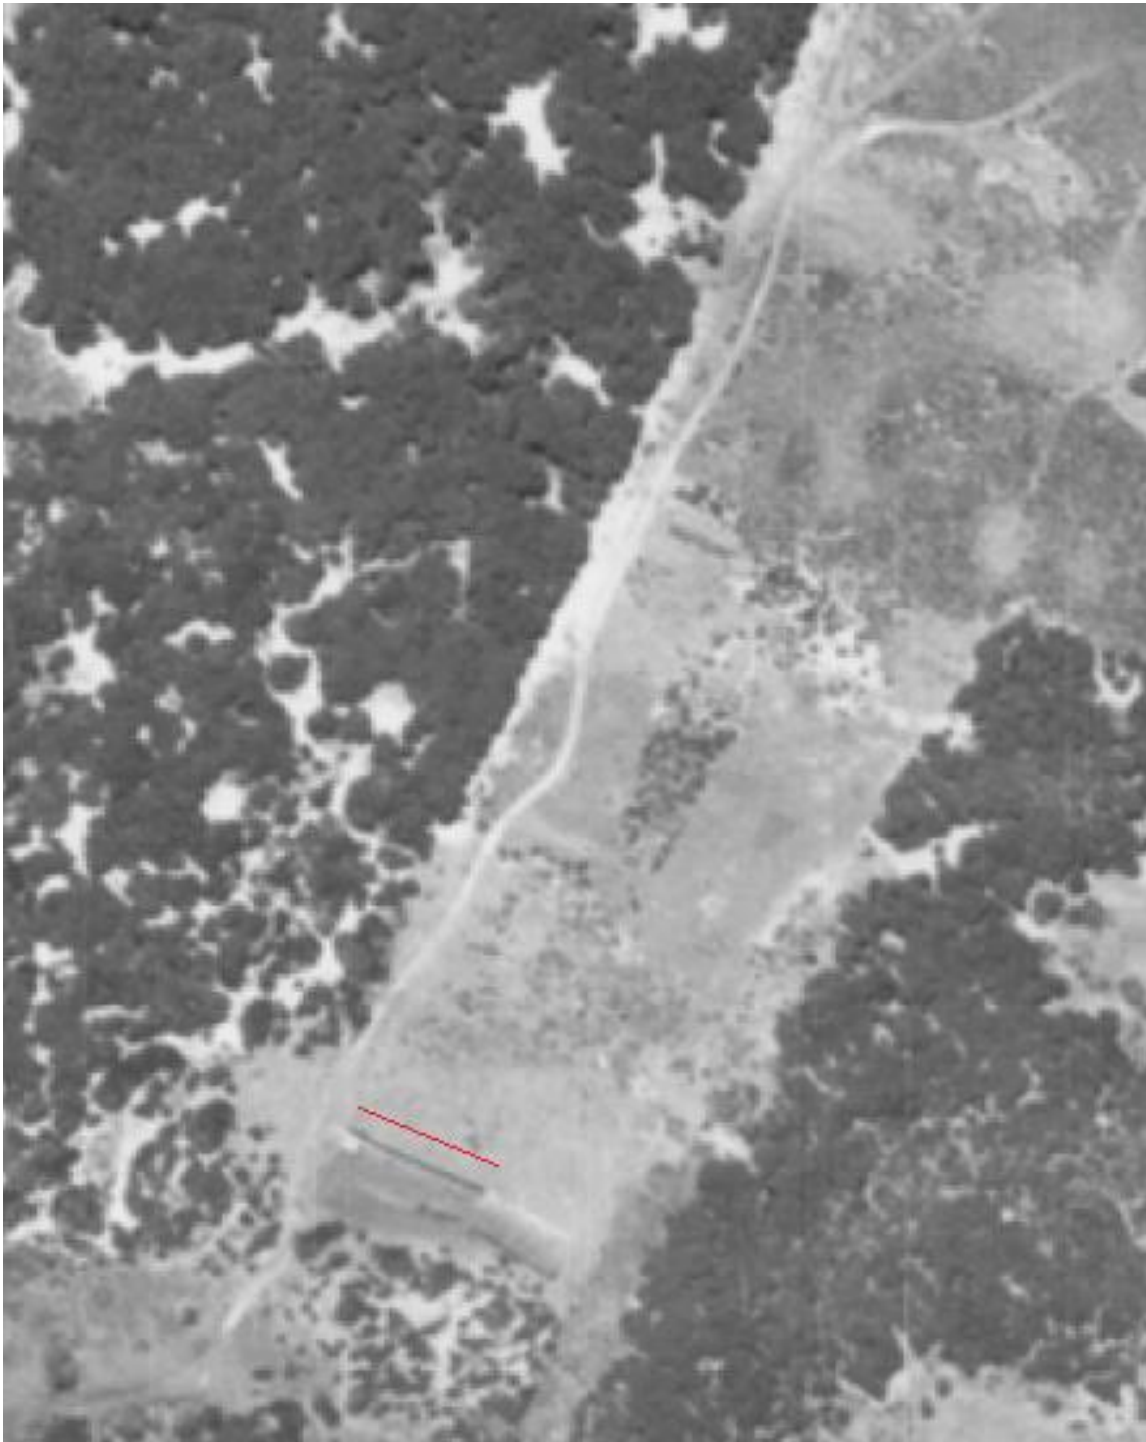
Figure 1: 1948 aerial image of the rifle butts and trench along its northern face. The extent of the trench is indicated by a red line. (Victorian State Government- Photo Mosaics: <http://services.land.vic.gov.au/maps/photomaps.jsp>).

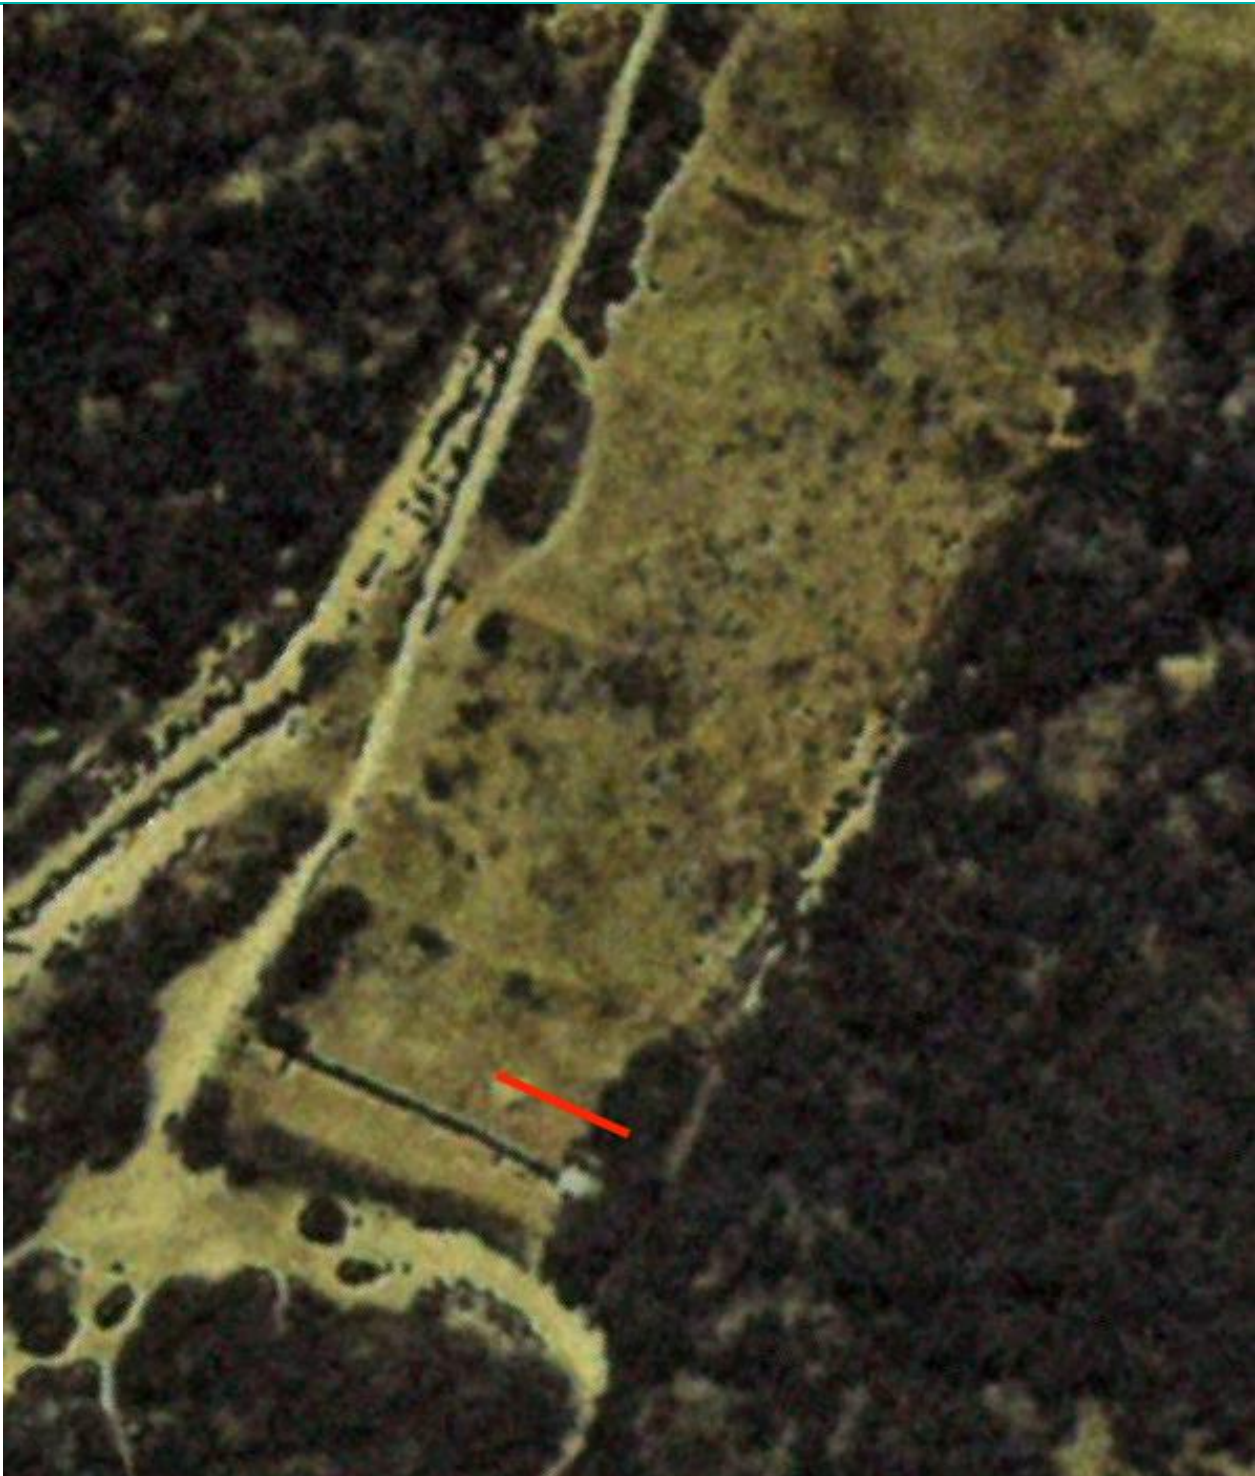
Figure 2: 1977 aerial image of the rifle butts and trench along its northern face with eastern roofed component visible (Google earth).

Works to repair or develop the range were undertaken during the mid-late 1900's. Materials used for the works included cement besa bricks in the trench walls, and lengths of metal train line as supports (see plates included below). The works also included the construction of a storage section at the eastern extent of the trench, with a corrugated iron roofed. While a photograph from 1977 clearly shows the roofed storage area at the eastern end of the trench, indicated on Figure 2 below.

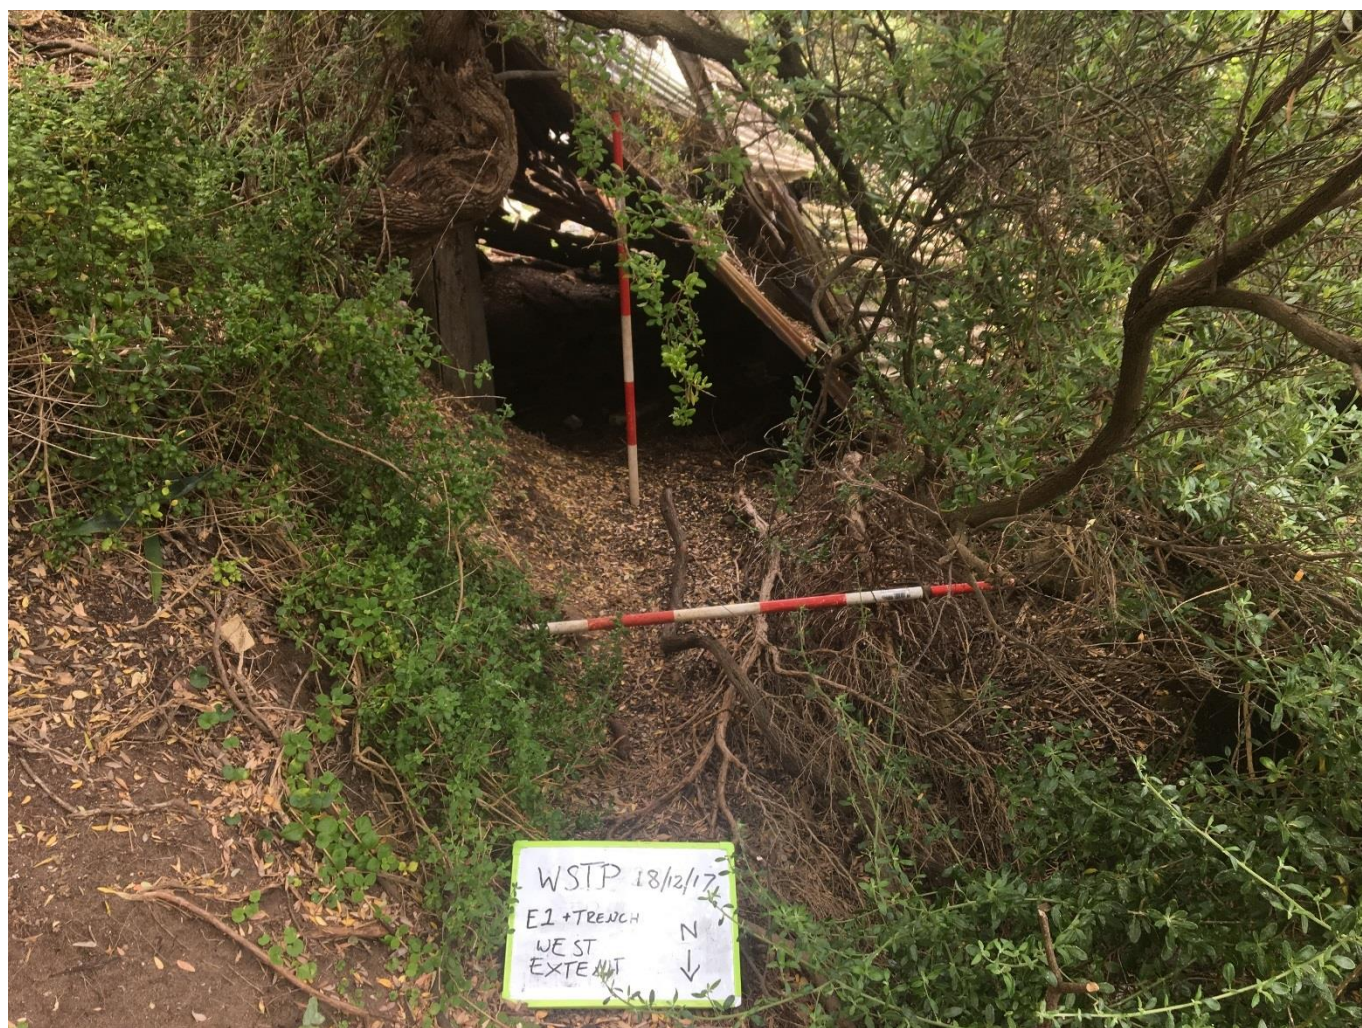
Figure 3: Western extent of the trench, showing collapsed roofing of corrugated iron sheeting. Facing east.

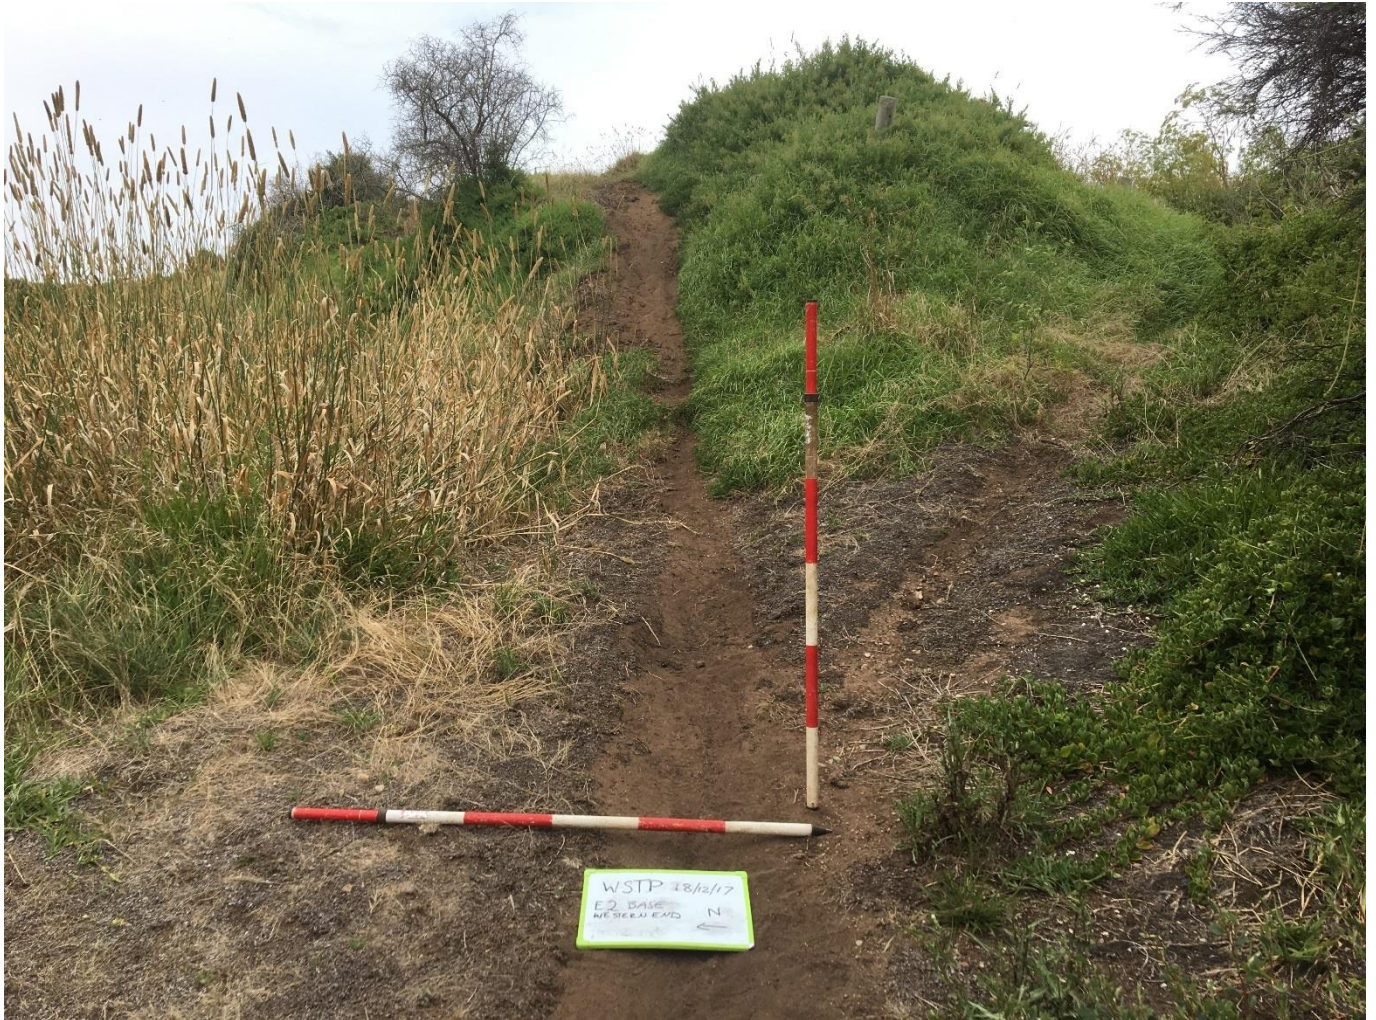
Figure 4 Facing the western extent of the rifle butts from an unsealed access road

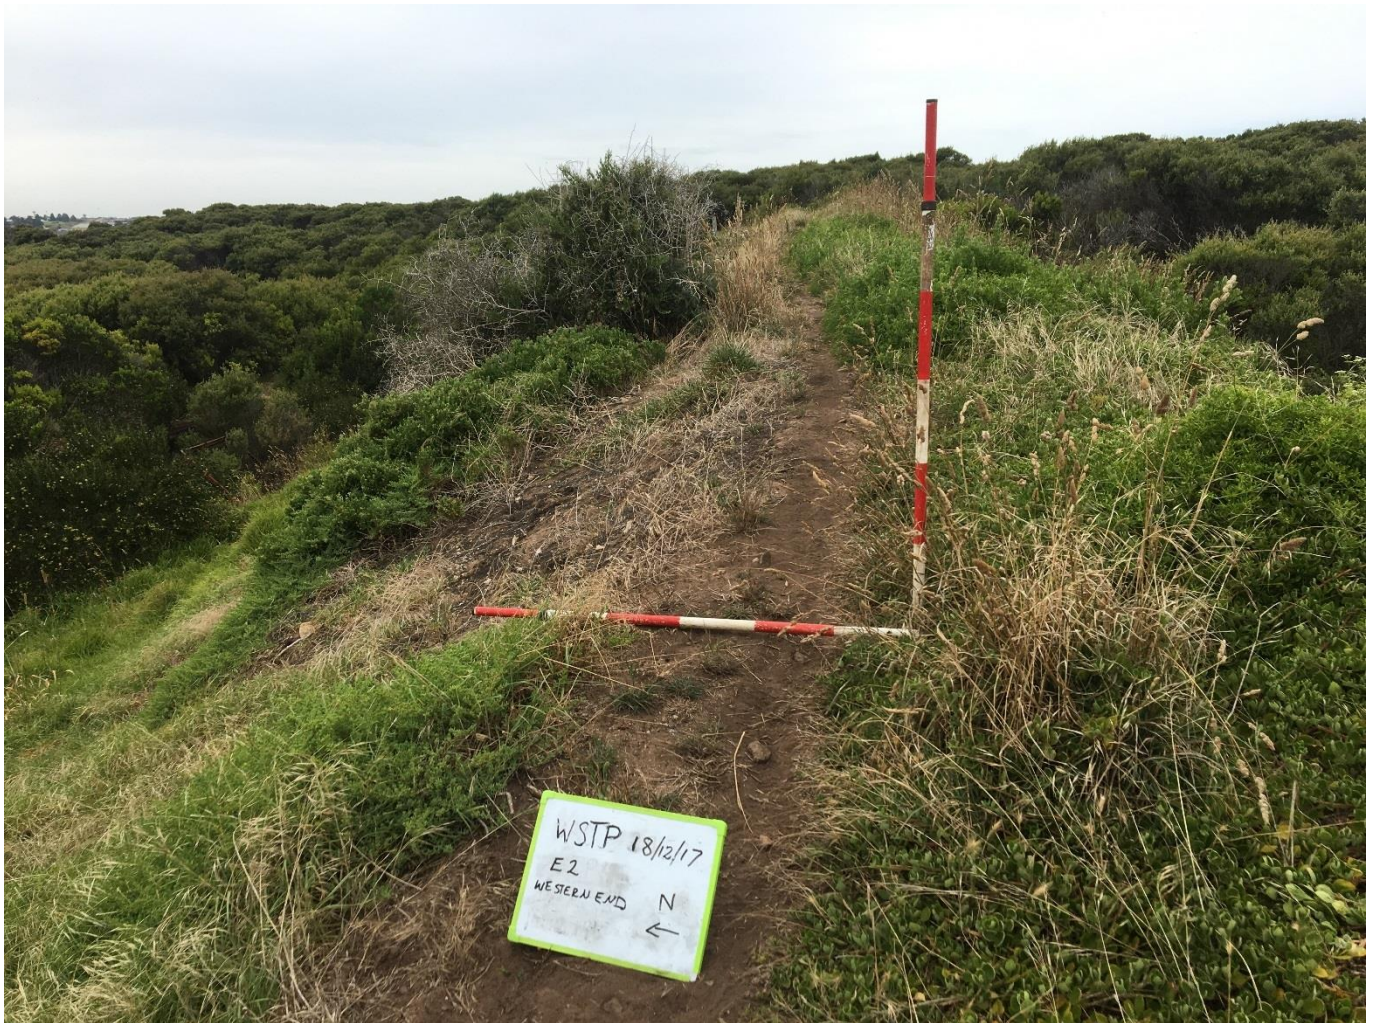
Figure 5 Top of the rifle butts facing east across the feature. The northern face of the butts is to the left of shot and slopes down to the trench.

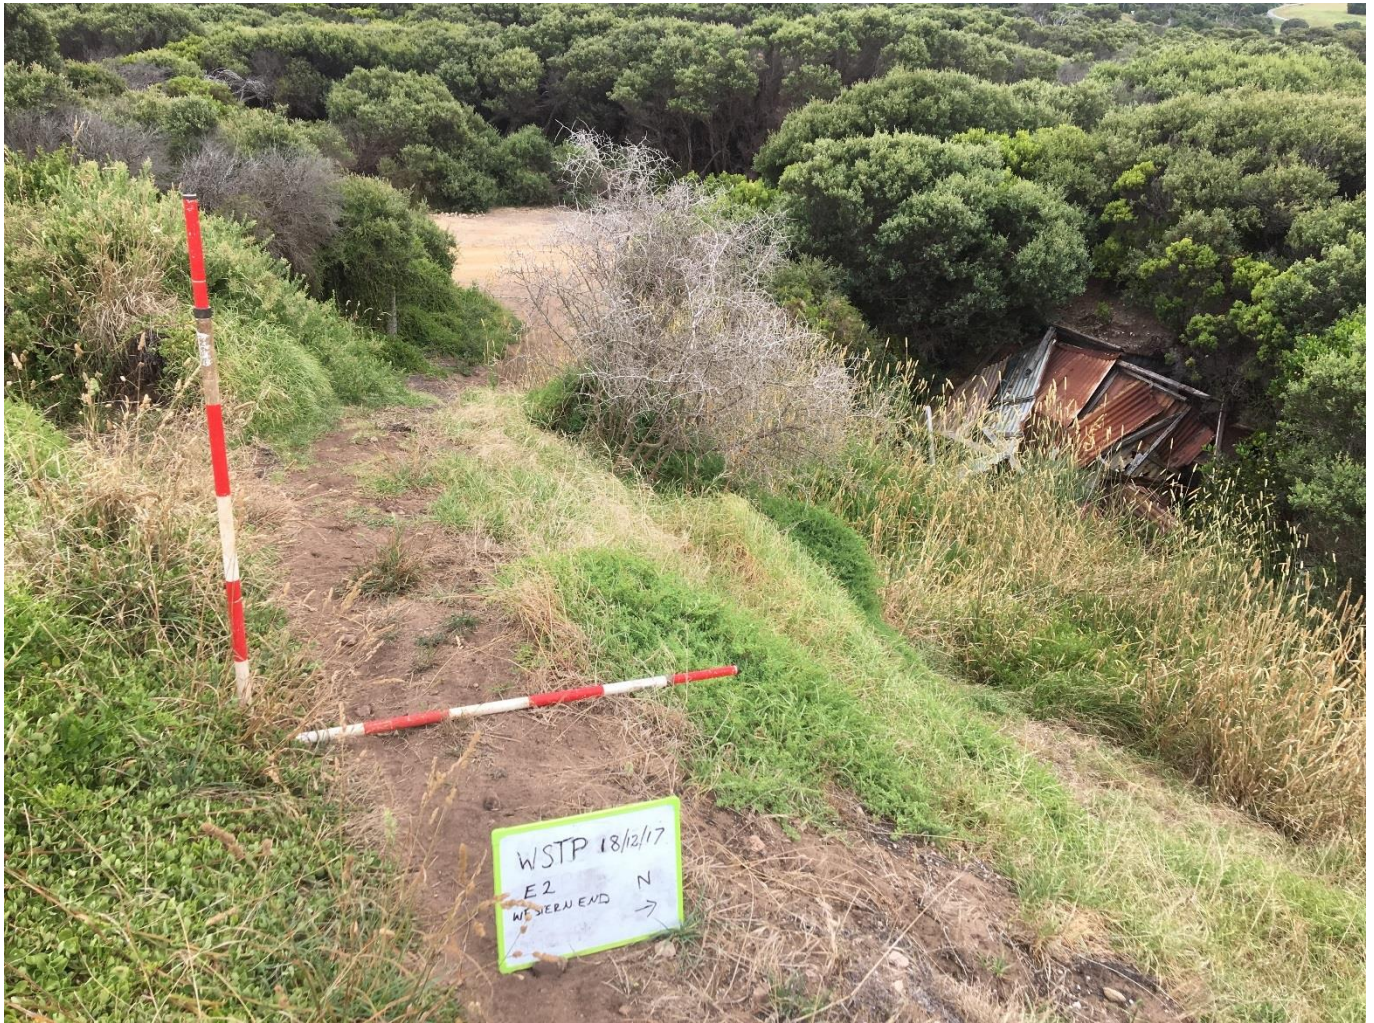
Figure 6 Top of the rifle butts facing west. The northern face of the butts is to the right of shot and slopes down to the trench.

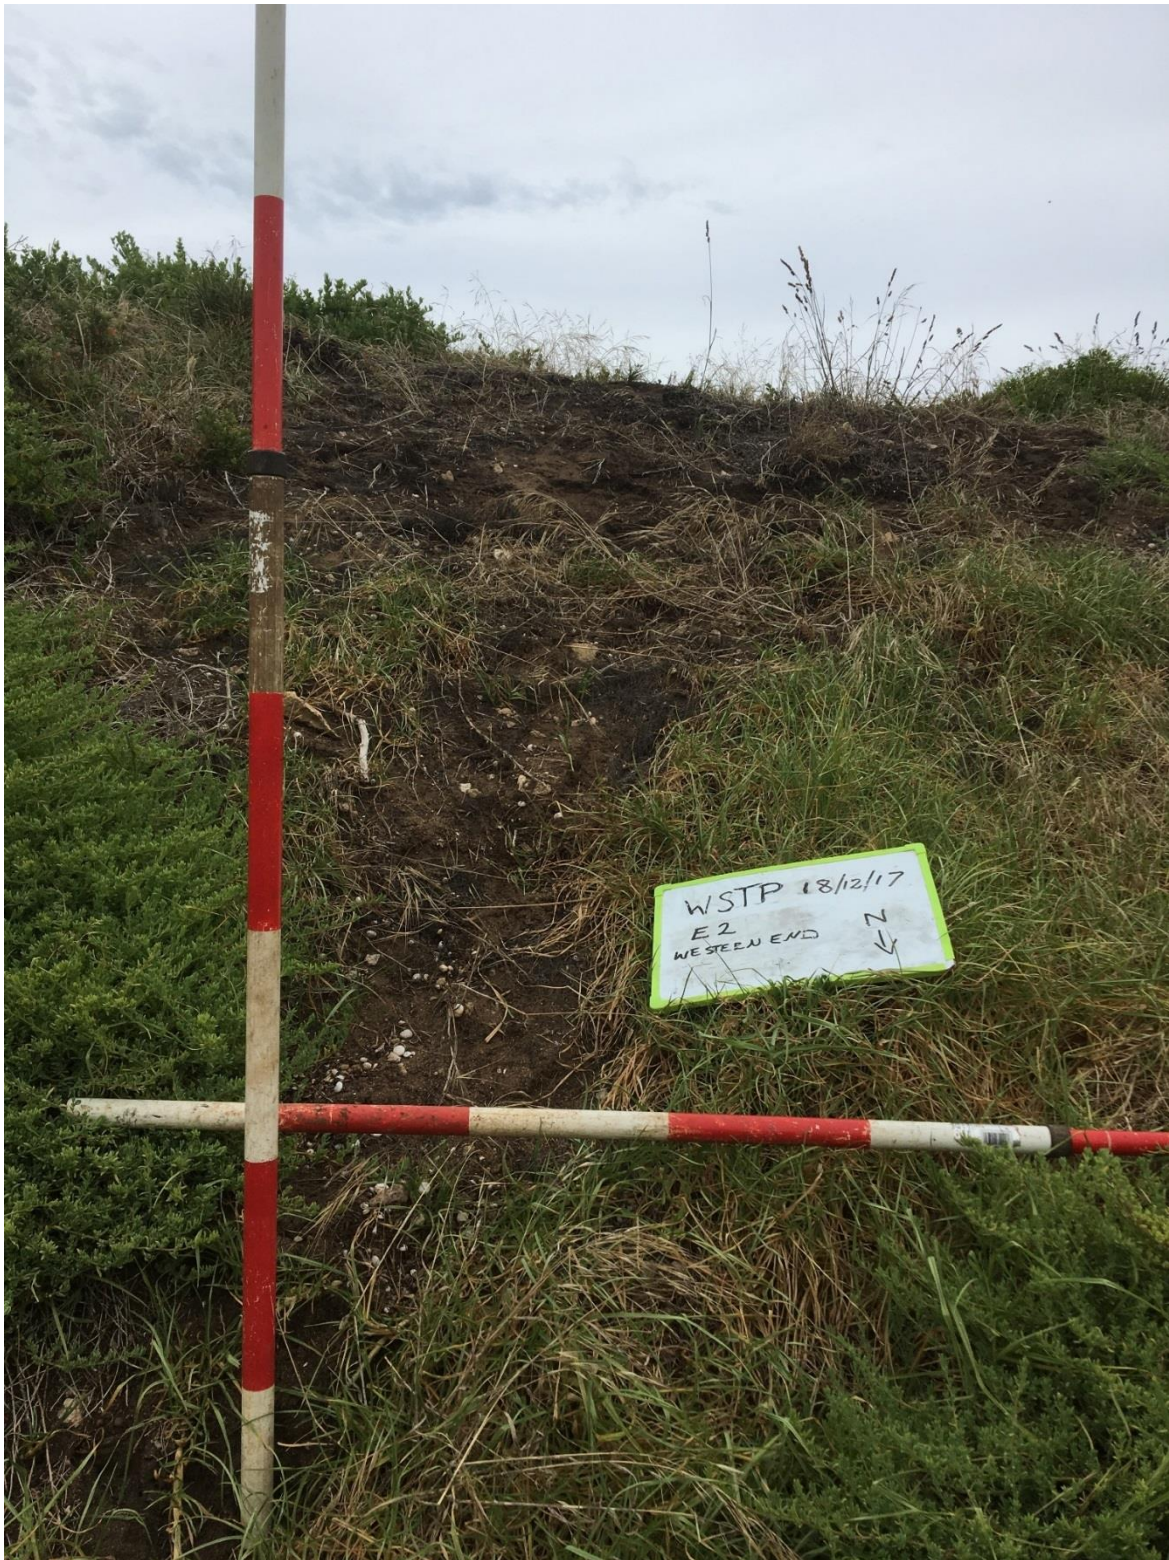
Figure 7 Top of the rifle butts facing south, up face of embankment. Western end

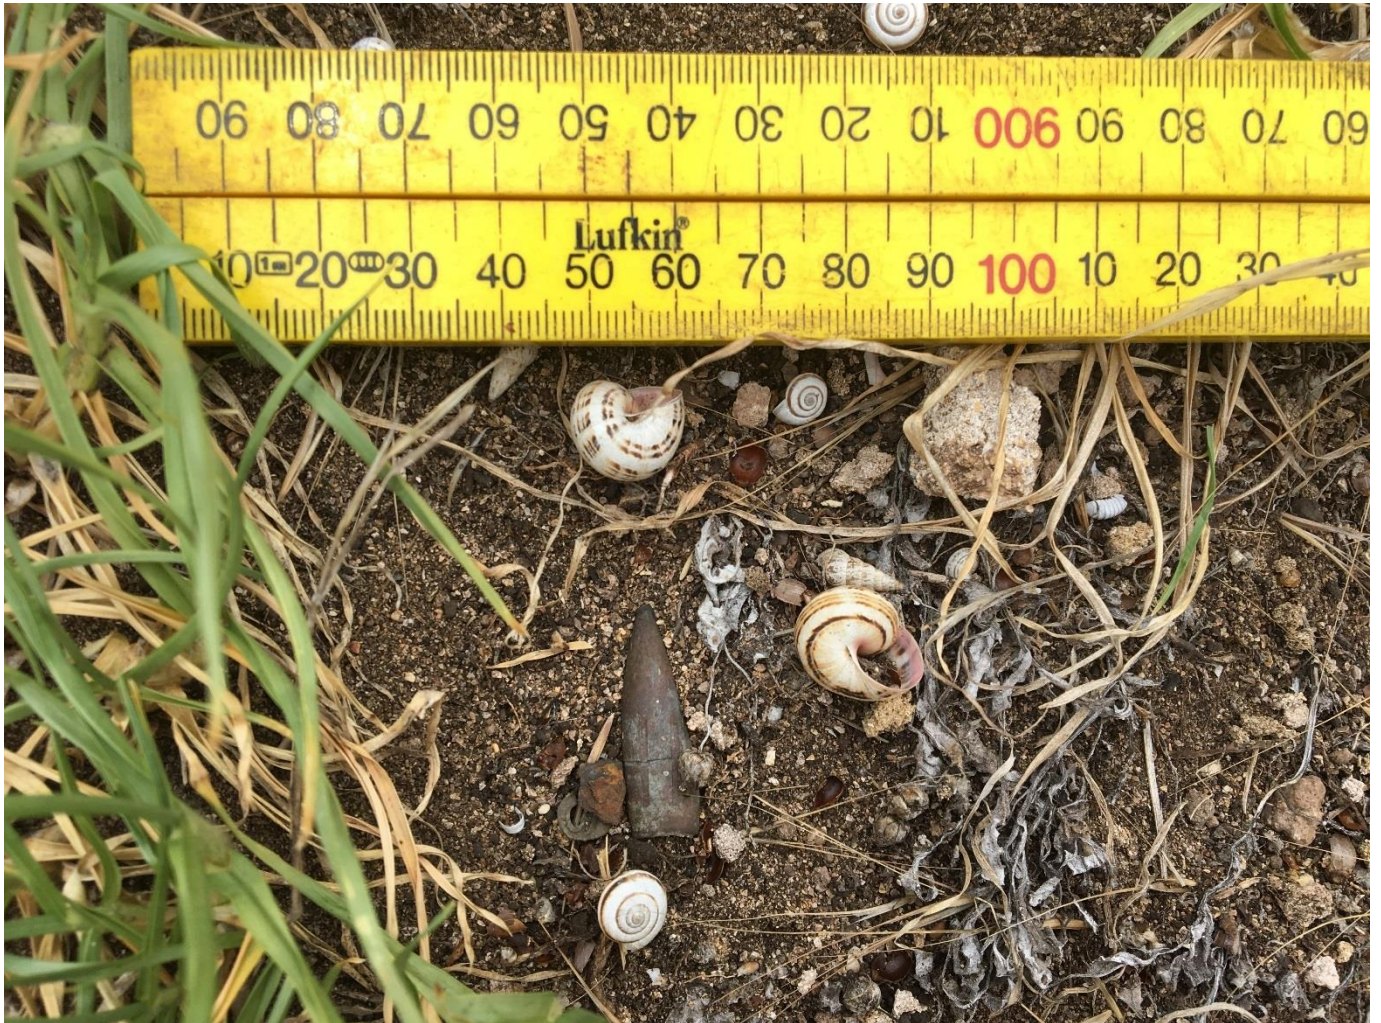
Figure 8 Spent rifle bullet visible on the butts.

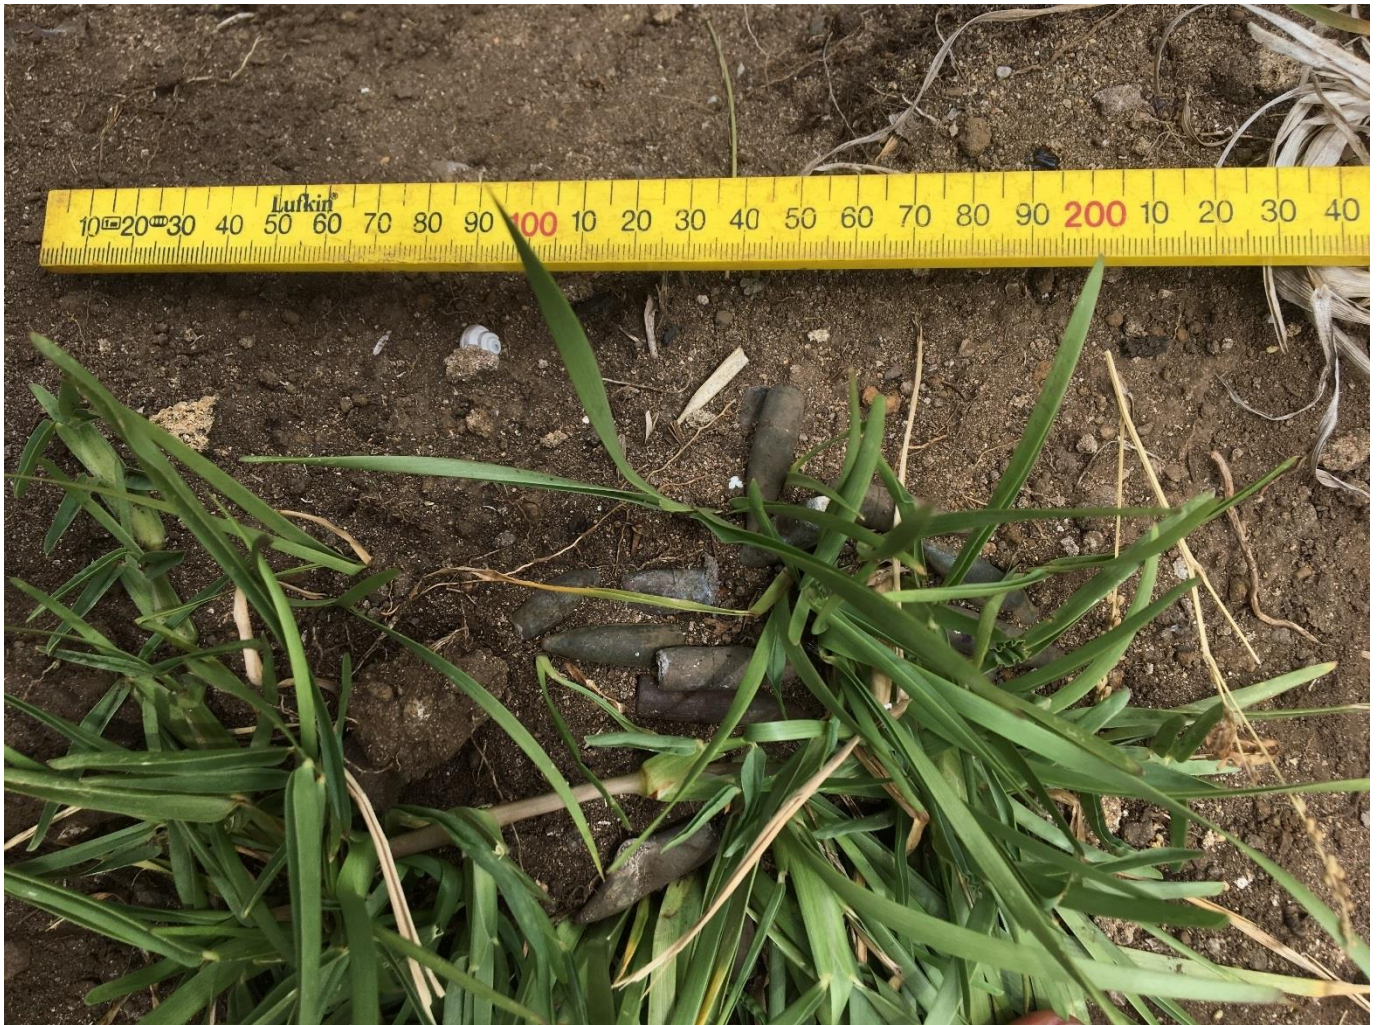
Figure 9 Spent rifle bullets at entrance to rabbit burrow within the butts.

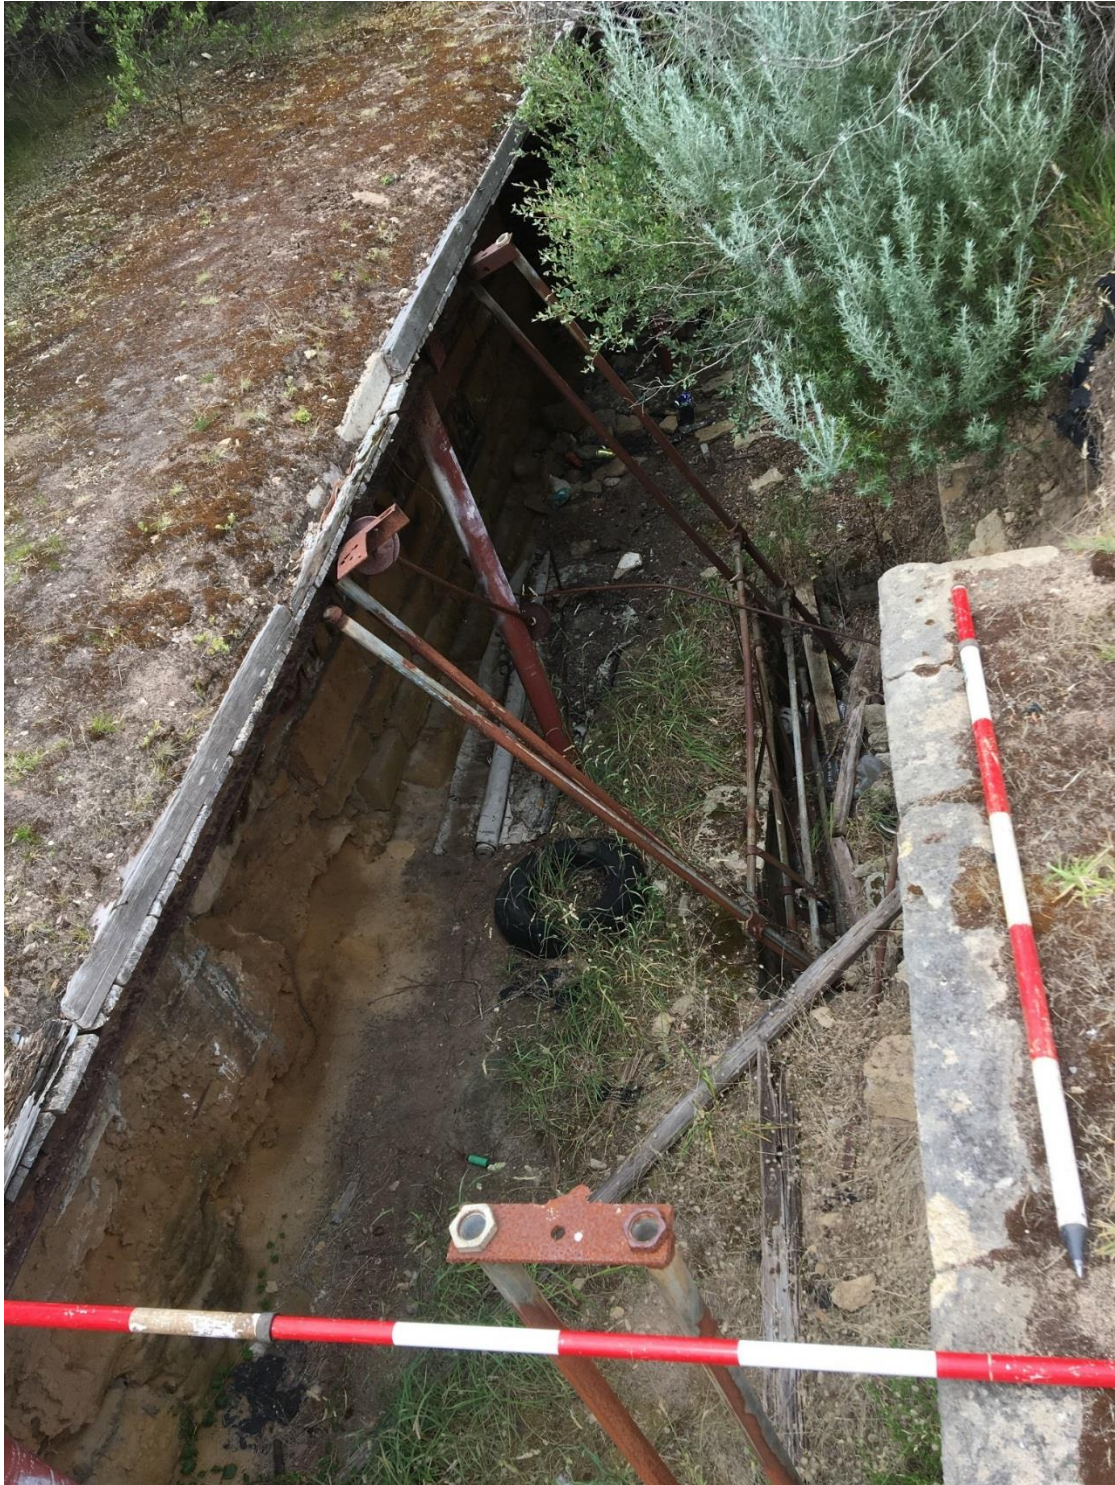
Figure 10 Constructed trench at forward (northern) face of rifle butts. Timber and masonry construction material visible. Steel components of target frames and pulley system evident. Rolled rifle targets are also visible at base of trench.

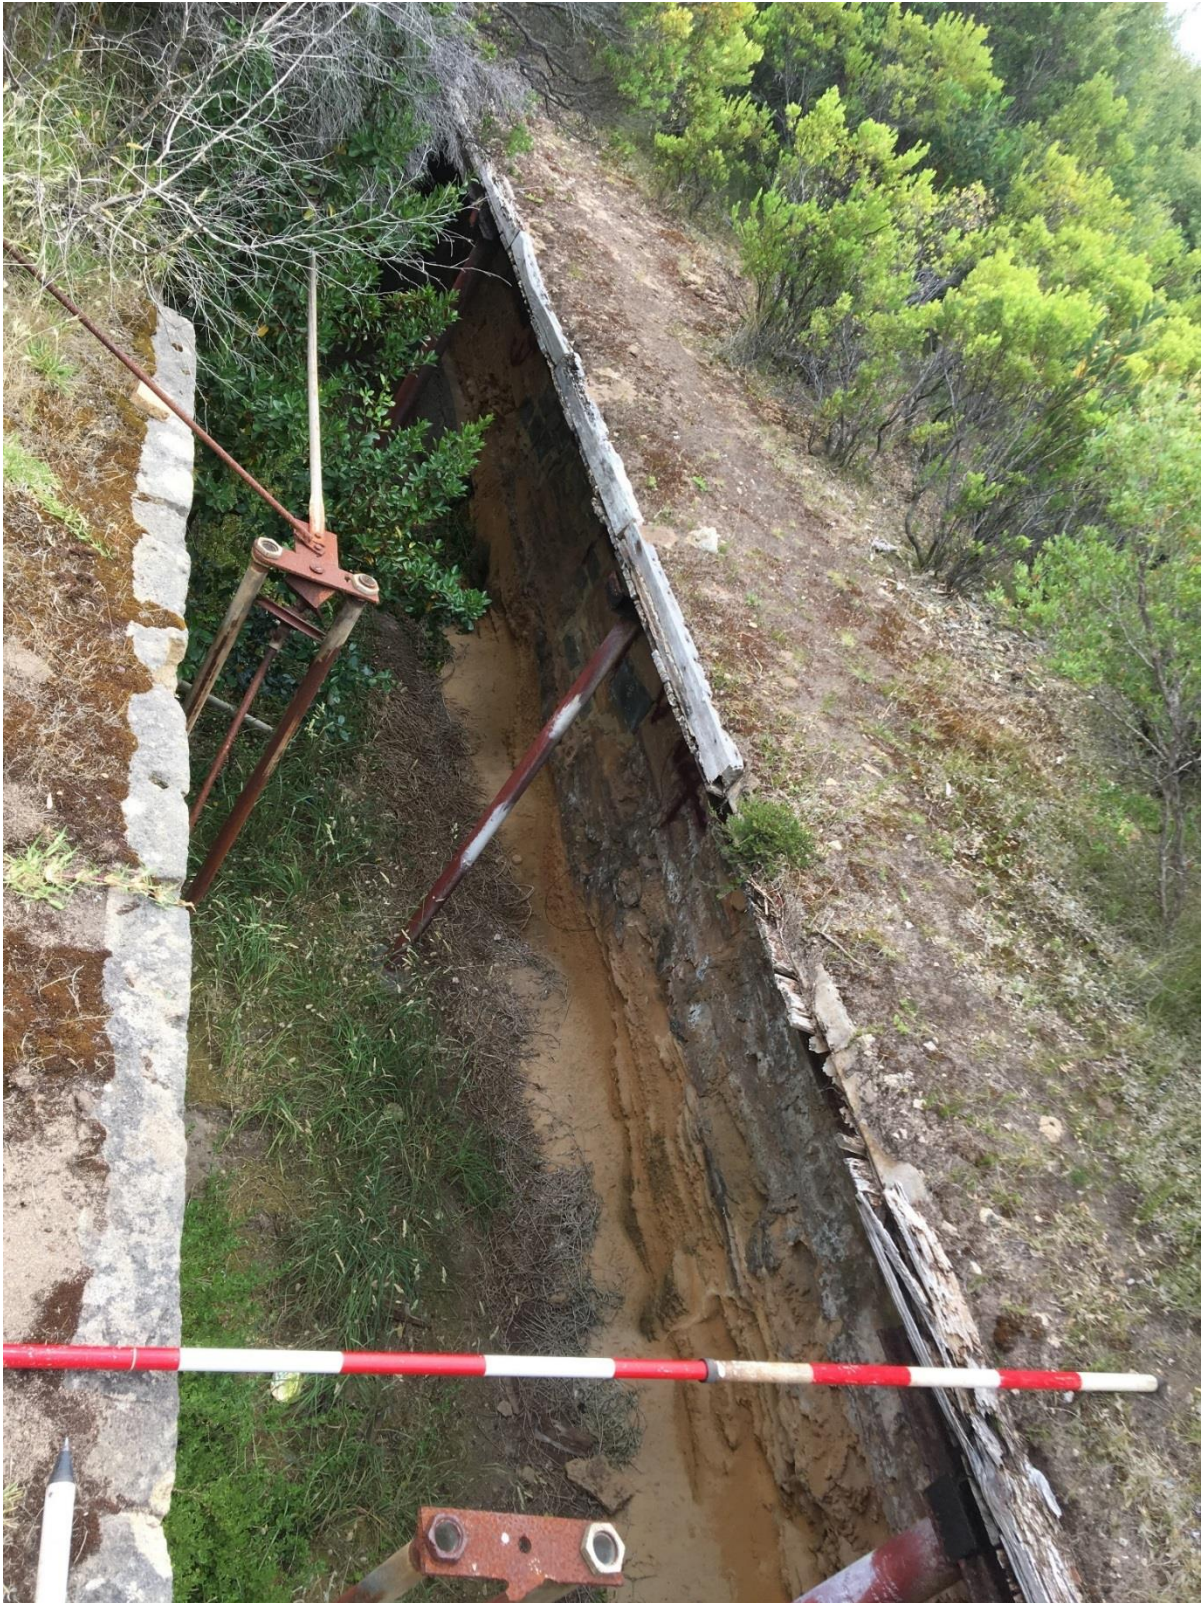
Figure 11 Constructed trench at forward (northern) face of rifle butts. Timbre and masonry construction material visible as well as steel components of target frames.

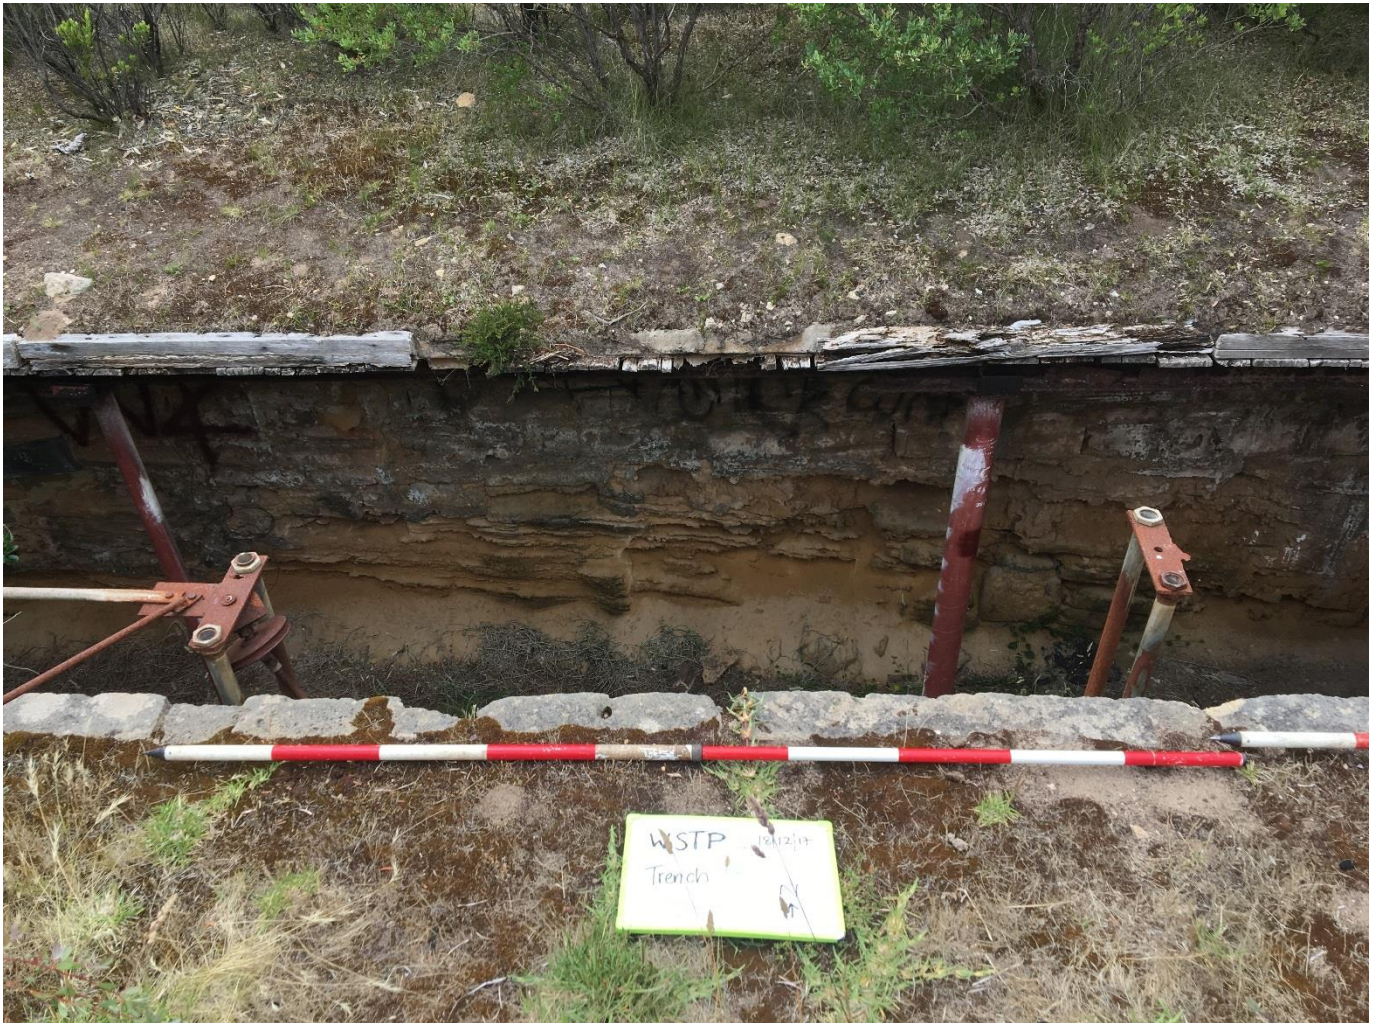
Figure 12 Constructed trench at forward (northern) face of rifle butts.

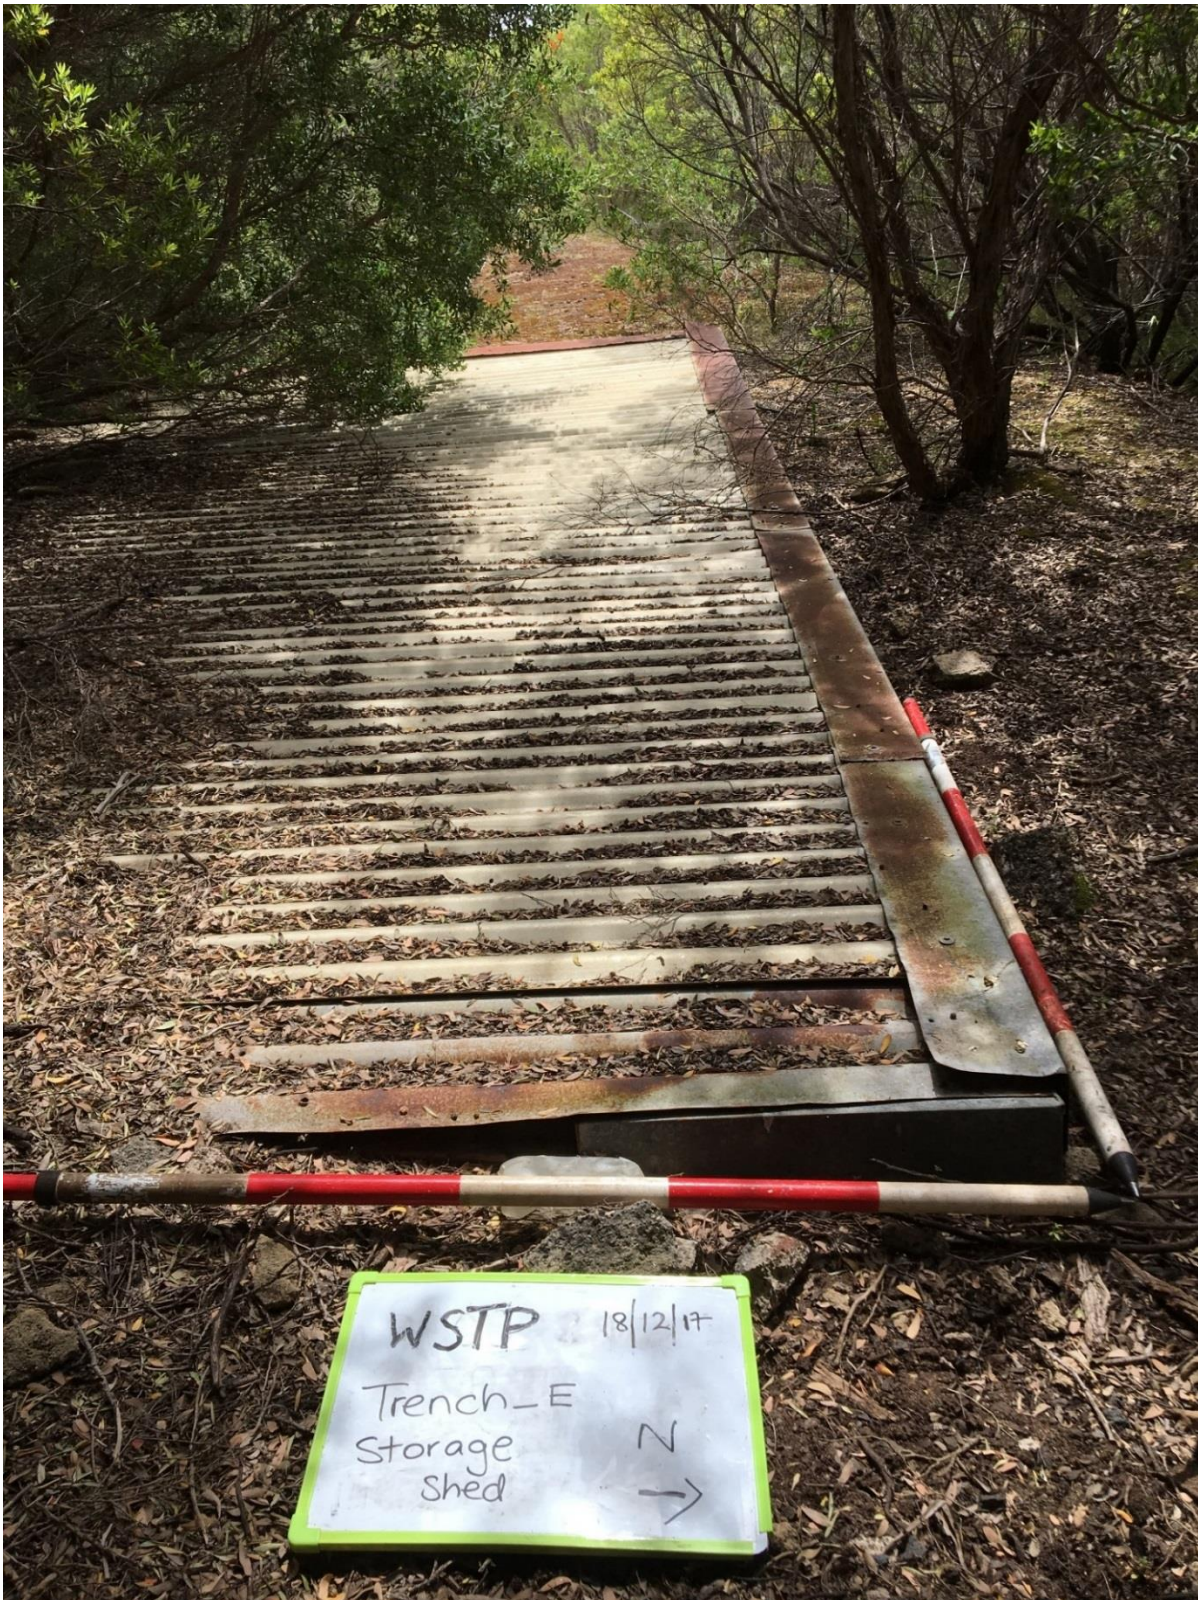
Figure 13 Roofed eastern extent of trench, identified as a storage area. The roofing of the sub-surface trench is at ground level and constructed from galvanized corrugated iron.
