# Historical archaeological site card

Place name: Warrnambool Rifle Range

## 6. Current description of site

## 8. Analysis of site (interpretation)

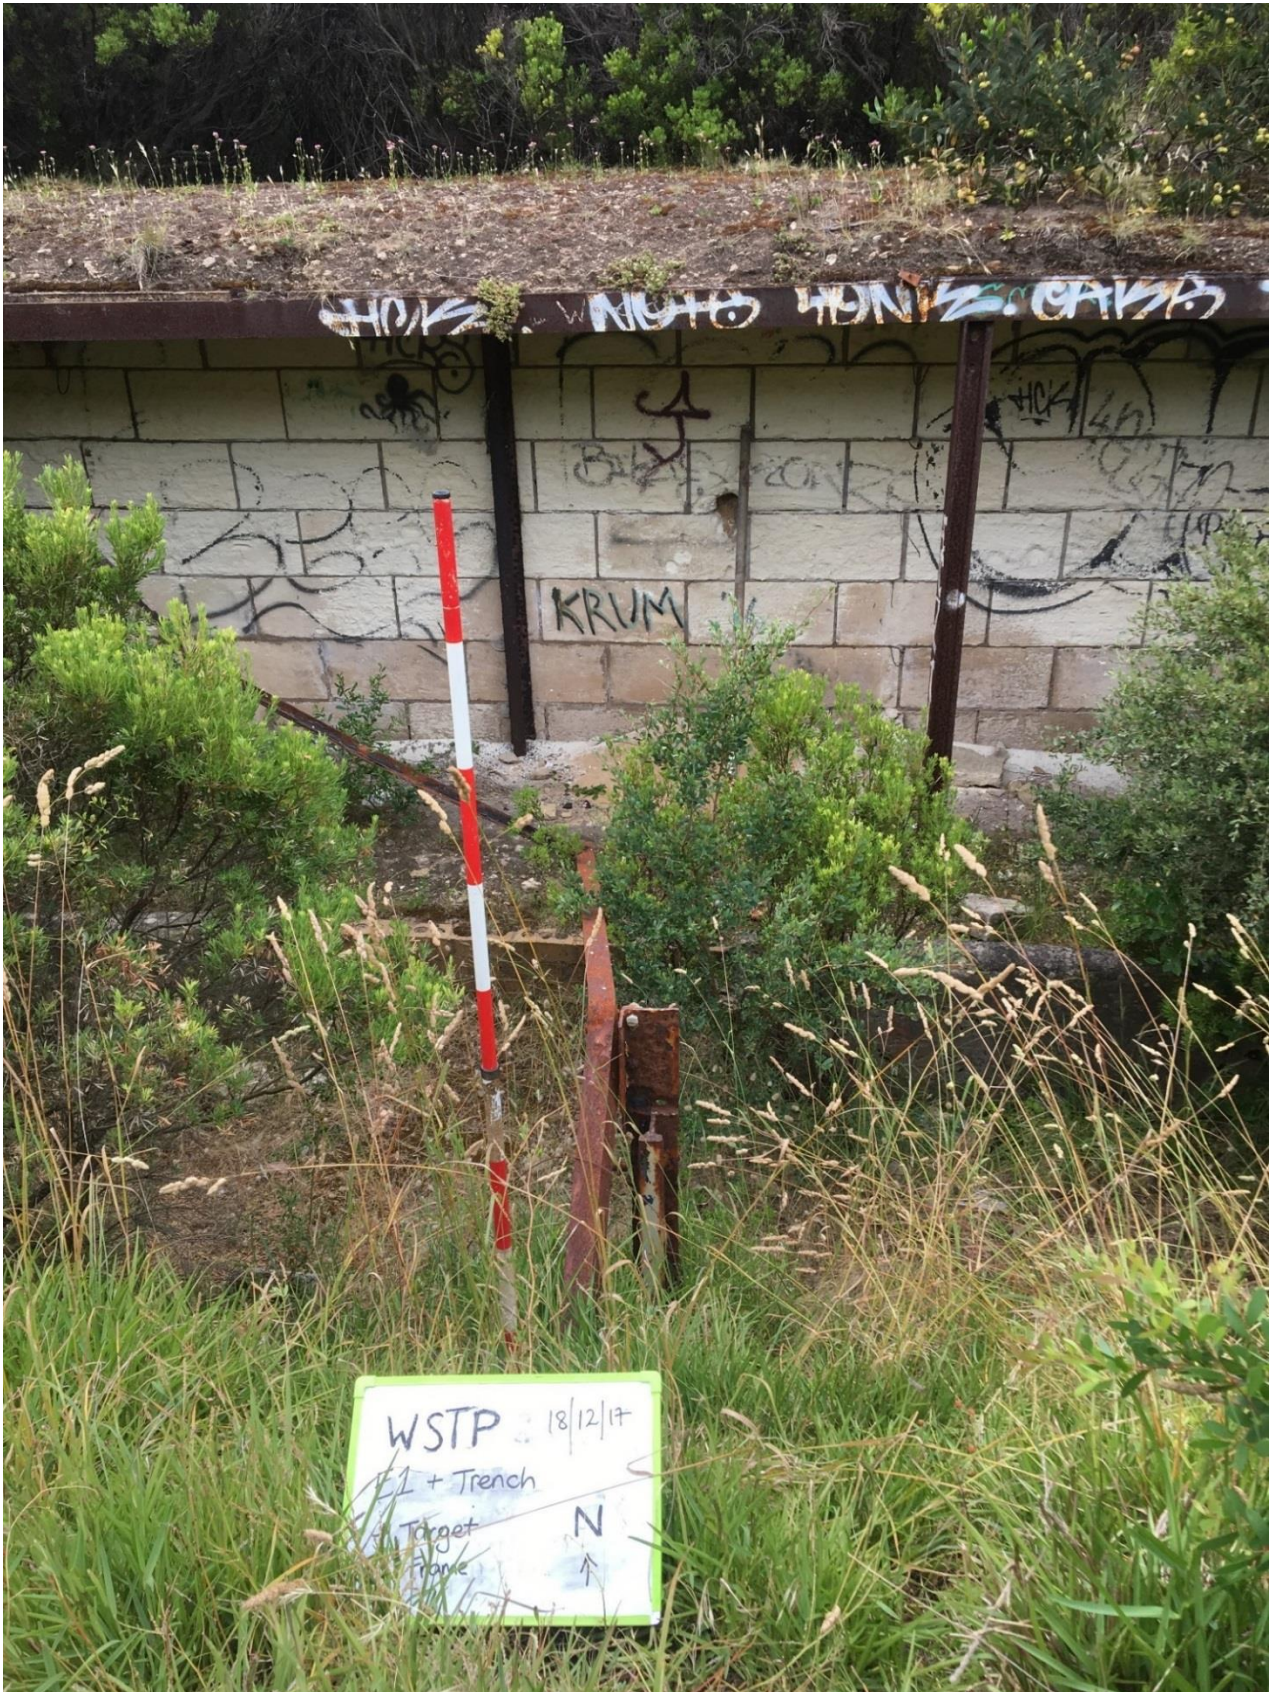
Figure 14 Recent components of trench at eastern extent. Materials used include masonry, and iron components, including supports made from reused rail track

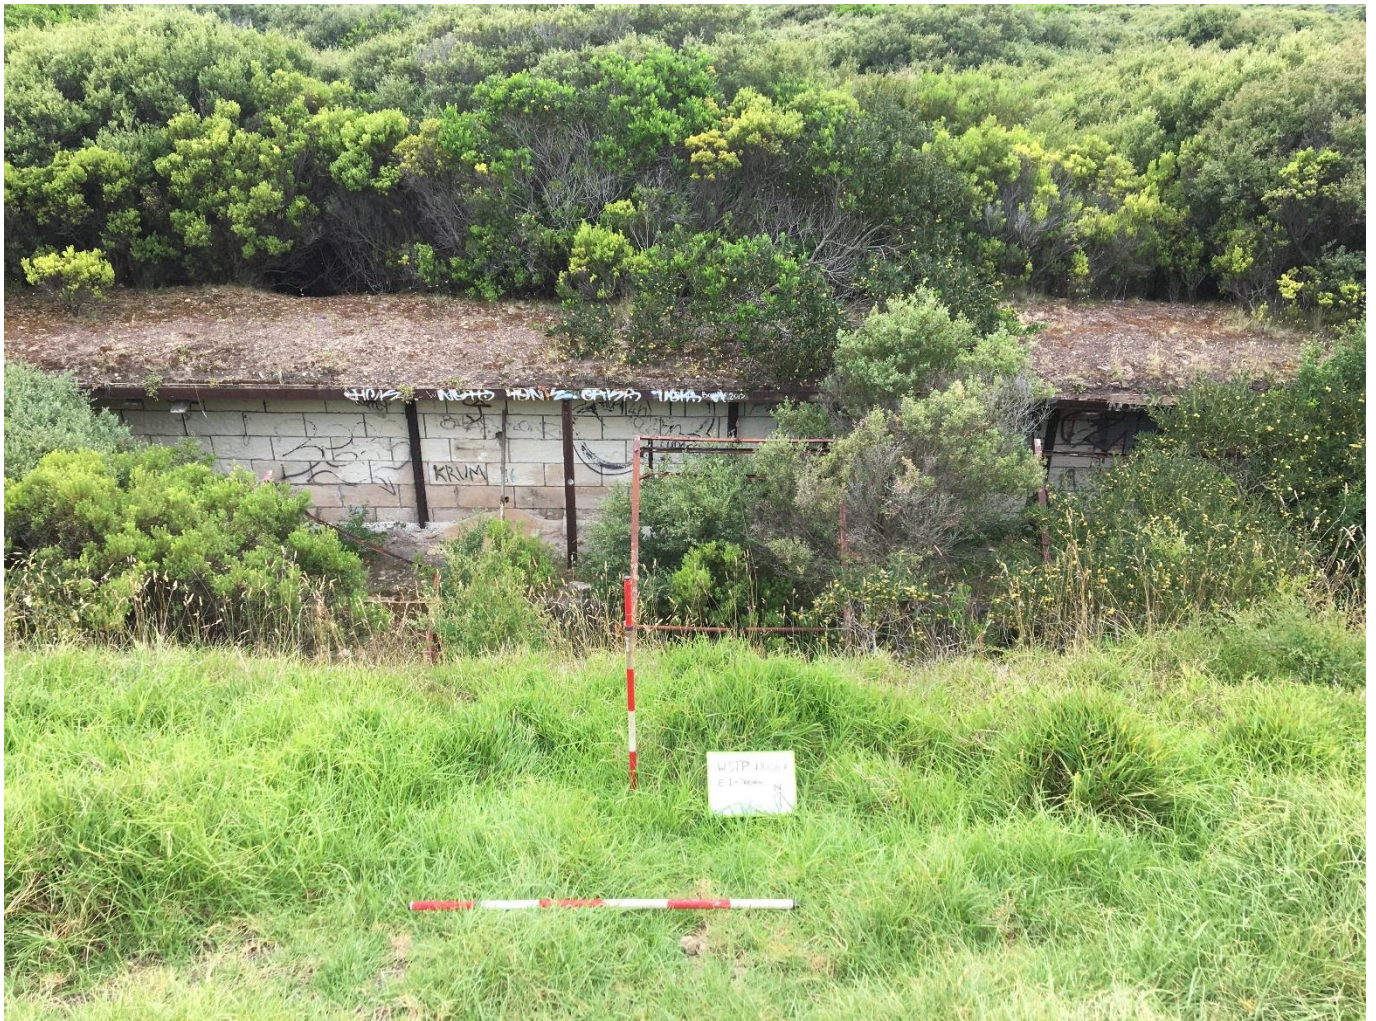
Figure 15 Eastern section of trench appears to be of newer construction. Materials used include masonry and reused railway track. Steel target frame visible in centre of shot.
