APPENDIX C DATA SHEETS

Boundary Fence, Walls and Main Entrance

Location: Lucan Street
Built: Timber fence & gates – by 1874
 Metal fence & gates – c.1885
 Brick walls – c.1880 -1910
Designer: Probably W.C. Vahland
Builder: Unknown

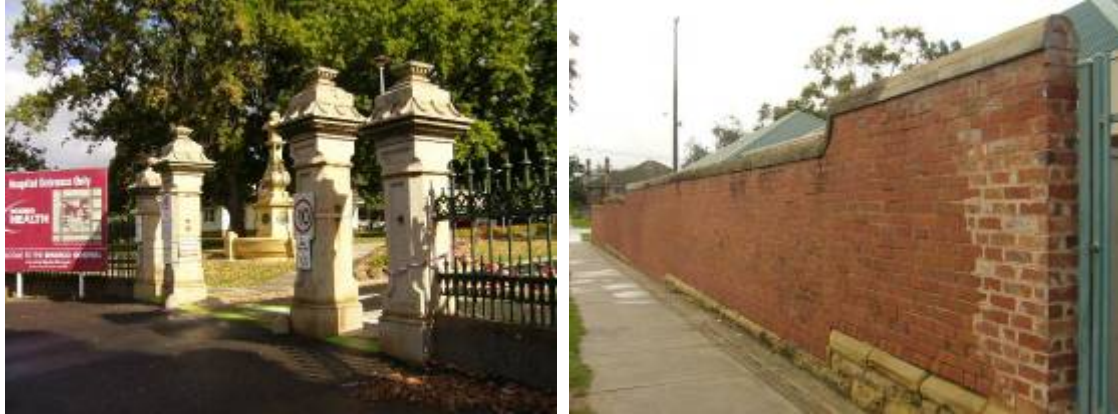
A decorative cast iron palisade fence, set into a bluestone base, extends along the Lucan Street boundary of the site. The main entrance into the site is located part way along this fence. The palisade fence curves inwards to form a semi-circular recess for the entrance, framed by two pairs of granite gate piers. The piers originally framed central iron gates, sufficiently wide for a horse-drawn vehicle, flanked by two smaller pedestrian gates. All the gates have since been removed, but the piers and fence are largely intact. Spherical gaslights, capped by a decorative crown, are mounted on cast iron posts at the junctions where the palisade fence curves in towards the main entrance.

Further granite piers are located at the corners of Lucan and Bayne Street, and Lucan and Arnold Streets. At these points the boundary treatment changes from the palisade fence to a brick wall. On both Bayne and Arnold Streets, it appears as though sections of brickwork have been cut out at the south-eastern ends of the wall, to improve visibility.

Where intact, the red brick wall has a sandstone plinth and is approximately 2 to 2.5 metres high. The wall is capped by a rendered roll-over top with embedded glass to deter intrusion. Simple brick buttresses are located at regular intervals on the inner face of the wall. The wall has been broken through and decapitated in a number of locations. It has also been rendered and painted in some sections along Arnold and Stewart Streets.

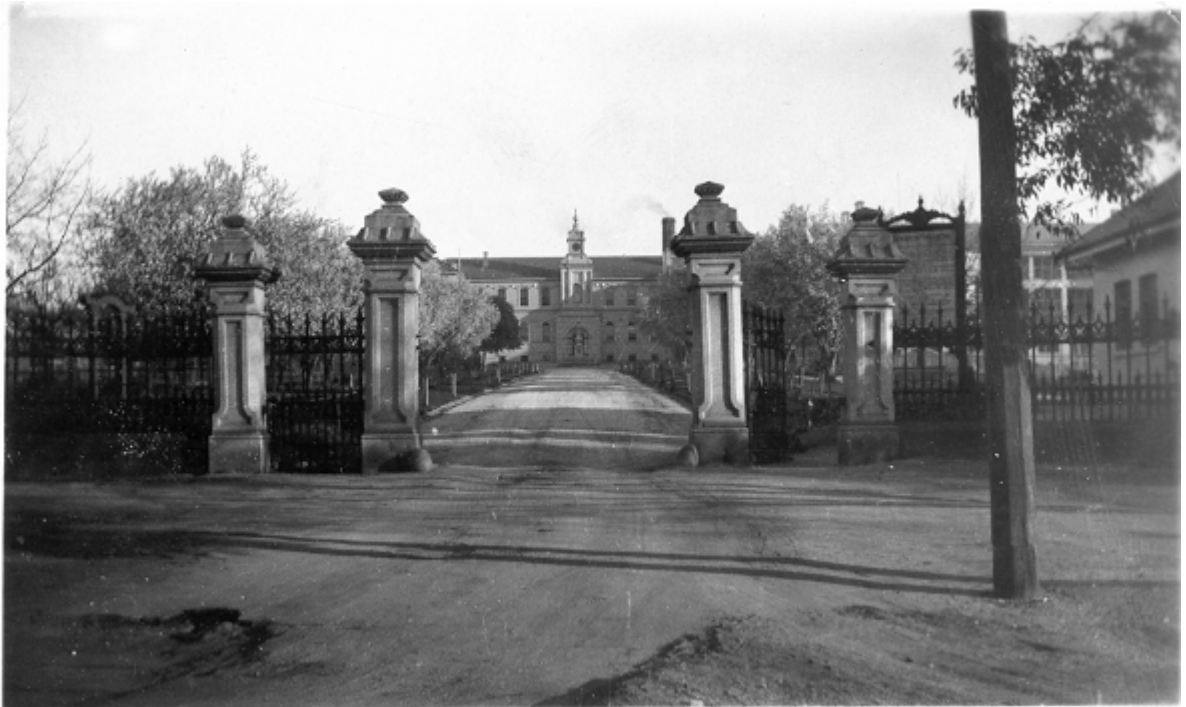
Undated photo of the Main Entrance.
Source: Bendigo Health Records

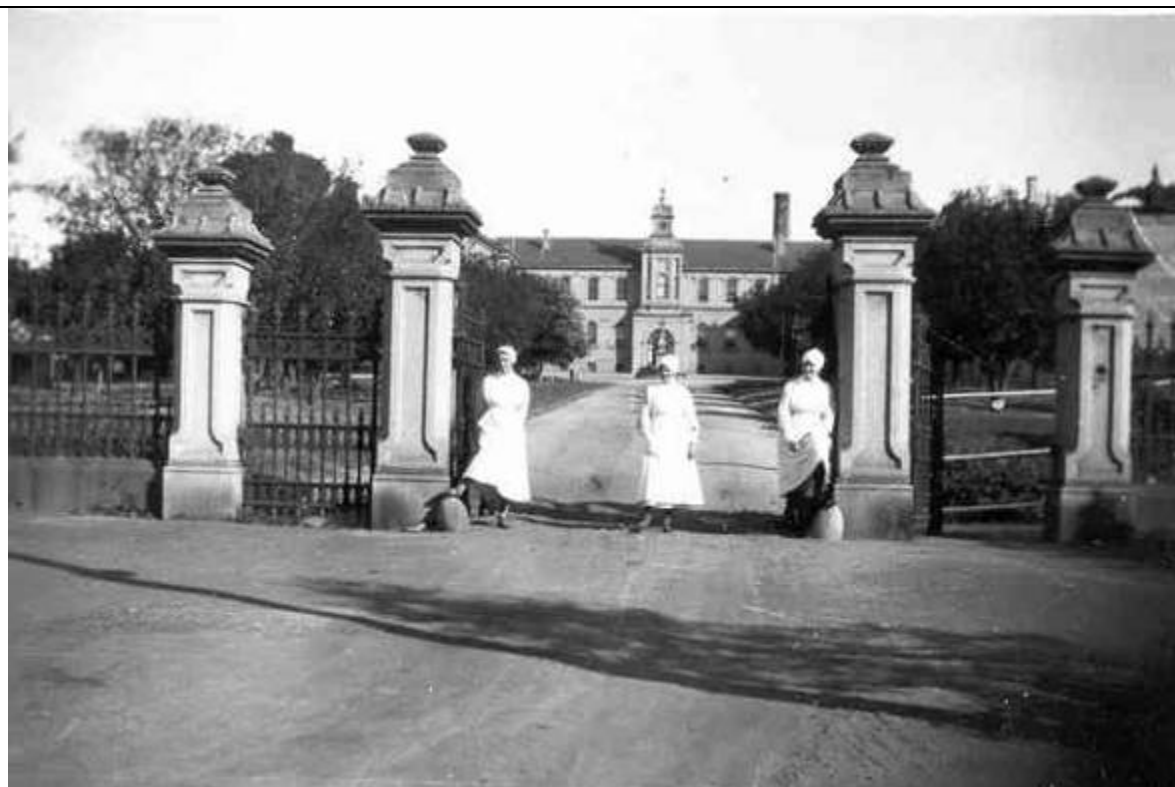
Main Entrance of the Bendigo Hospital, undated photograph. (Note that the gates are partly visible)
Source: Bendigo Health Records

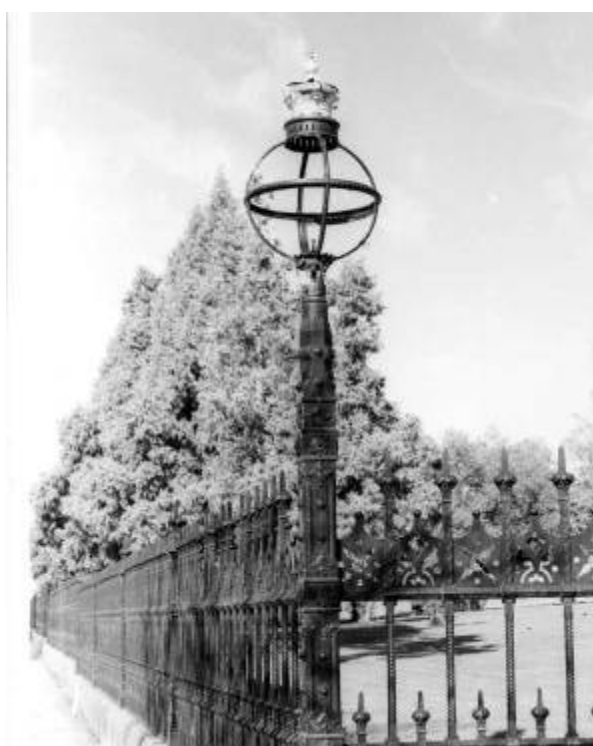
Undated photo of the Lucan St fence, showing the frame for gaslights at the Main Entrance. The opalescent globe is missing from the lamp.
Source: State Library Victoria
