B3 Mortuary

Location: Stewart Street
Built: 1887
Designer: W.C. Vahland
Builder: Unknown

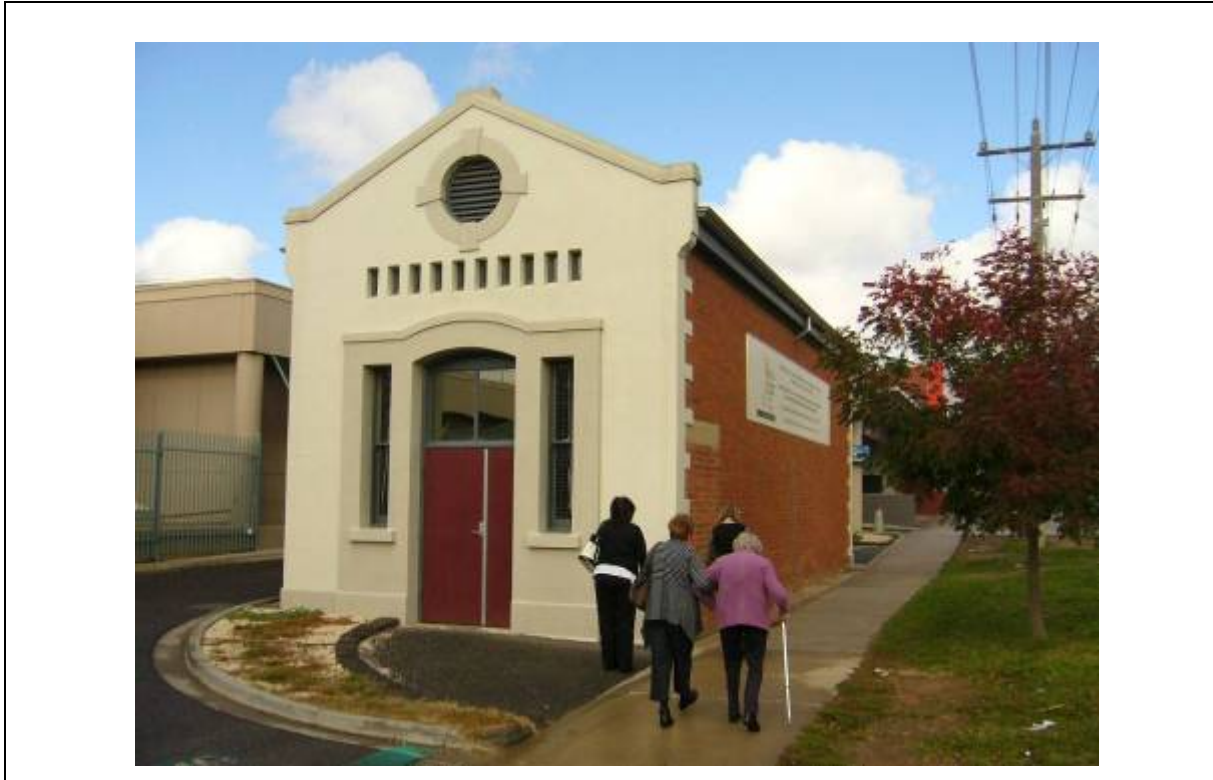
A single-storey red brick and rendered building with a gabled roof clad with corrugated iron. The rectangular building is built on the Stewart Street boundary. Sections of the high brick boundary wall around the hospital site have been removed from the Stewart Street boundary and this wall originally abutted both ends of the Mortuary building (as shown in the photograph below), accounting for its plain brick elevation to Stewart Street. Instead, the building was designed with entrances on the two gabled side elevations.

These elevations on the short ends of the building each feature a central door with top light, flanked by narrow timber-framed, double-hung windows. Rendered dressings surround these door and window openings, and also surround circular vents with timber louvres in the gables above. Other rendered details include the gable coping, plinth and quoins at the building corners. On both building ends, a row of ten small rectangular openings extends above the windows and door, but below the circular vent. These openings are now glazed, but were probably left open originally to increase the ventilation of the building.

There is evidence of a simple door opening on the Stewart Street elevation, which has since been bricked-up. Externally, the building is relatively intact; however, the original door on the north-east elevation has been replaced with a modern flush door.

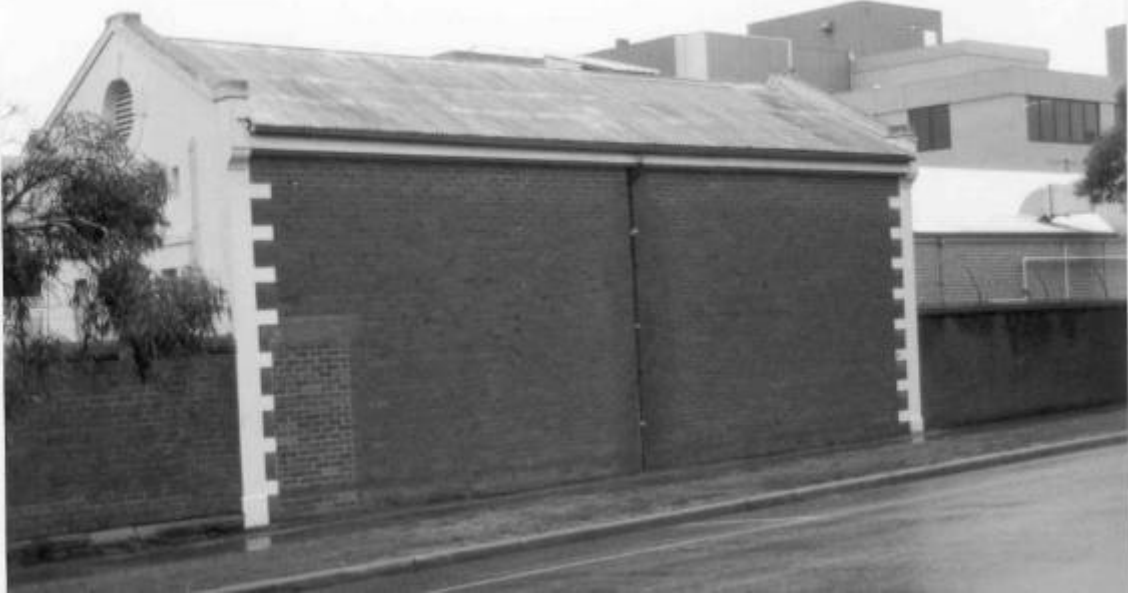
The Mortuary prior to restoration works, 1997. Note that the boundary walls abutted the building.
Source: Bendigo Health Records

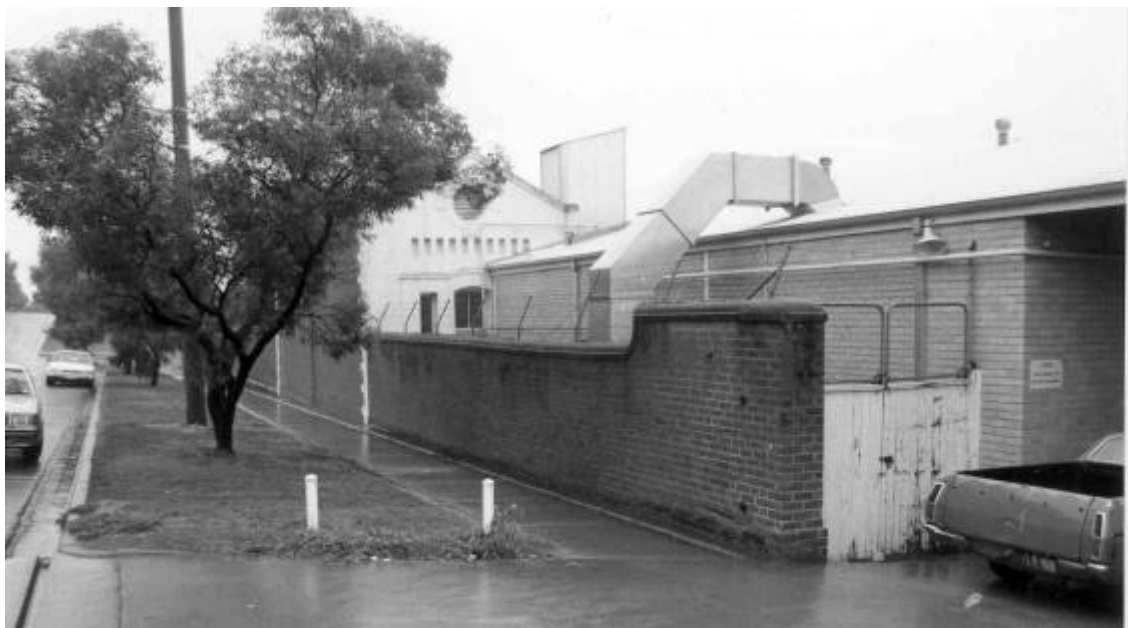
The Mortuary prior to restoration works, 1997. Note the abutting building, which has since been demolished.
Source: Bendigo Health Records

The Mortuary was built in 1887 and replaced an earlier morgue on the hospital site. It has not been used as a morgue for many years. A Stores and Refuse Disposal Building was shown as adjoining the southern side of the Mortuary in 1959 drawings and in the 1997 photograph below, this adjoining building has since been demolished. The Mortuary was used in recent years as a museum and archive for some of the hospital's records. A plaque on the building records that it was designed by WC Vahland and restored in 2003.
