**Location:** Mercy Street  
**Built:** Circa early 1880s  
**Designer:** Probably Vahland and Getzschmann  
**Builder:**

#### History:

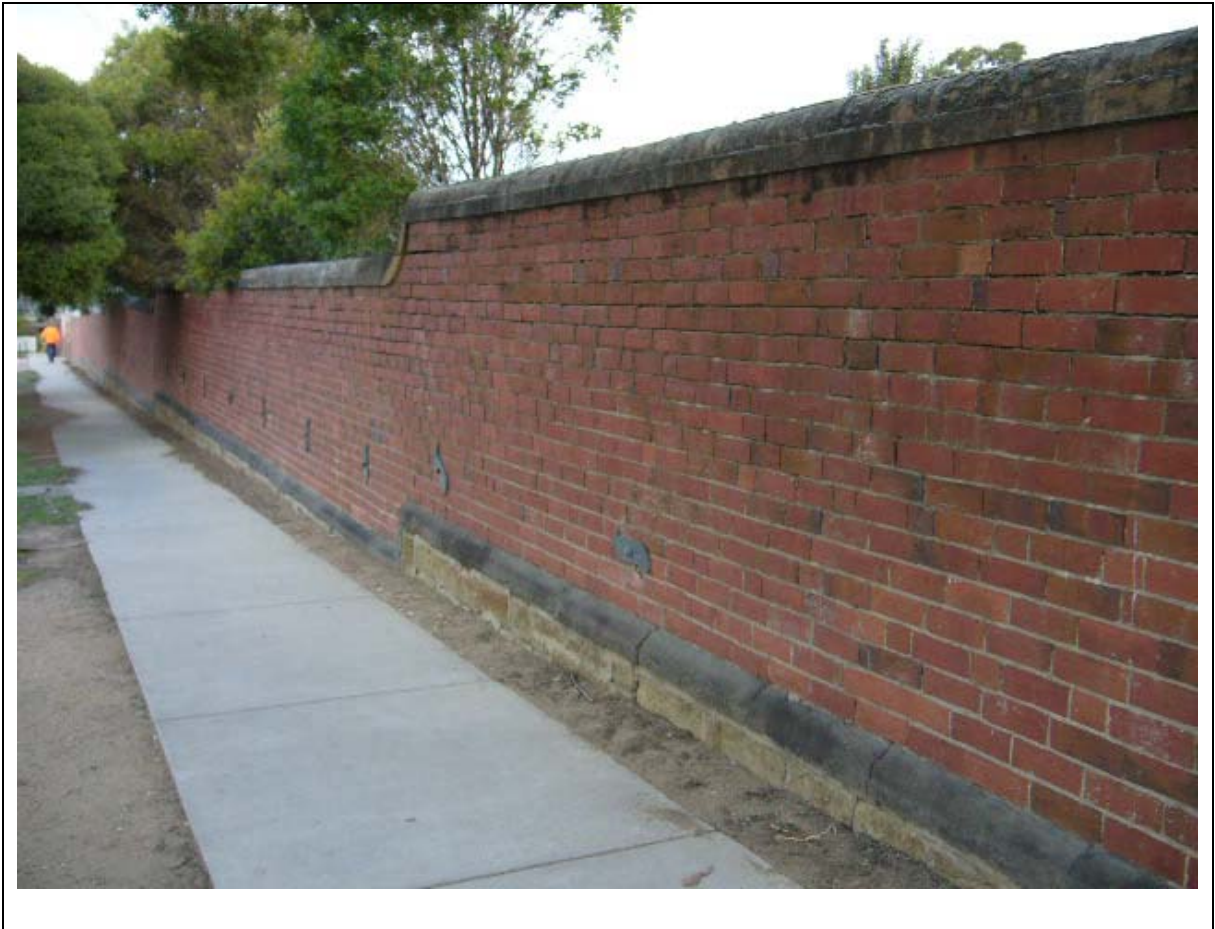
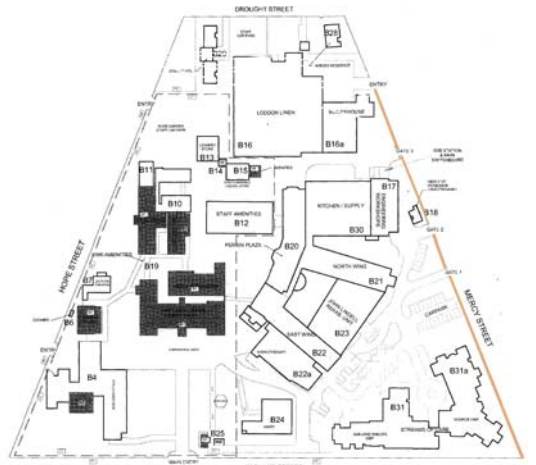
A brick wall approximately 2m high primarily in stretcher bond with every fourth course a header-stretcher-header-stretcher arrangement. The wall is capped by a rendered roll over top (originally with embedded glass to deter intrusion) and built on a rock faced base of sandstone and tooled basalt work.

This wall is less intact than Hope Street in that it is penetrated by two pedestrian openings and three vehicular openings. The first 32m of the wall are the most intact, followed by a pedestrian opening with lowered wall sections (5m), then a recent rebuilding of the wall over the following 15m.

The following 21m (58-79m mark) has some metal balustrade attached to the wall top prevent intrusion, followed by a further 21m of original wall (79-100m), a pedestrian gate, a vehicular entry gate, (at 107-112m) then further sections of original wall and vehicular entry gates at the 132m & 174m marks. The wall terminates at approximately 218m from Barnard Street where it returns into the site. At the 179m mark the following 8m has been rebuilt and then for approximately 10m before the end of the wall (at 207 –circa 218m) the wall shows further evidence of rebuilding. There are other shorter rebuilt sections such as at the 171-174m mark.
