Kiosk in the centre of Perrin Plaza

Location: mid site
Built: 1958
Date range: 1958 and reconfigured again in the 1990s and 2000s
Designer: Originally part of the YFGS work
Builder:

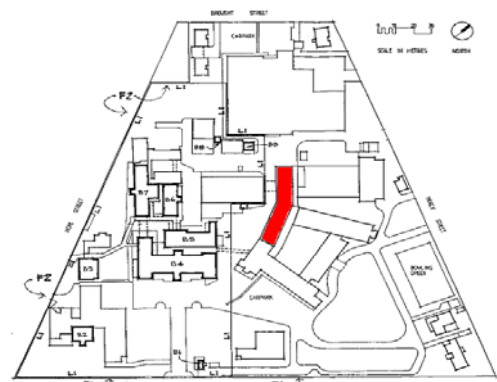
The structure is a one-storey brick faced building with a shallow slope metal roof with no apparent formal architectural arrangement.

Inspection of the building identifies several phases of brick construction related to a number of changes this area has undergone.
