1999 CONSERVATION MANAGEMENT PLAN

H O F F M A N B R I C K W O R K S

DAWSON STREET, BRUNSWICK

A P R I L 1 9 9 9

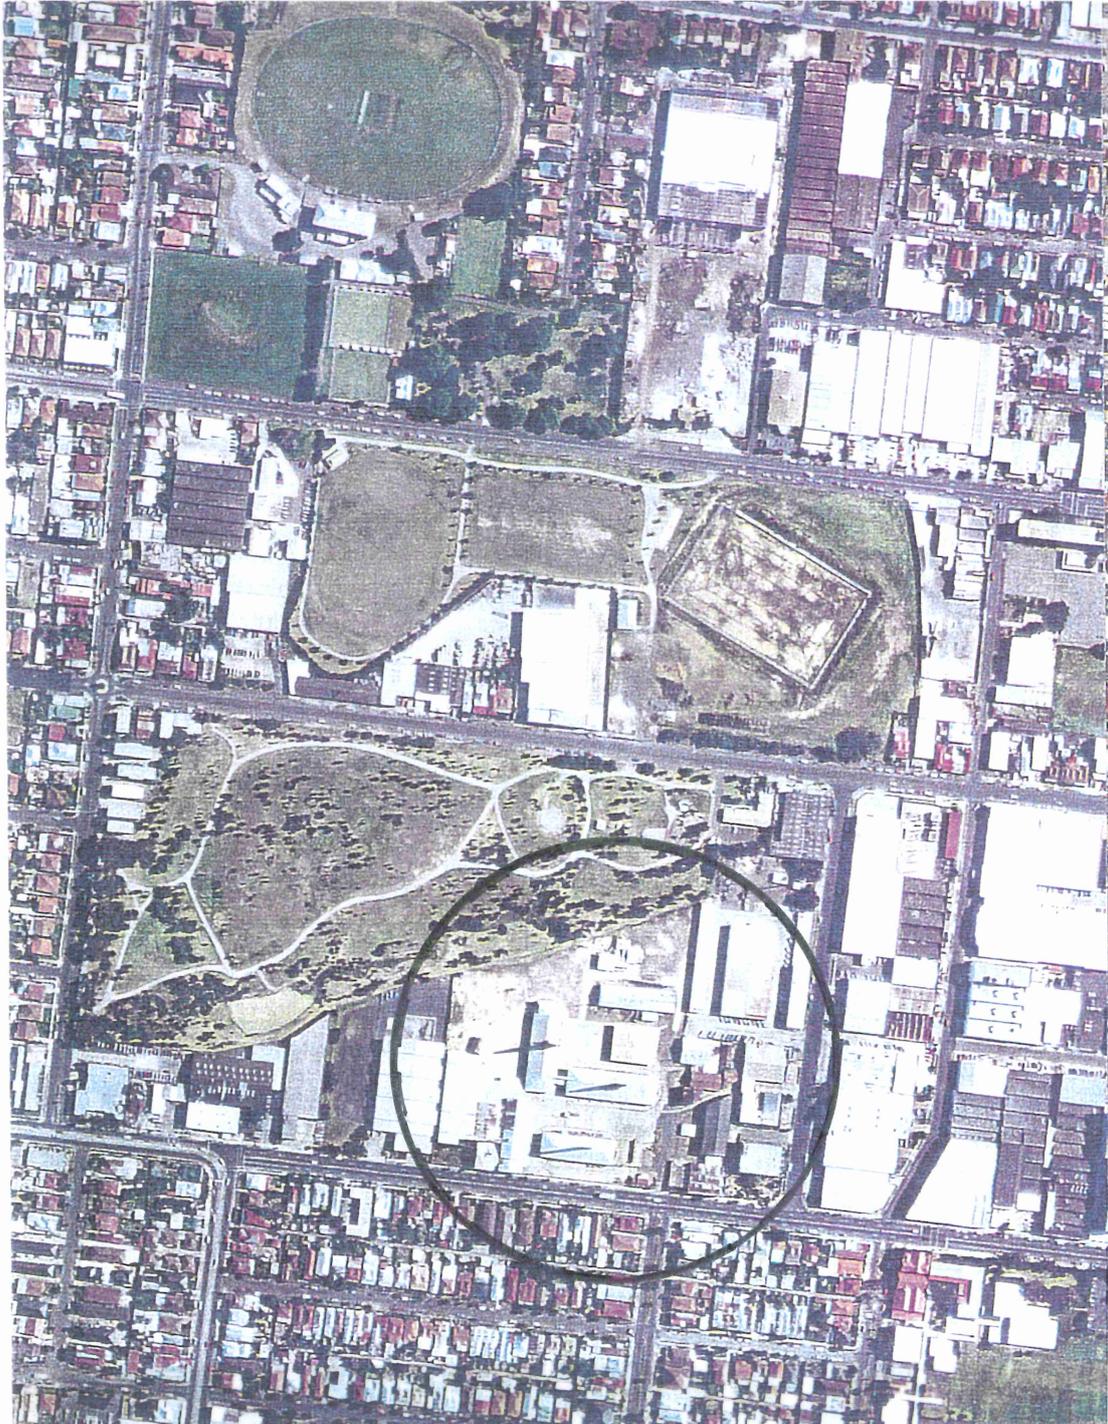
Figure 1
Site Plan

Aerial Photograph of the Hoffman Brickworks and Surrounds

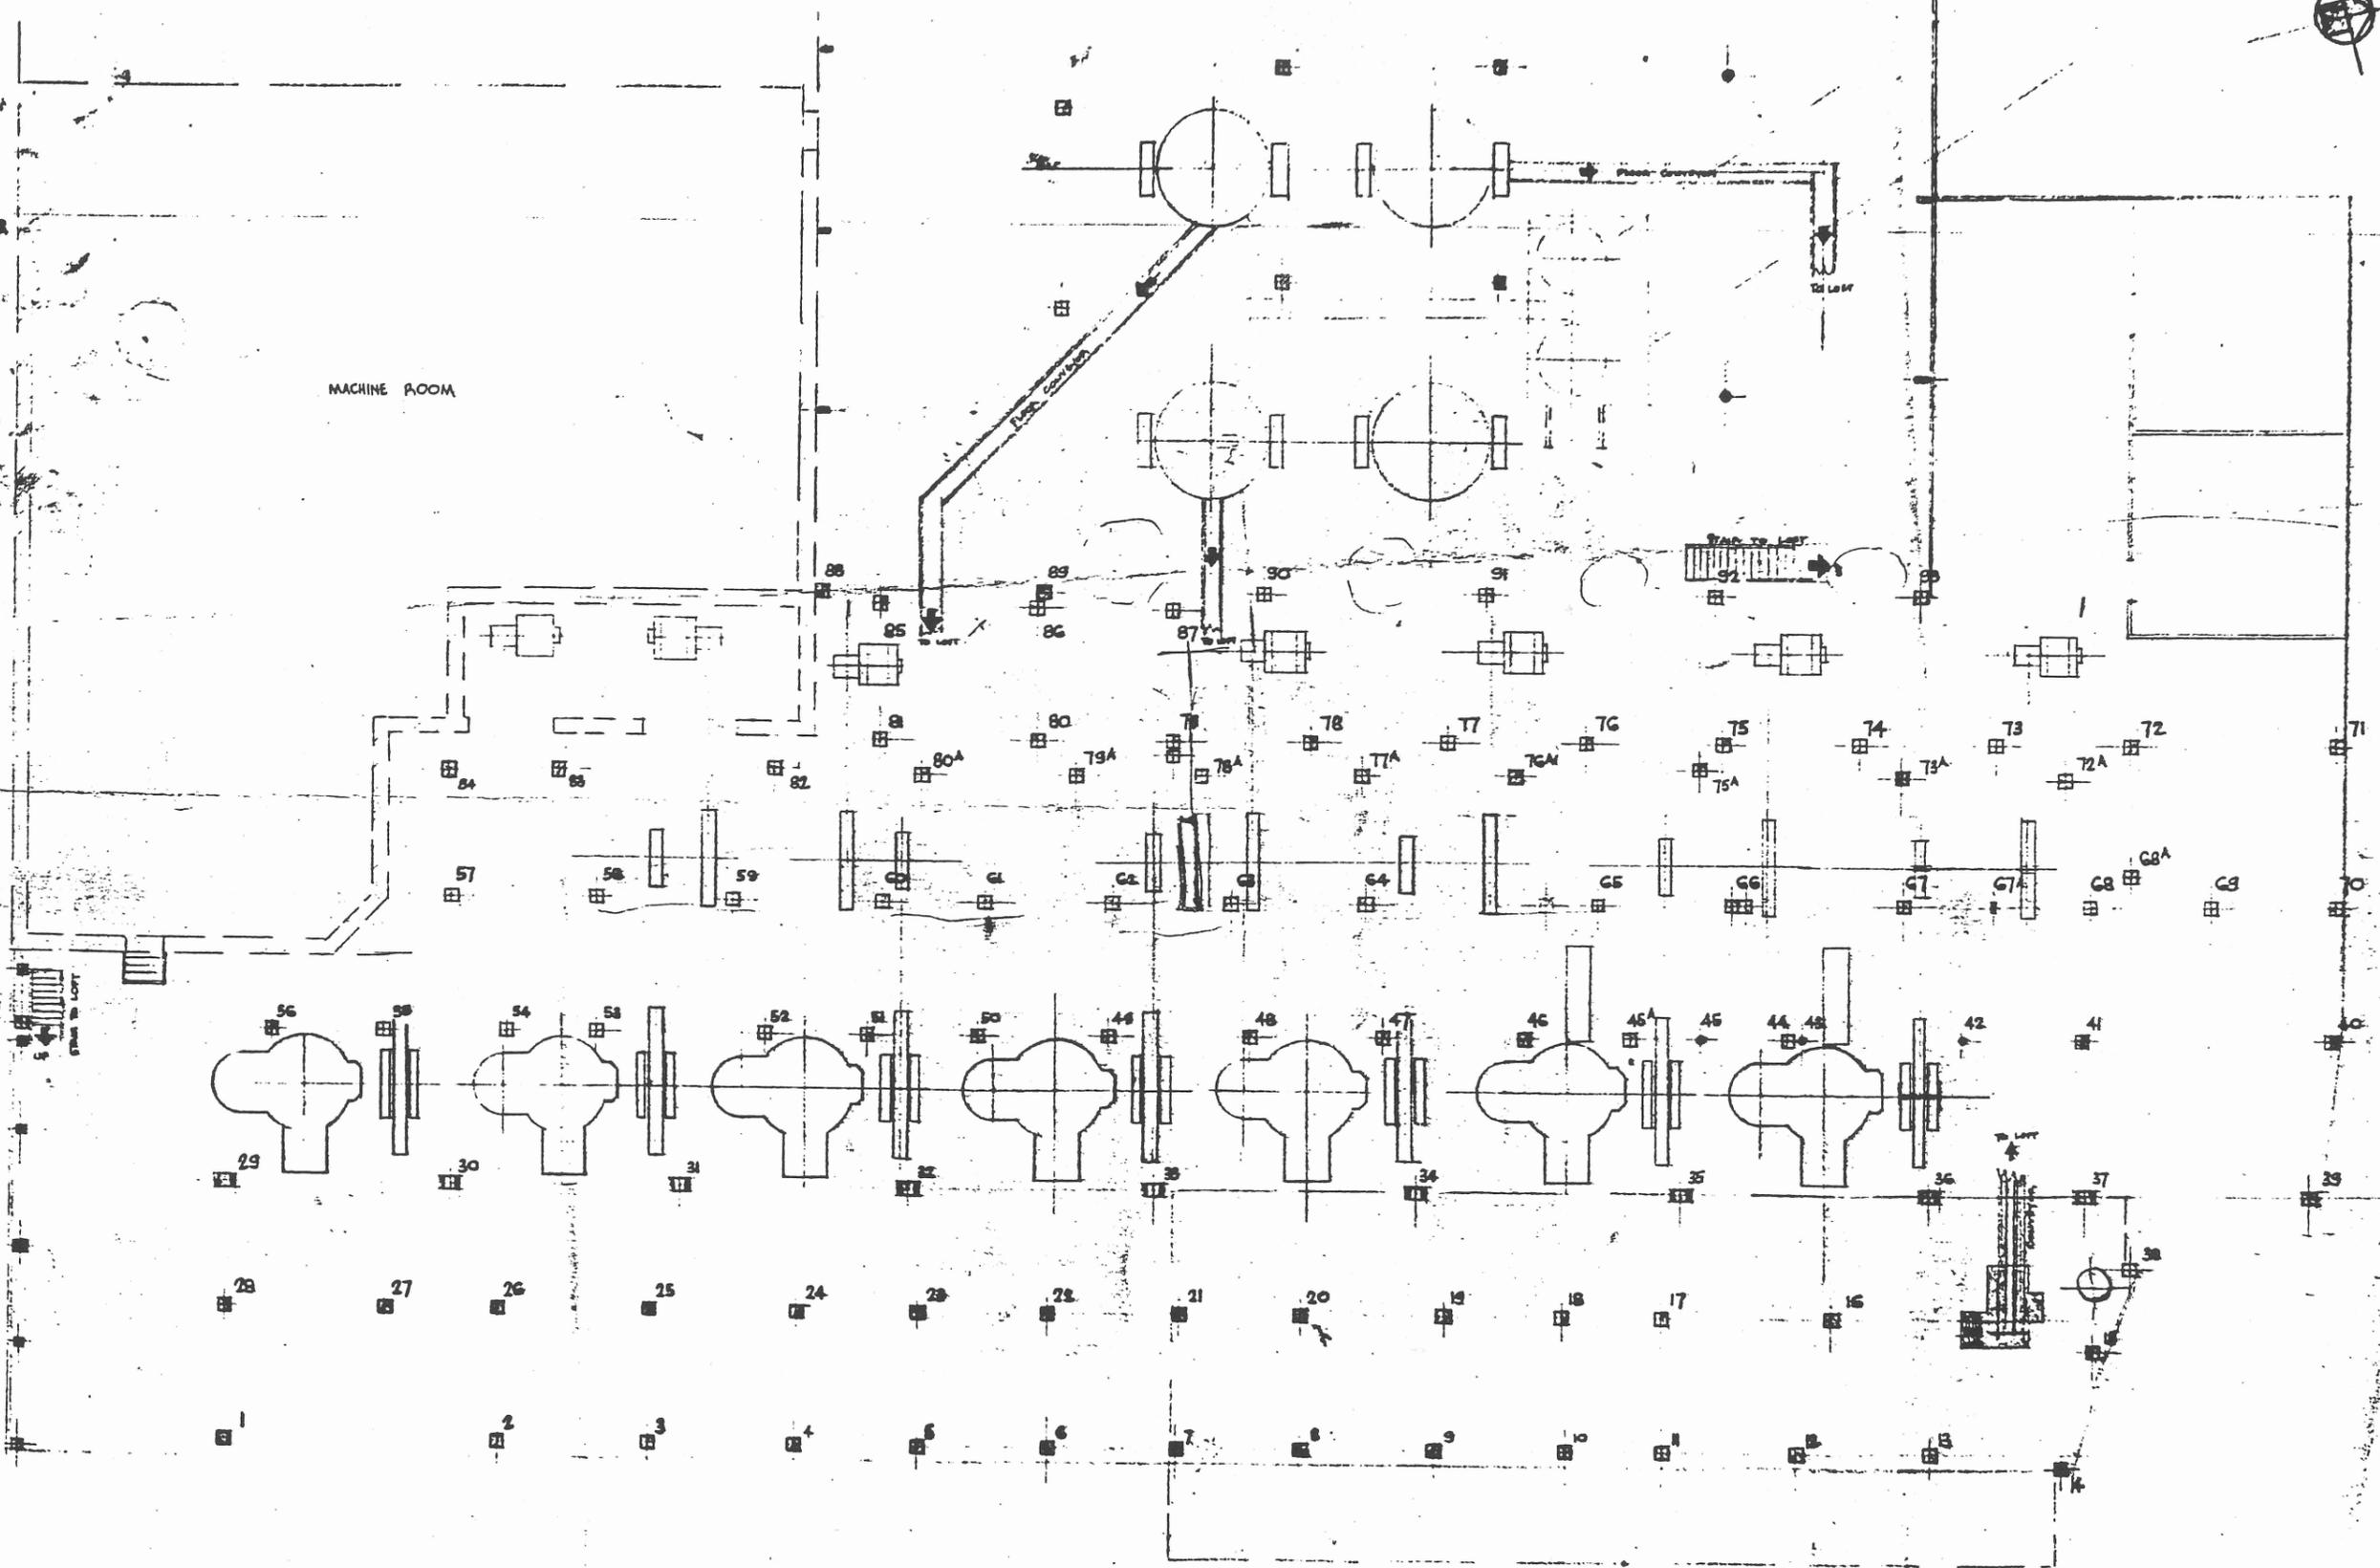
Figure 5
1958 Sketch Plan of the Brick Making Plant in Buildings 5 & 7

BRICK MAKING PLANT	SCALE	1/8" = 1'-0"
EXISTING LAYOUT	DRAWN	R. W. H. S. H. S.
	DATE	11-11-58

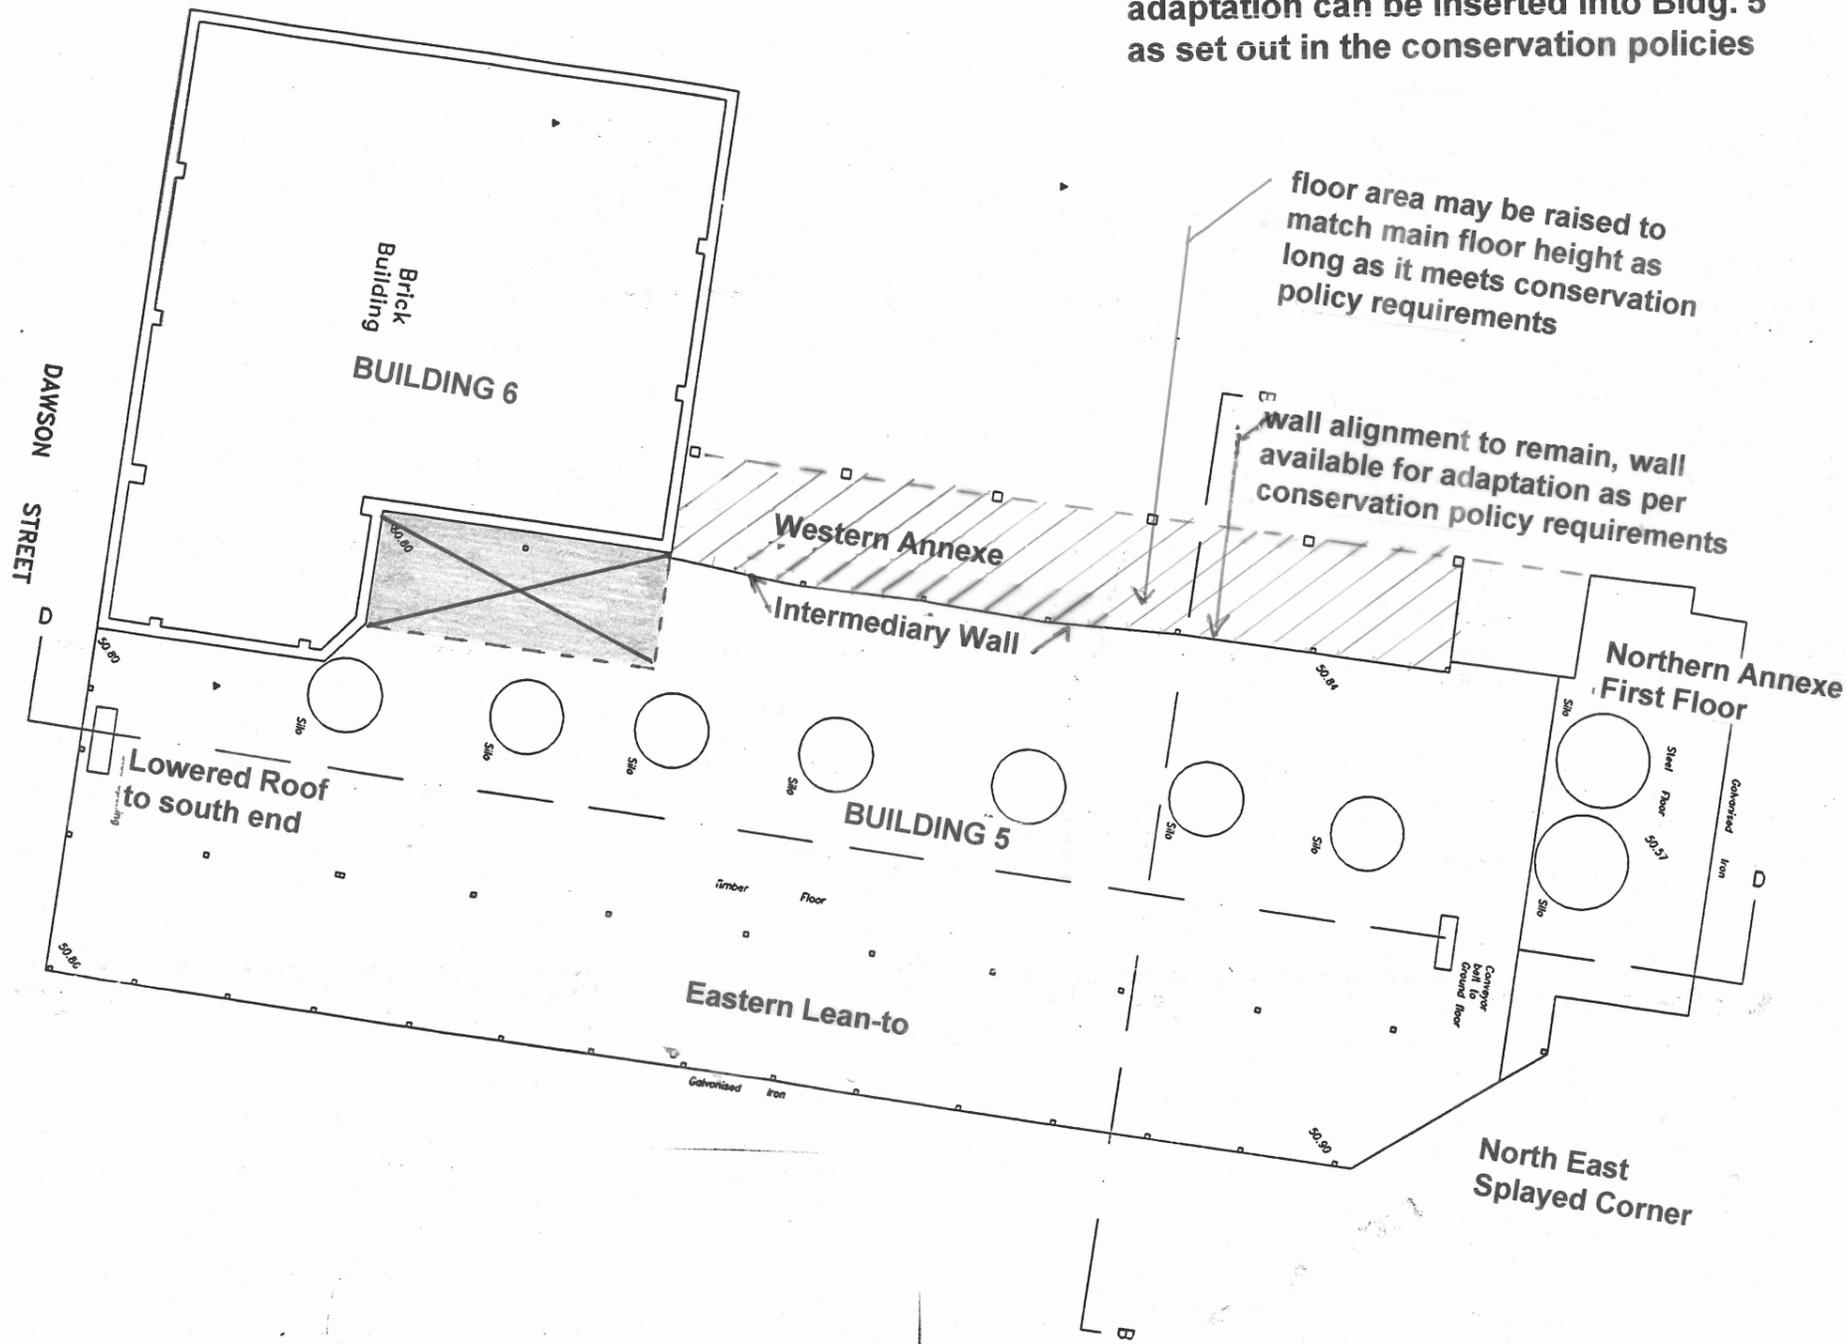
Areas Available for Adaptation - Bldg 5 Upper Floor Plan

Providing existing historic fabric is retained, new elements required for adaptation can be inserted into Bldg. 5 as set out in the conservation policies

An assessment of the equipment located on the upper levels of Building 5 should be undertaken by an industrial archaeologist, in association with a former brickworks employee familiar with practises, in order to identify its use and individual and overall significance. This assessment should be used to inform further recommendations relating to the selection of equipment for retention or otherwise. It should also address the significance of the bay of Building 6 which projects into Building 5 as identified on figures 12 and 12a.

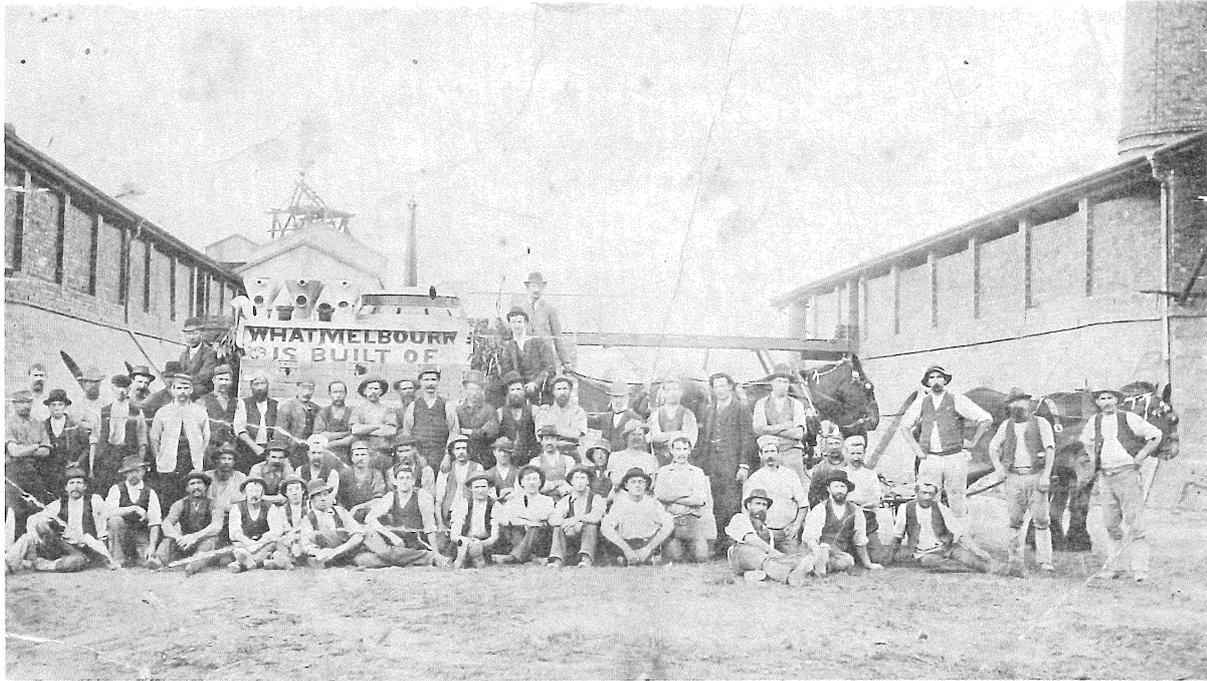
Figure 1. Hoffman's Pottery, Brunswick. Late 1870's.
Source: Bennetts, Don., *Melbourne's Yesterdays: A Photographic Record 1851-1901*, Souvenir Press, Menindie, 1976, p. 123.

Note: Photograph shows two Hoffman Kilns at the Number 1 Works during the late 1870s, before the construction of Number 2 Works in the 1880's. This photograph provides evidence that the upper level of the Hoffman Kilns were entirely constructed from brick.

Photographic evidence showing the kilns at the No. 1 works in Albert Street and of kiln 1 in the 1920s and 1930s⁵⁵ clearly shows brick upper walls. An 1870s photograph of No 1 works clearly shows brick to the upper section of two kilns.⁵⁶ It is not documented when or for what reason the brick upper walls were replaced by galvanised iron walls. It is thought that the movement in the kilns, due to the firing process may have destabilised sections of the wall.⁵⁷

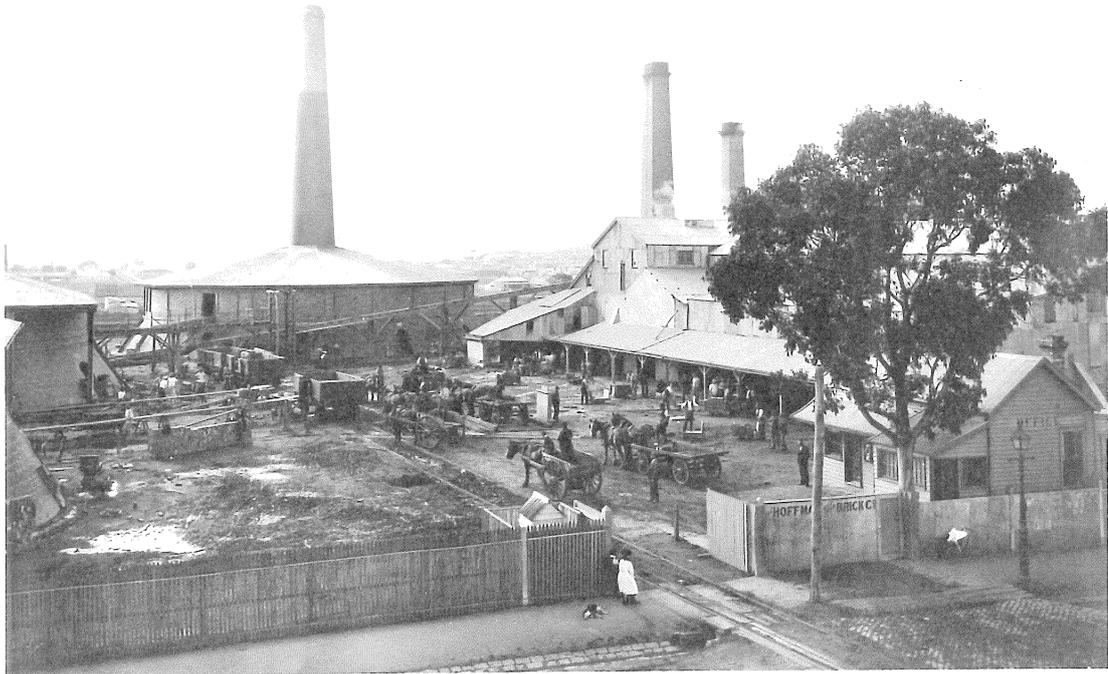
Figure 2. Undated photograph showing the kilns and brickpress building at the No. 1 Works. The first Hoffman kiln erected by the company in 1870 is in the centre of the photo.
Source: University of Melbourne Archives

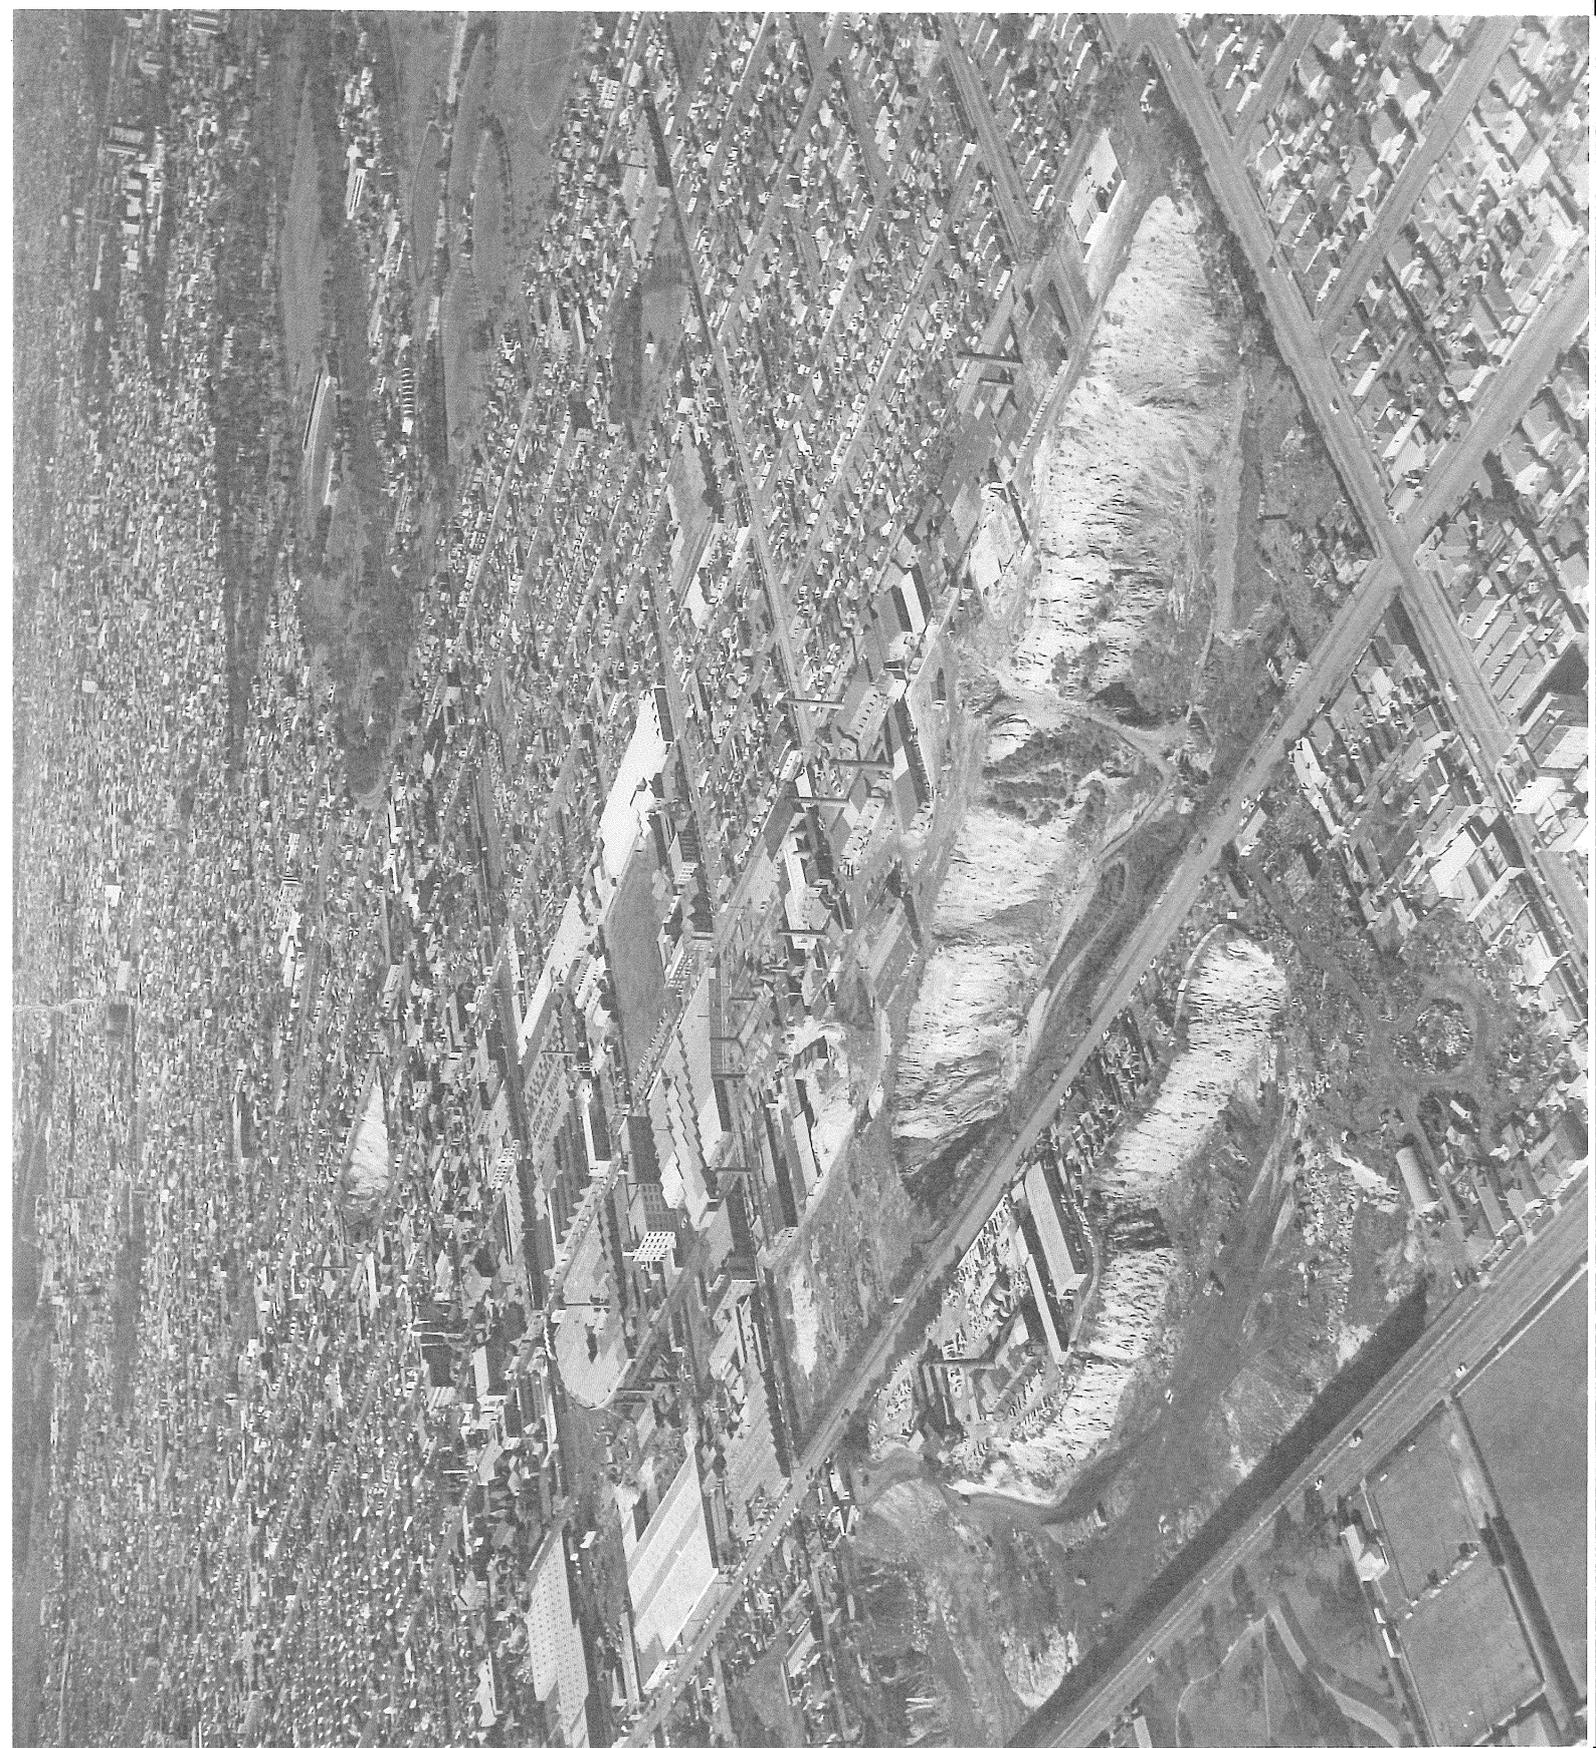
Figure 4. c.1960 aerial of the Hoffman Brickworks Number 1 and 2 works.
Source: Herald and Weekly Times Ltd. Melbourne. Held on site.

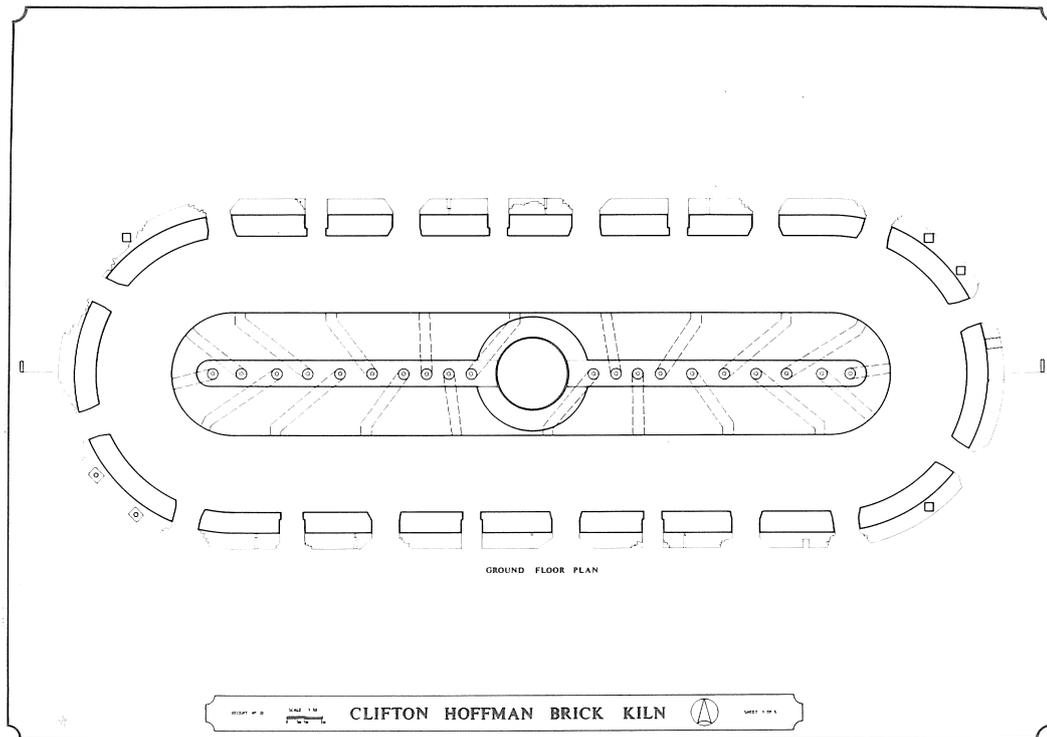
Figure 5. Hoffman Kiln 1, Ground Floor Plan. Matthew Flinders Measured Drawing Competition.

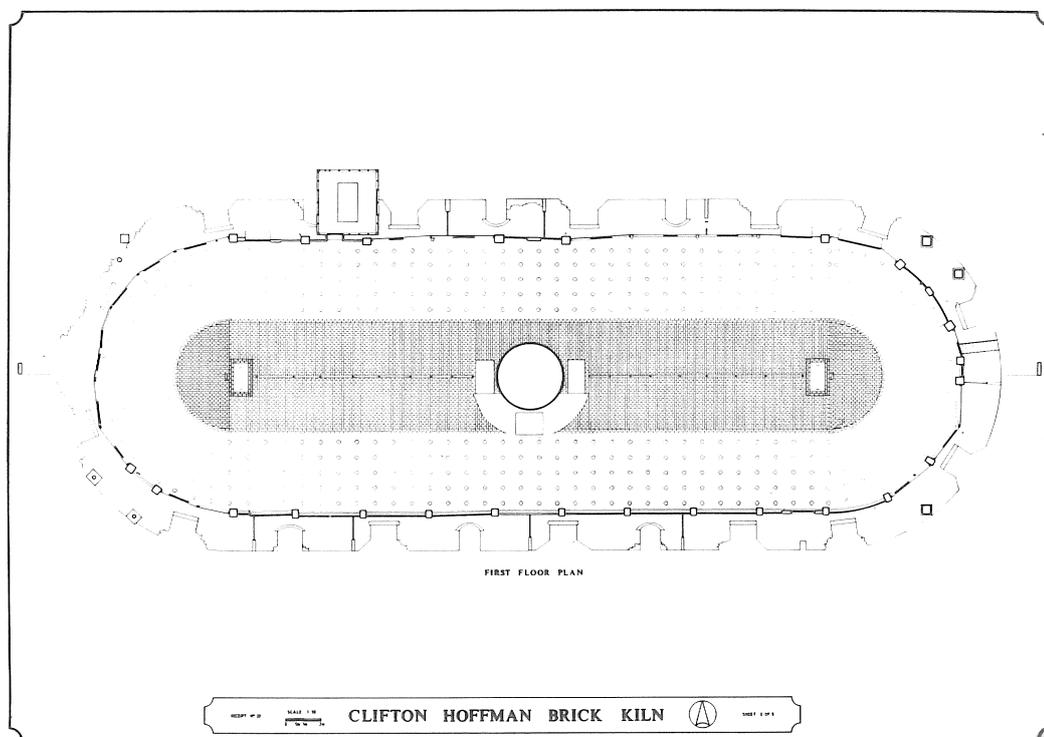
Figure 6. Hoffman Kiln 1, First Floor Plan. Matthew Flinders Measured Drawing Competition.

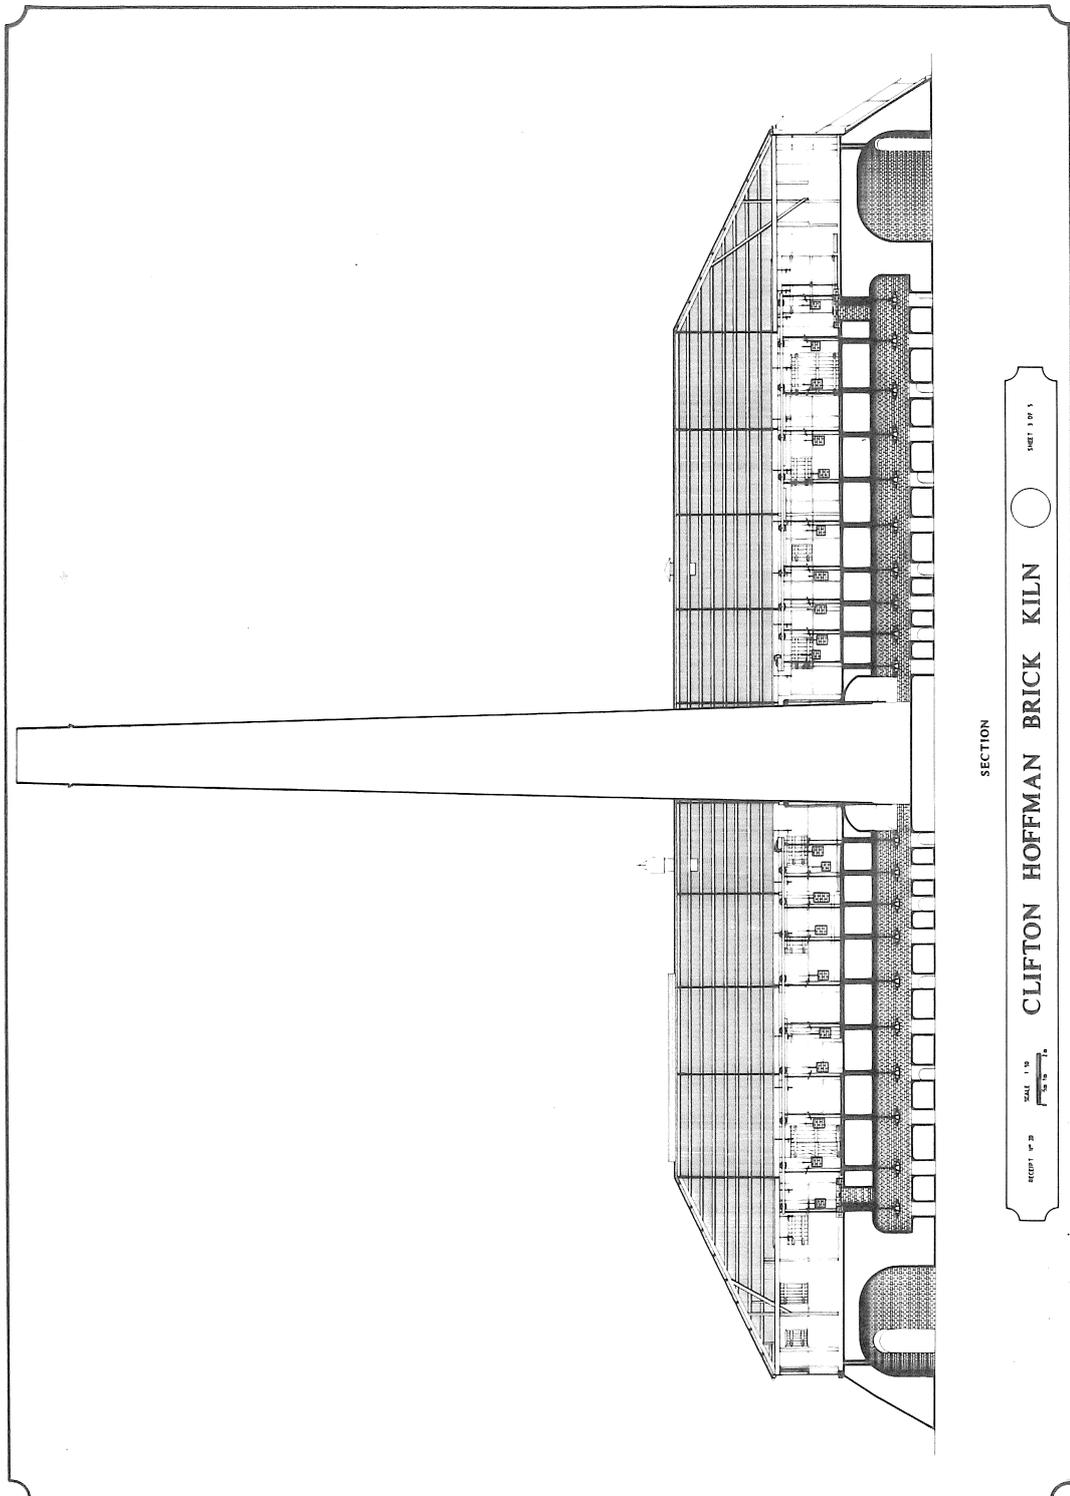
Figure 7. Hoffman Kiln 1, Longitudinal Section. Matthew Flinders Measured Drawing Competition.

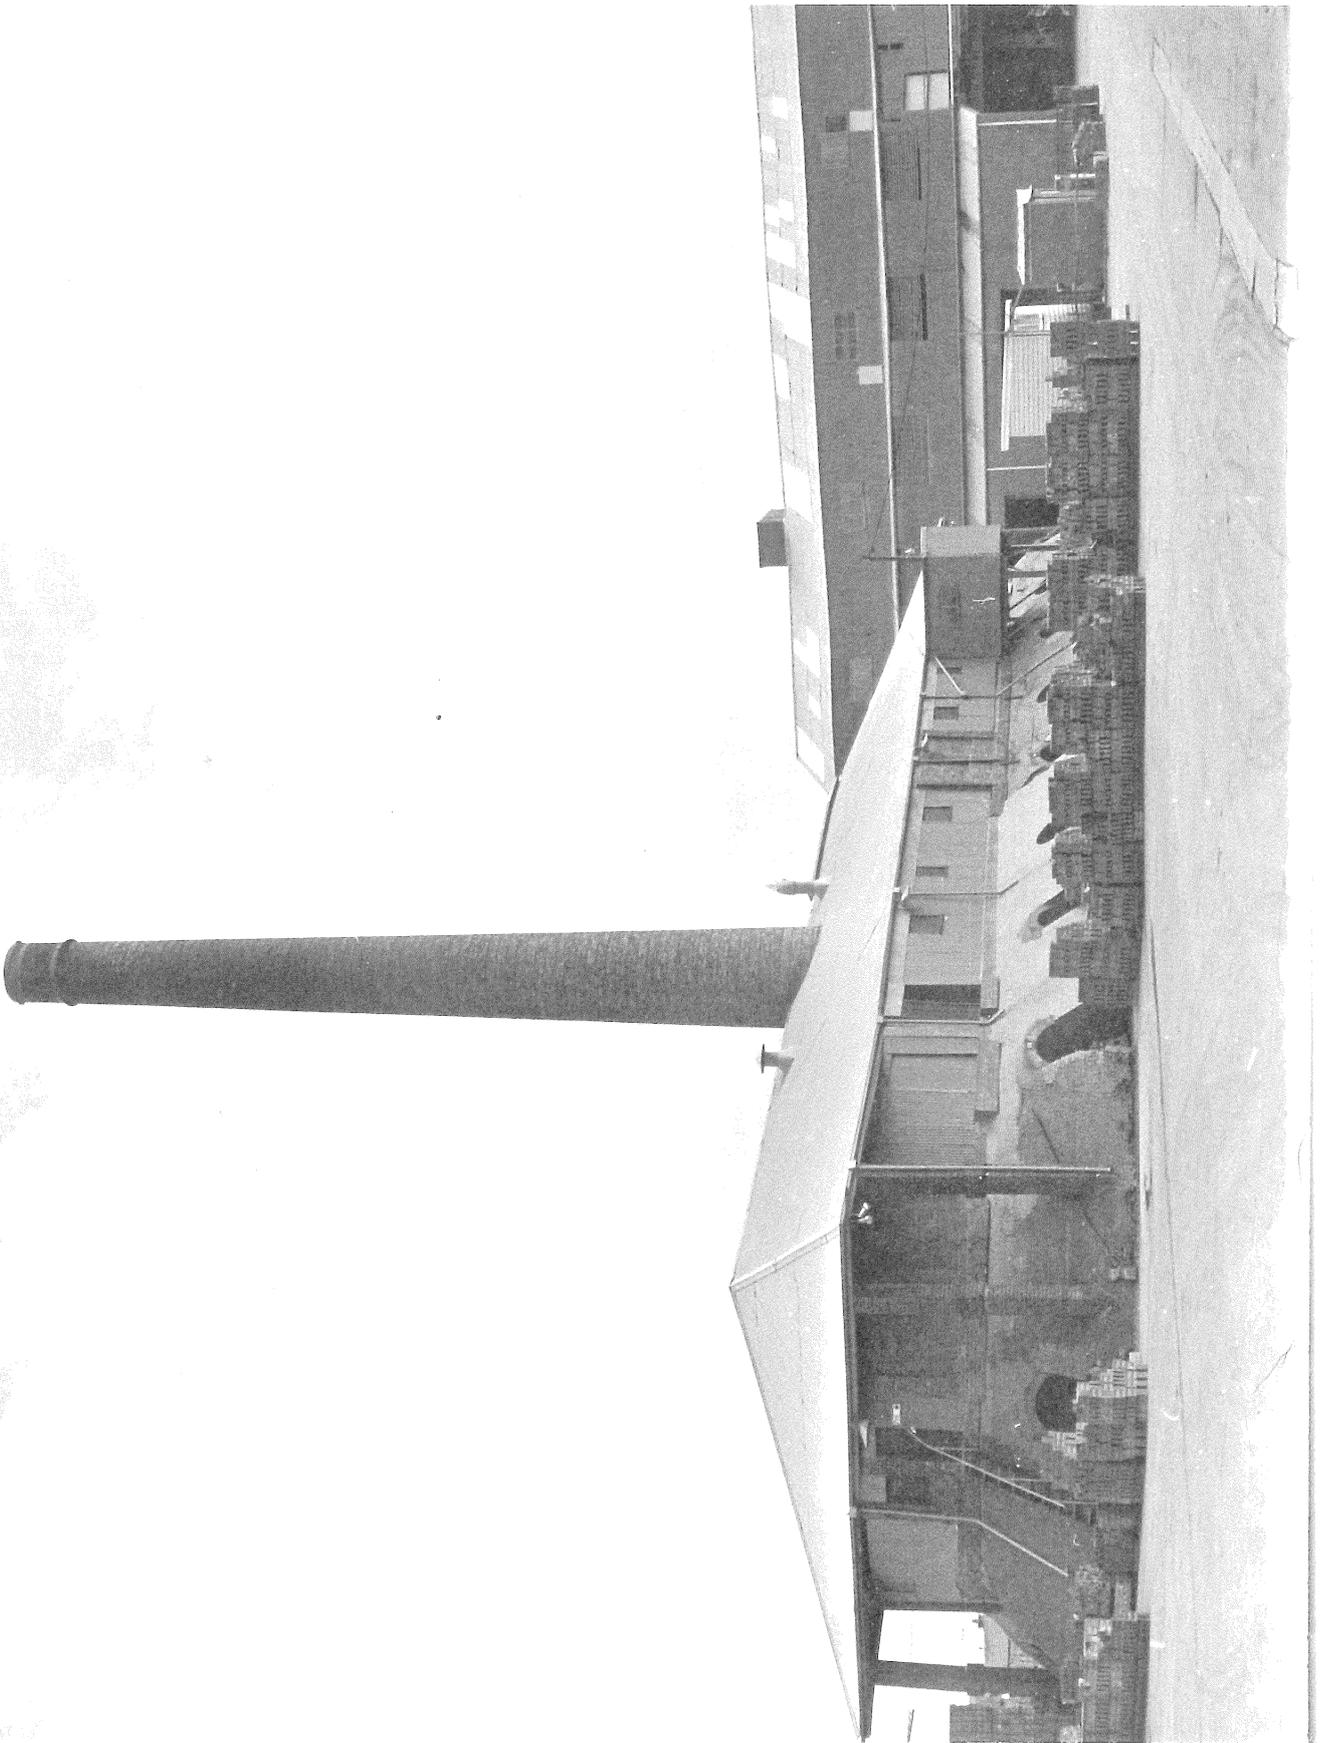
Figure 8. 1988 photograph showing Kiln 3 and Building 5 in the rear. The small cabin attached to the kiln housed oil firing equipment.
Taken by Iain Stuart.

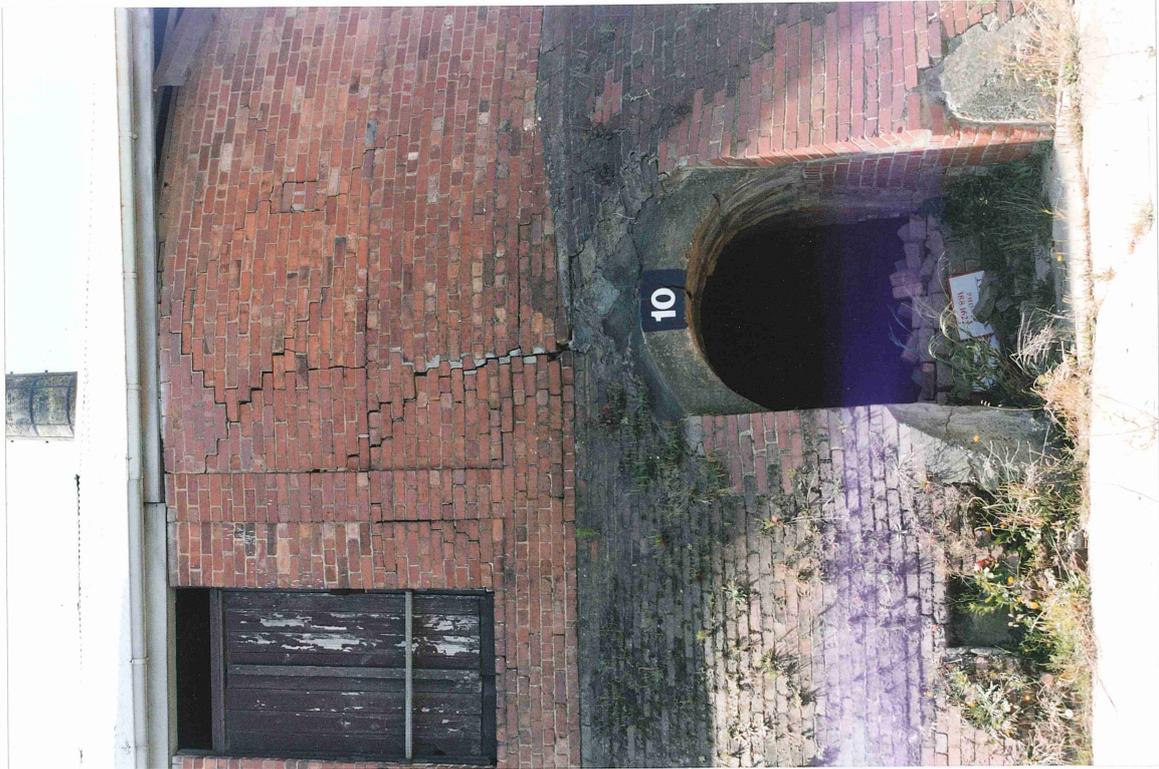
Figure 10. Hoffman Kiln 2. Photo shows modified wicket and cracking associated with brickwork panels to upper level of the kilns. Taken by Helen Lardner and Iain Stuart.

The structural assessment of the upper walls of kiln 2 has found that the remaining sections of brick walls are unsafe. It recommends against re-establishing brick walls in this position and suggests that metal clad walls which are relatively flexible and can incorporate adequate lateral bracing systems within the plane of the wall be used.⁵⁹ It is clear from inspection of the upper walls that repair and rebuilding have taken place in the past. It was noted in Allom Lovell and Associates' Conservation and Management Plan that no documentary evidence has been found to support the assertion that the upper walls were originally all brickwork.⁶⁰ However, photographic evidence⁶¹ showing other kilns on the Hoffman No. 1 site⁶² and Kiln 1 in the 1920s

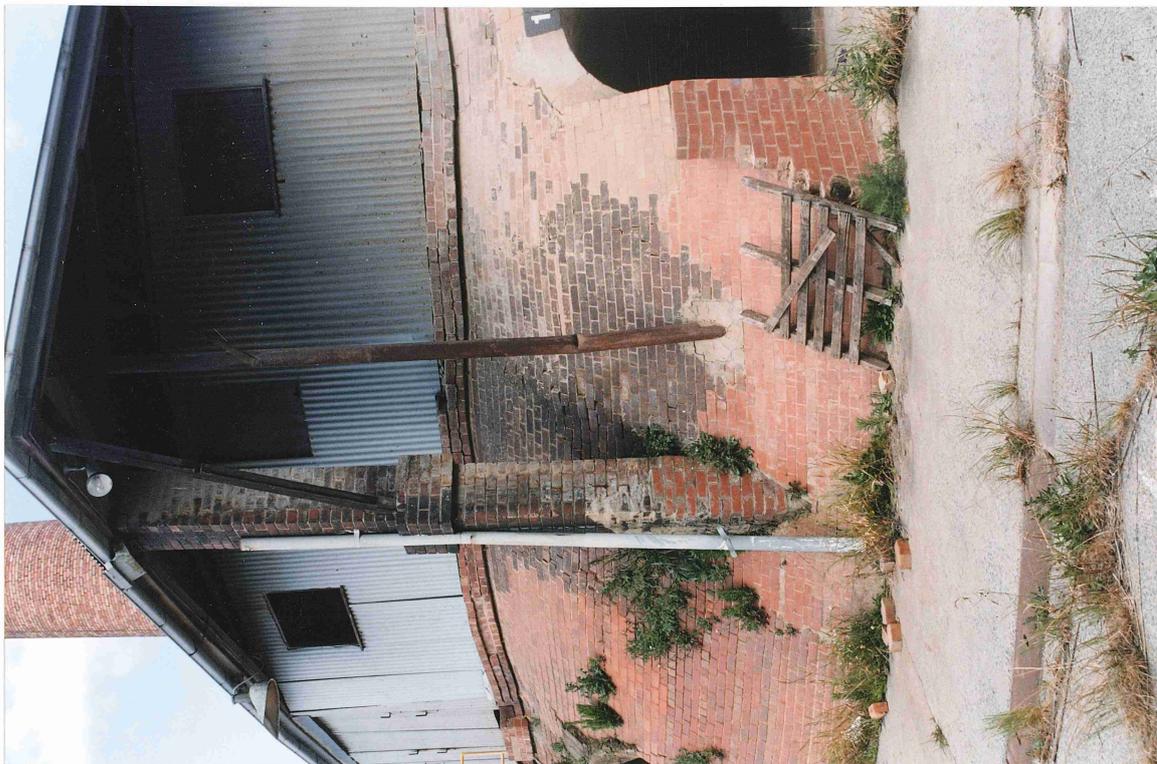
Figure 11. Hoffman Kiln 2. Photograph shows corrugated iron panels to upper level of the kilns. Photo taken by Helen Lardner and Iain Stuart.

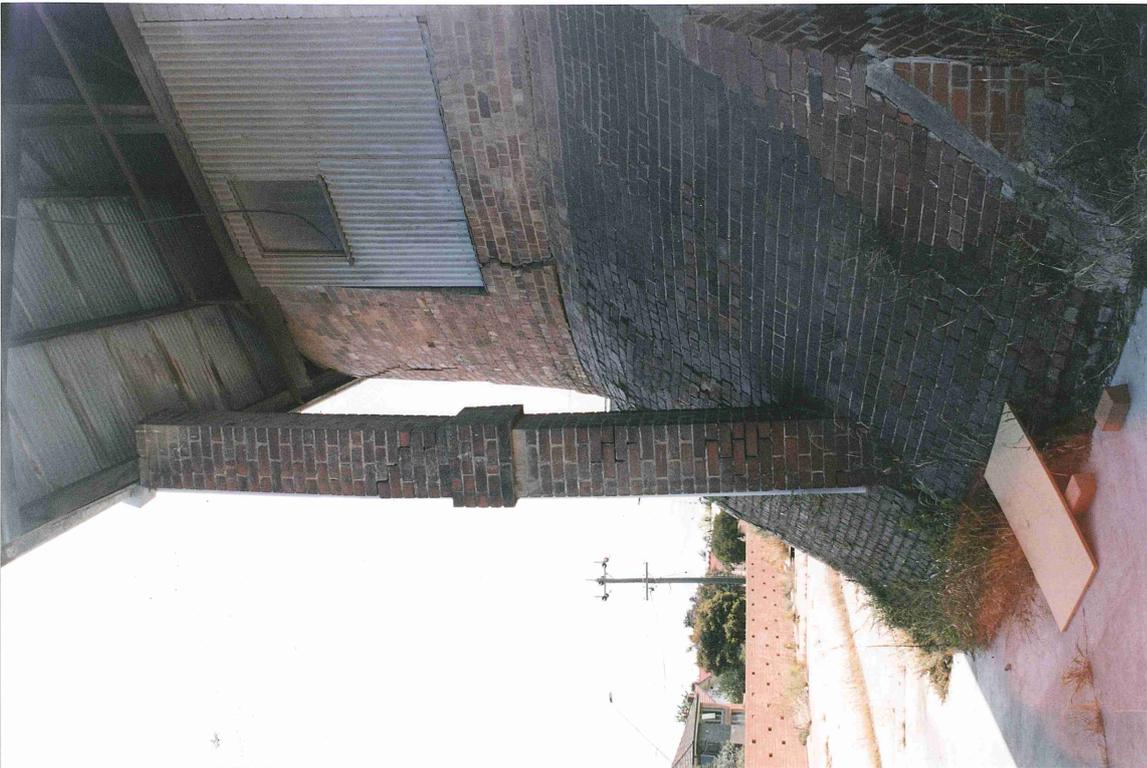
Figure 12. Hoffman Kiln 3. Photo showing structural failure to brick pier.
Taken by Helen Lardner and Iain Stuart.

The structural assessment of the brick piers in each corner of the kilns which support the roof is that they are unsafe. They will need extensive rebuilding or replacement with steel members and may require more substantial concrete footings below the ground.³³

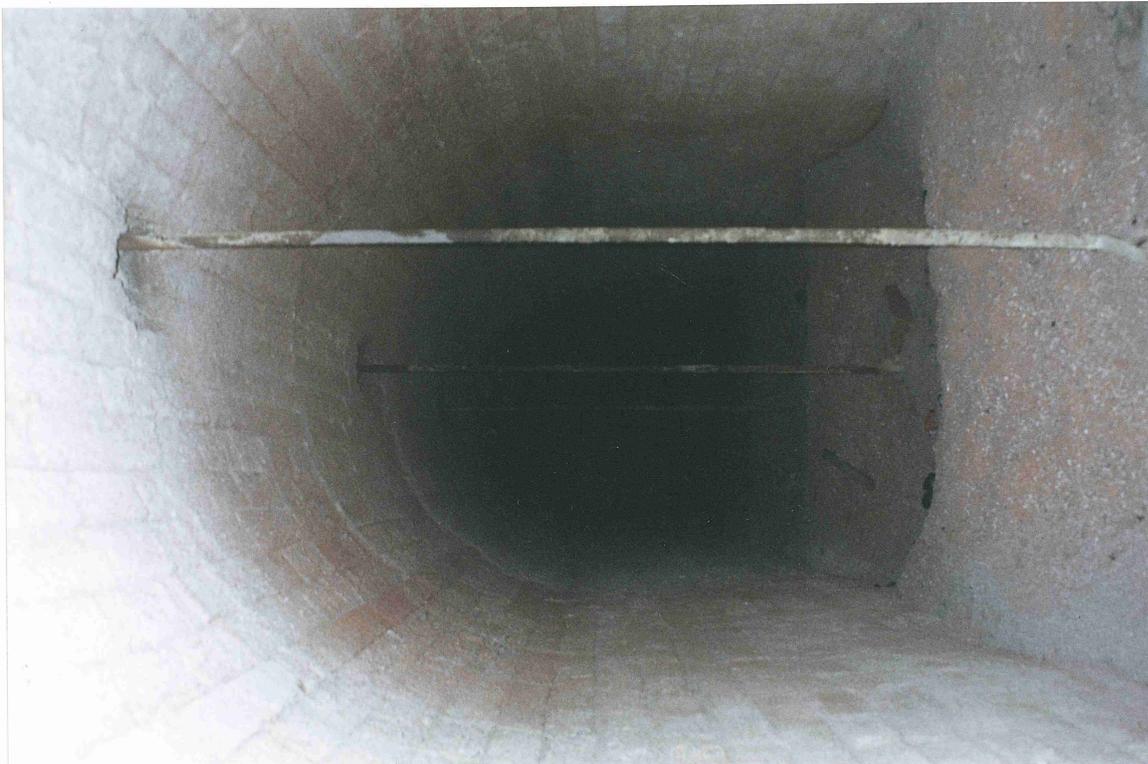
Figure 13. Hoffman Kiln 2. Photograph shows tunnel system and damper
between first and ground levels
Photo taken by Helen Lardner and Iain Stuart.

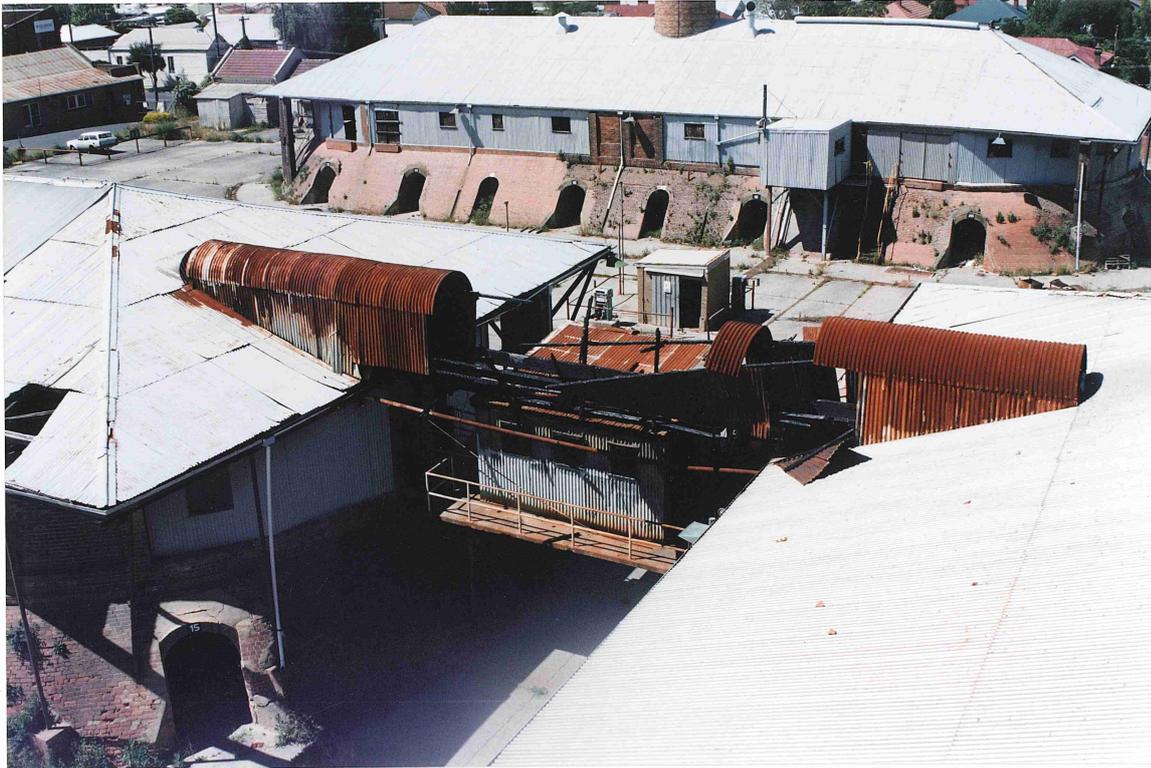
Figure 14. Building 4. Remnants of the crypto oil firing building which powered Kilns 1 and 2.
Taken by Helen Lardner and Iain Stuart.
