1999 CONSERVATION MANAGEMENT PLAN

H O F F M A N B R I C K W O R K S

DAWSON STREET, BRUNSWICK

A P R I L 1 9 9 9

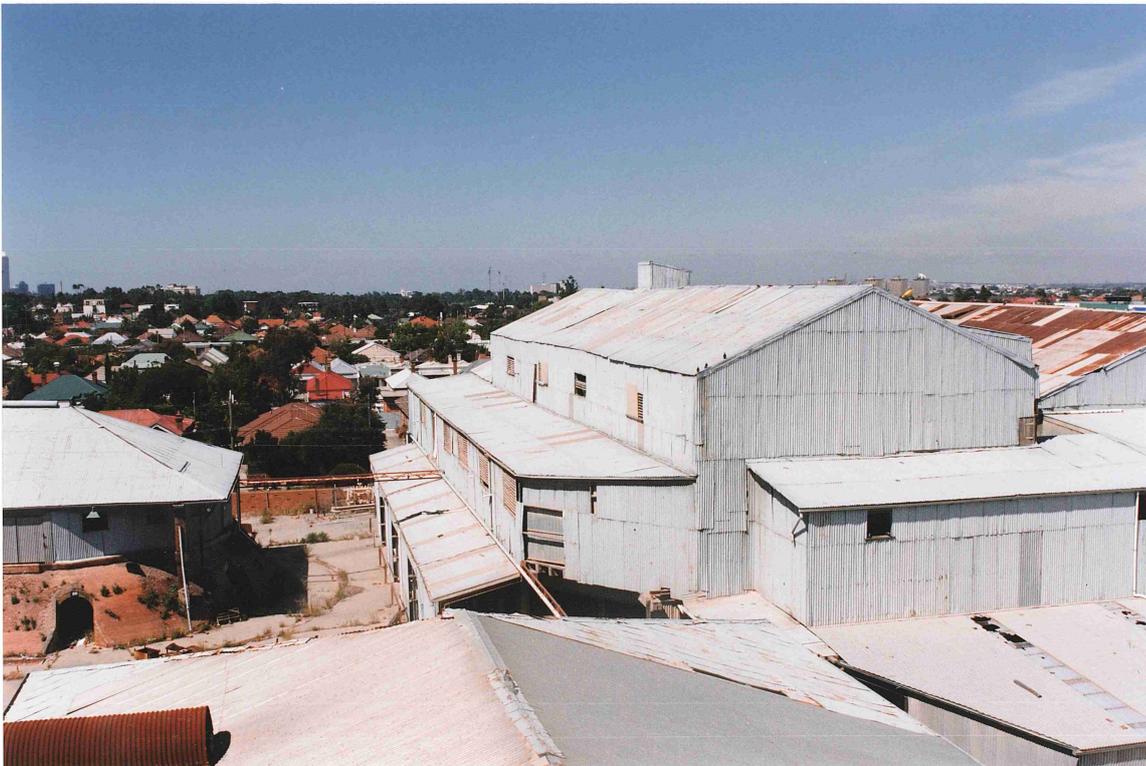
Figure 14. Building 4. Remnants of the crypto oil firing building which powered Kilns 1 and 2.
Taken by Helen Lardner and Iain Stuart.

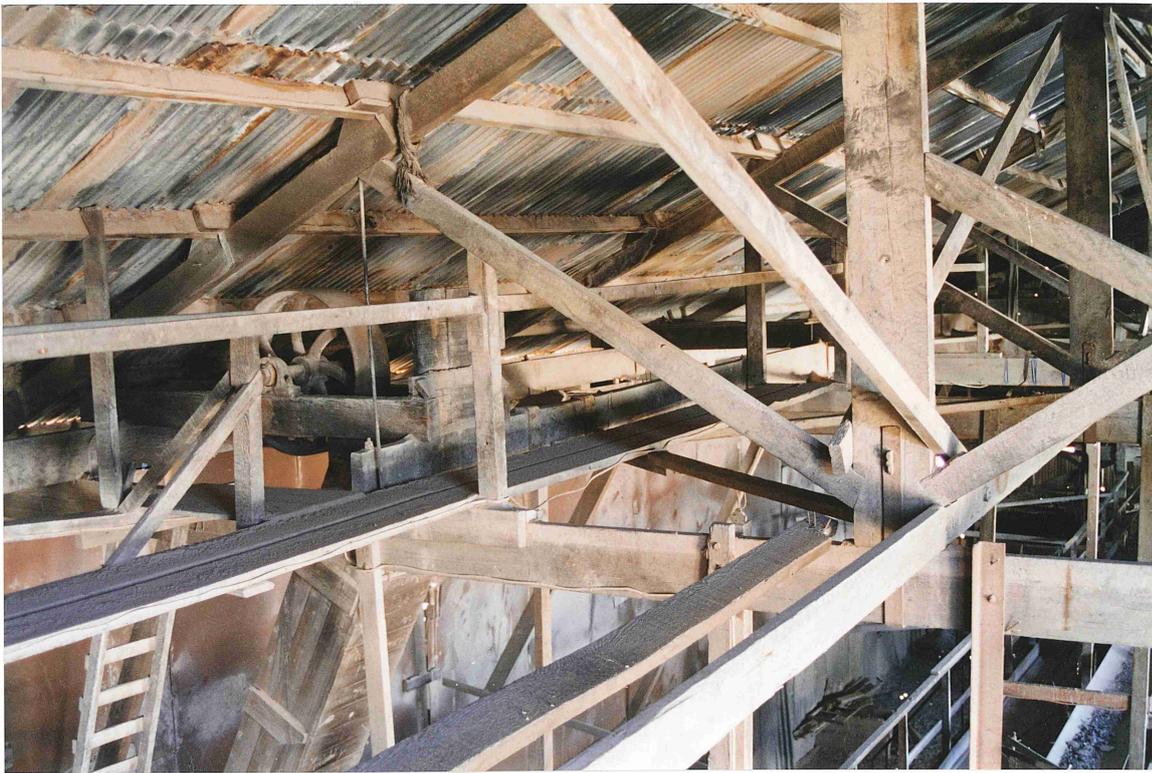
Figure 16. Building 5 - loft level. Photograph shows the equipment for moving material from Building 7 to Building 5 and the adhoc roof structure of the Brick Press Building.
Taken by Helen Lardner and Iain Stuart.

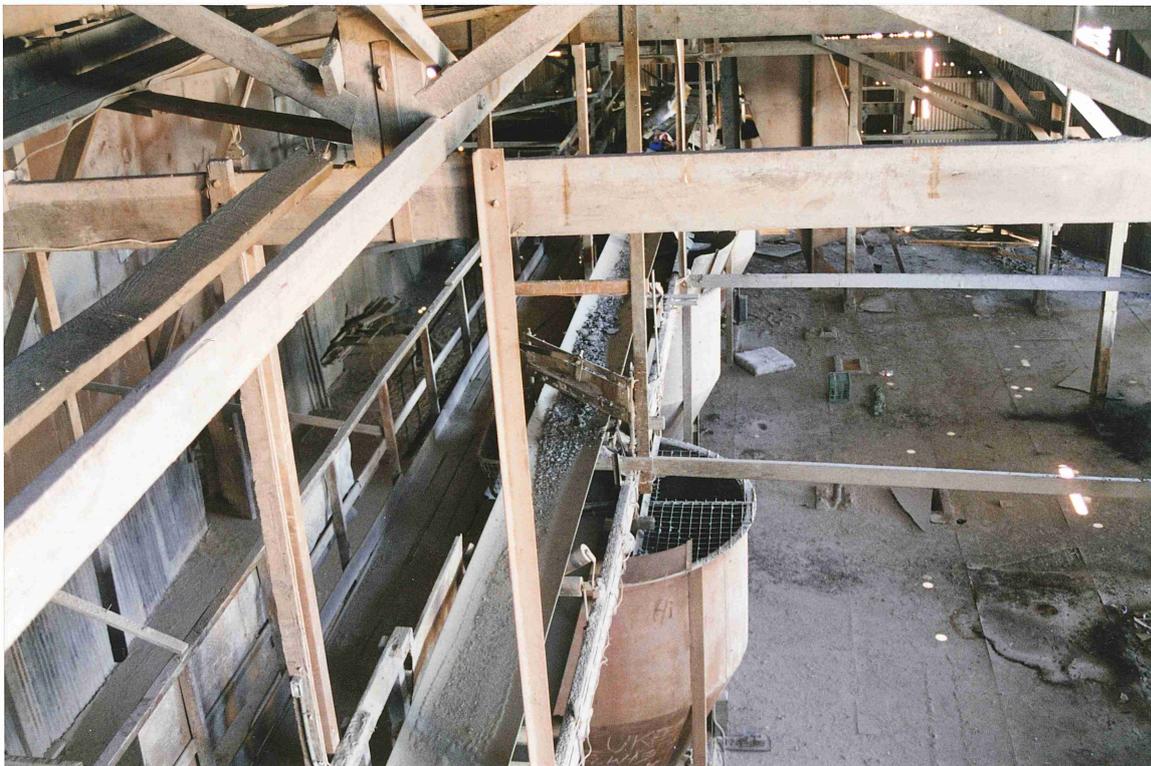
Figure 17. Building 5 - mezzanine level. Photograph shows the conveyor belt used to deposit material into the hoppers situated on the first floor.
Photo taken by Helen Lardner and Iain Stuart.

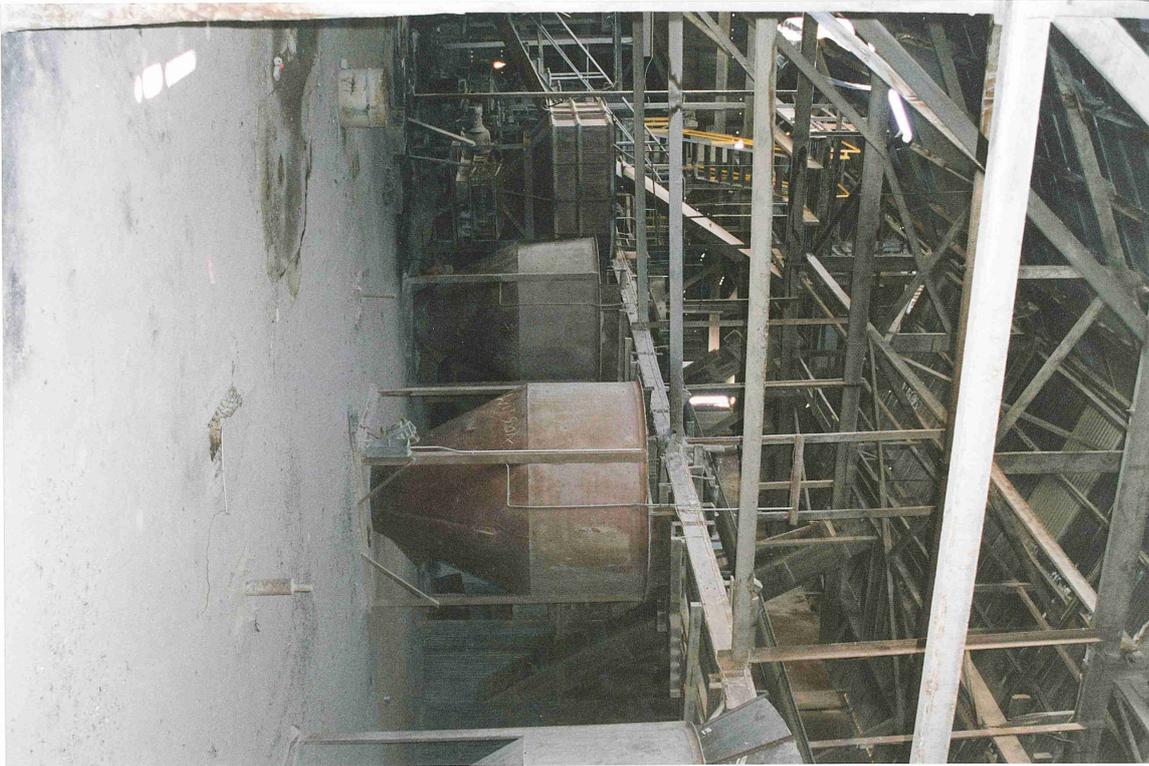
Figure 18. Building 5 - first floor level. Photograph shows timber building structure and hoppers.
Taken by Helen Lardner and Iain Stuart.

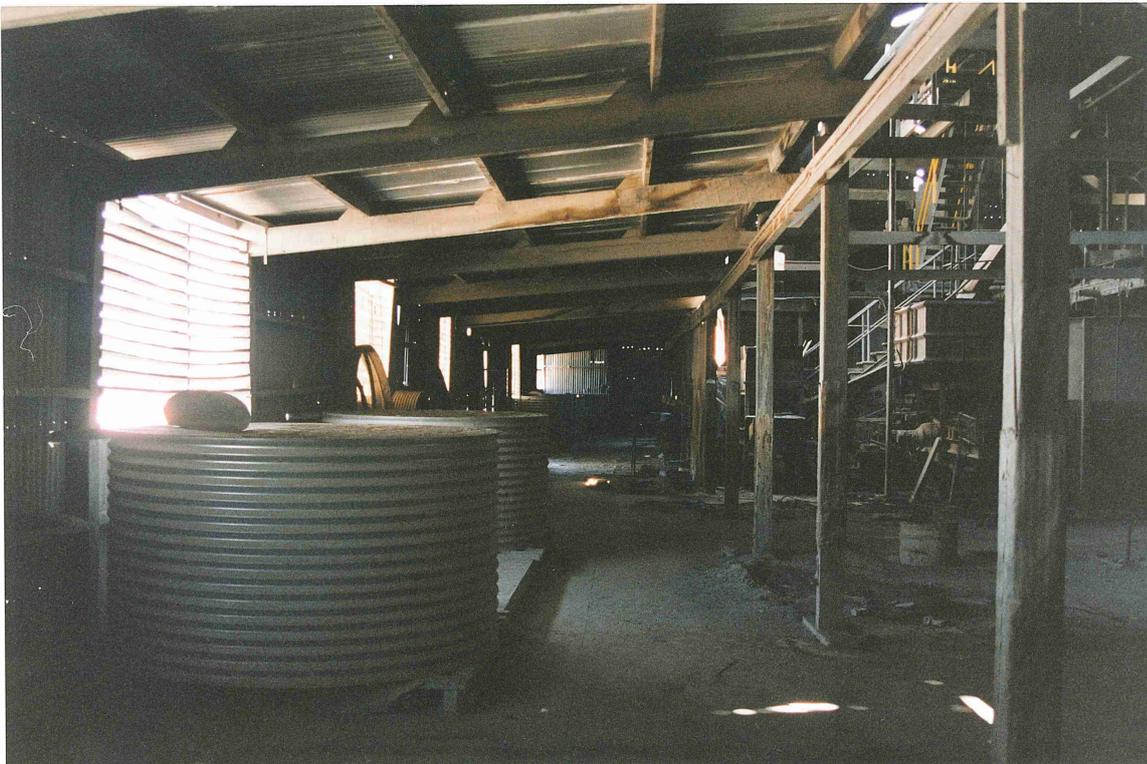
Figure 19. Building 5 - first floor eastern annexe. Photograph shows the separate roof structure and corrugated iron storage tanks.
Photo taken by Helen Lardner and Iain Stuart.

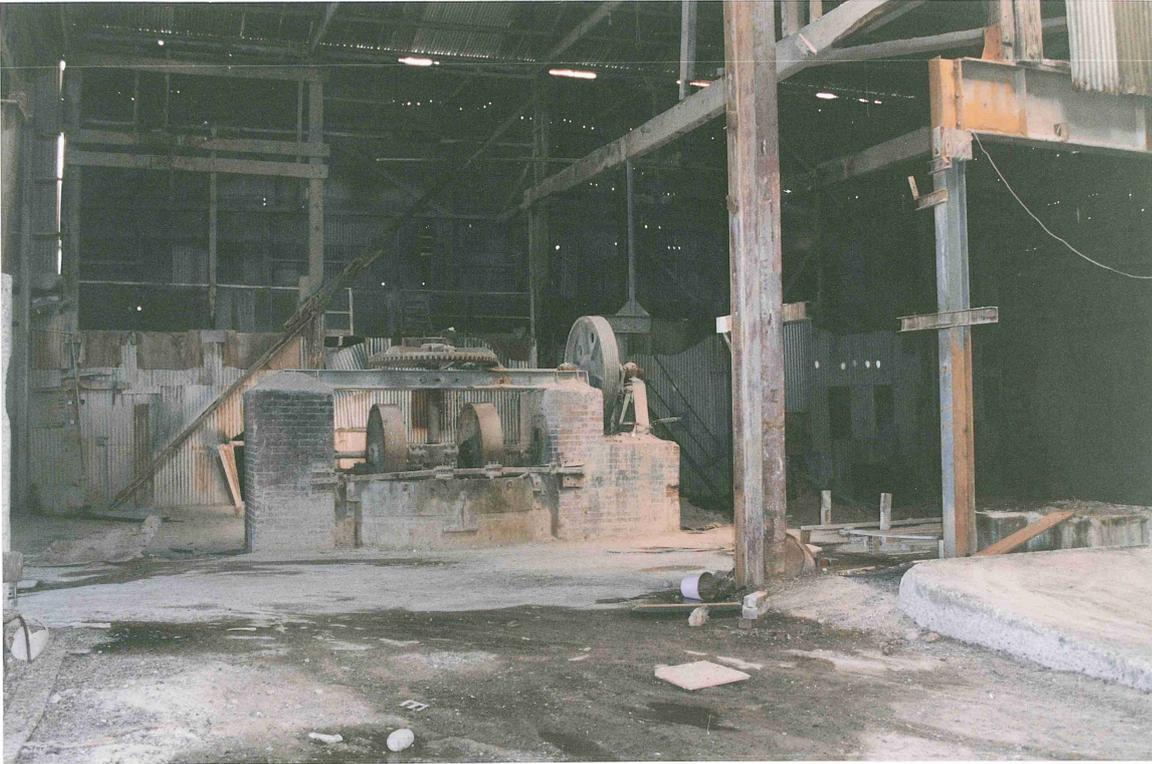
Figure 20. Building 7. Photograph shows the remaining edge runner mill.
Taken by Helen Lardner and Iain Stuart.

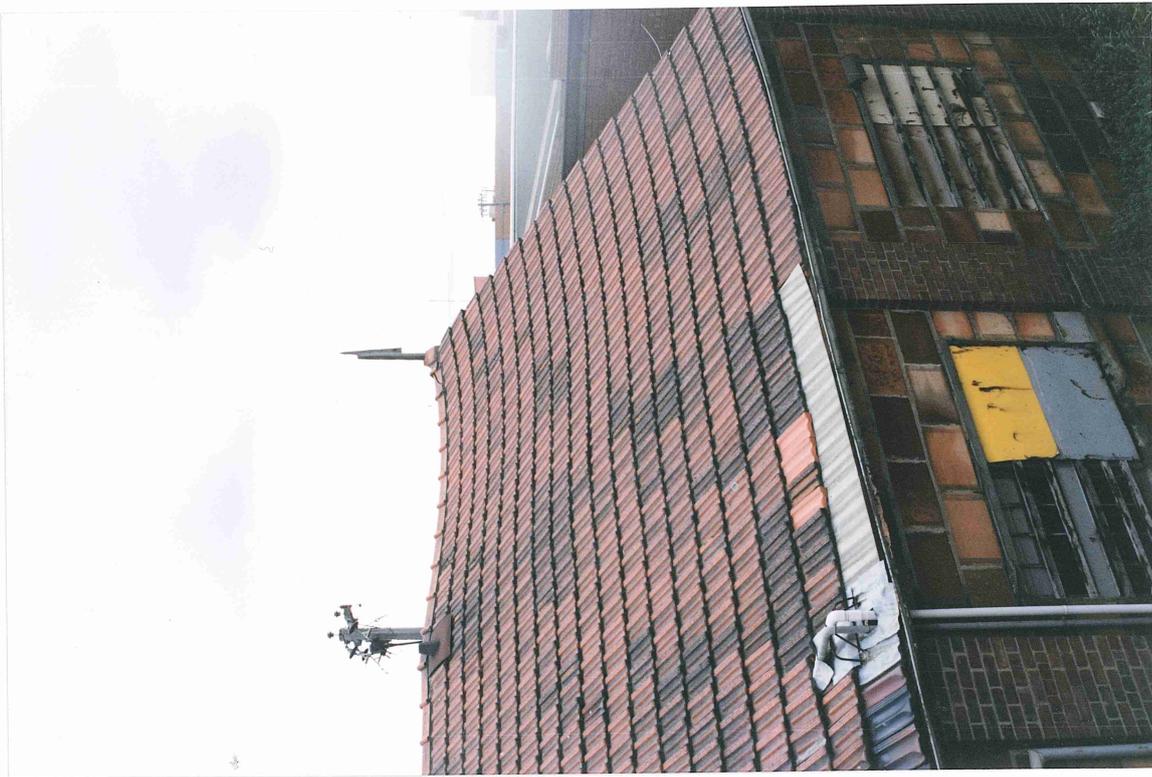
Figure 22. Building 17. Photograph shows the building's sagging roof structure and the hollow glazed blocks to the walls
Taken by Helen Lardner and Iain Stuart.

The structural capabilities of the hollow, rectangular, glazed pottery blocks is unknown. If the walls are retained, further structural engineering investigation is required.⁴⁰ The tile roof is in poor condition and would need substantial additional strengthening to be retained. The ridge beam and the purlins are unsatisfactory for the weight of the tiles. It is likely that repair would involve the tiles being dismantled.⁴¹ The east wall of this building requires extensive rebuilding for structural stability.⁴² If the hollow pottery blocks are retained, it may need to be in a non-structural capacity.

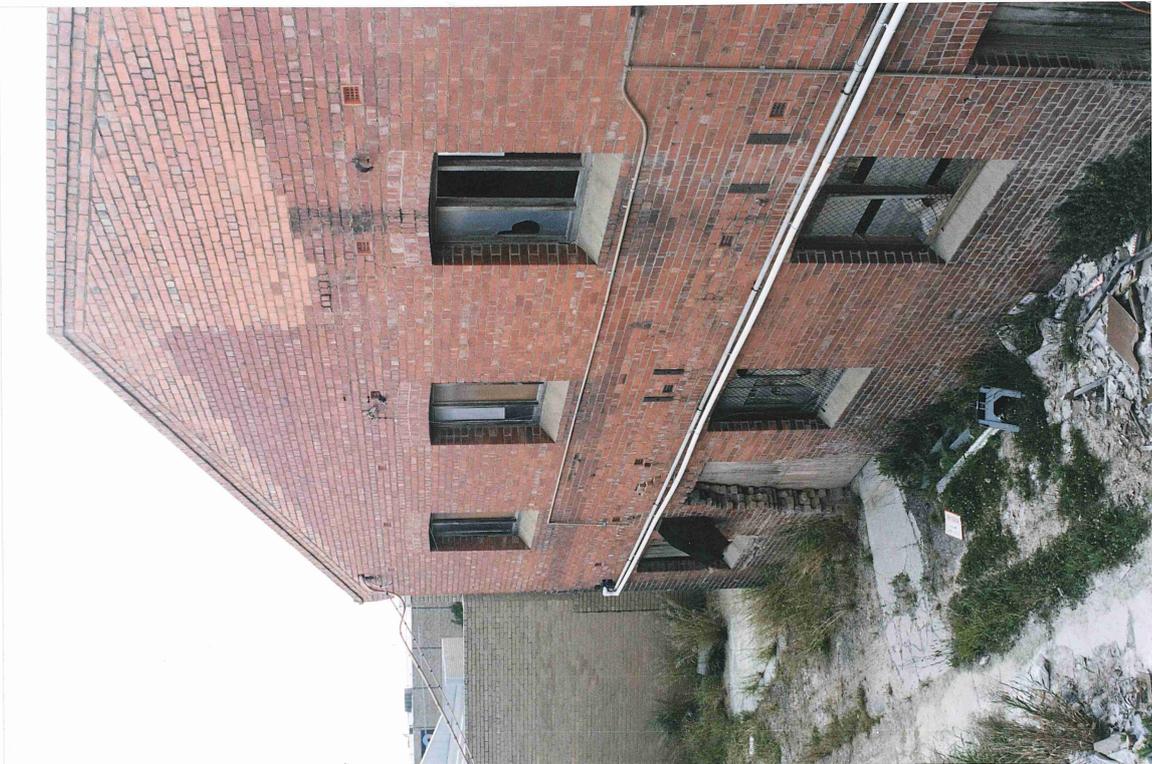
Figure 23. Building 19. Photograph shows the modified north wall with evidence of the former saw-tooth roof. This wall has been identified as structurally unsound.
Photo taken by Helen Lardner and Iain Stuart.

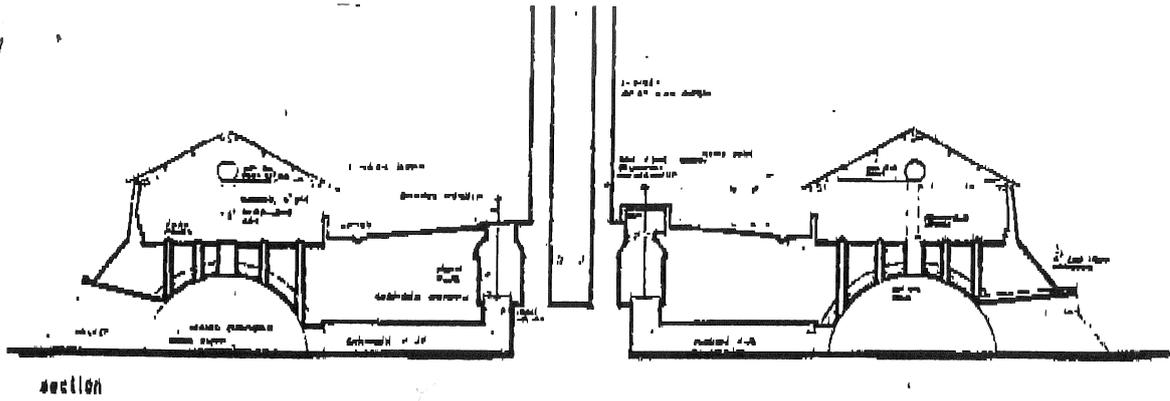
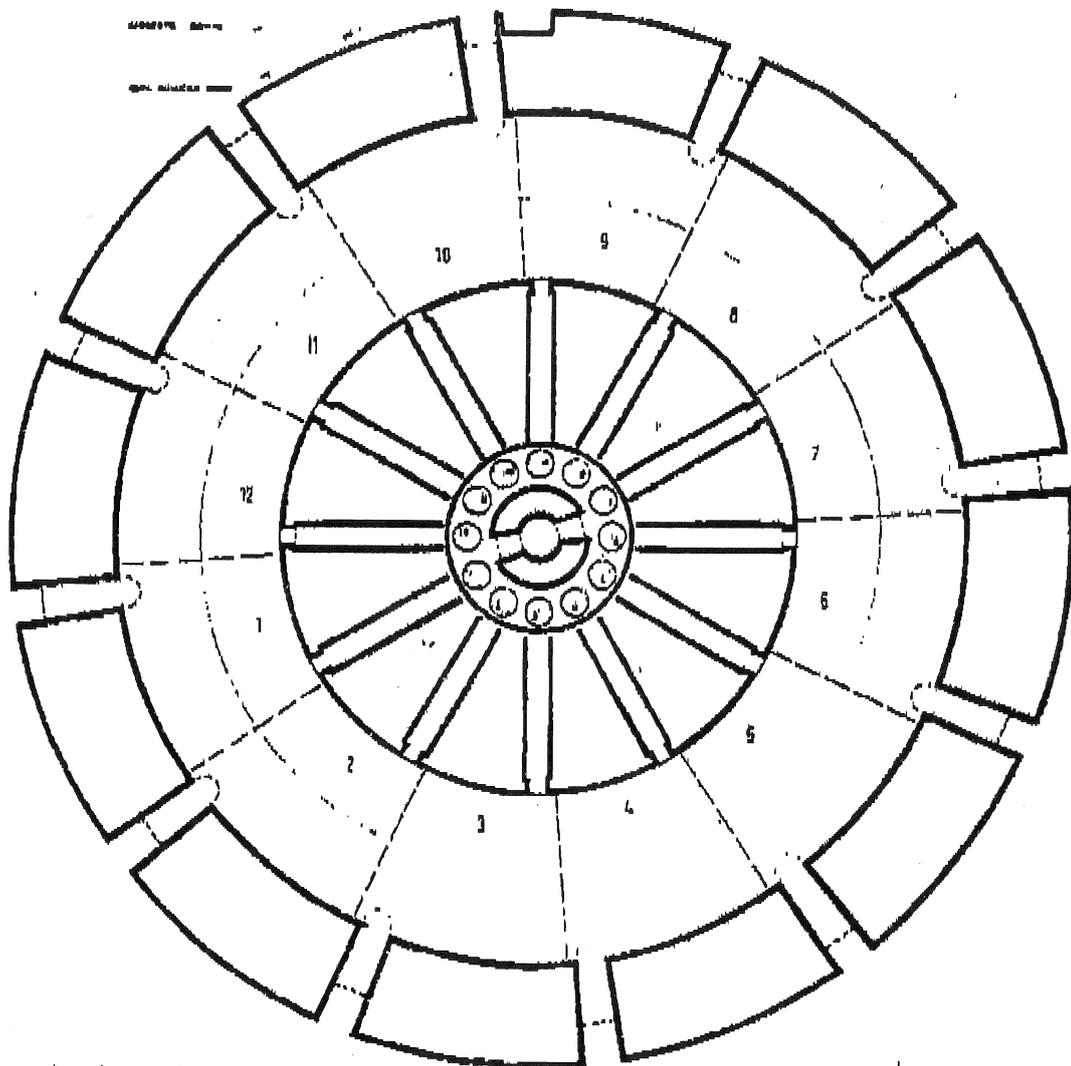
FIGURE 14. 1868 HOFFMAN KILN, MAPPERLEY RISE BRICKWORKS, NOTTINGHAM, UK

HOFFMANN CONTINUOUS KILN, MAPPERLEY RISE BRICKWORKS, NOTTINGHAM
 survey of existing January 1971

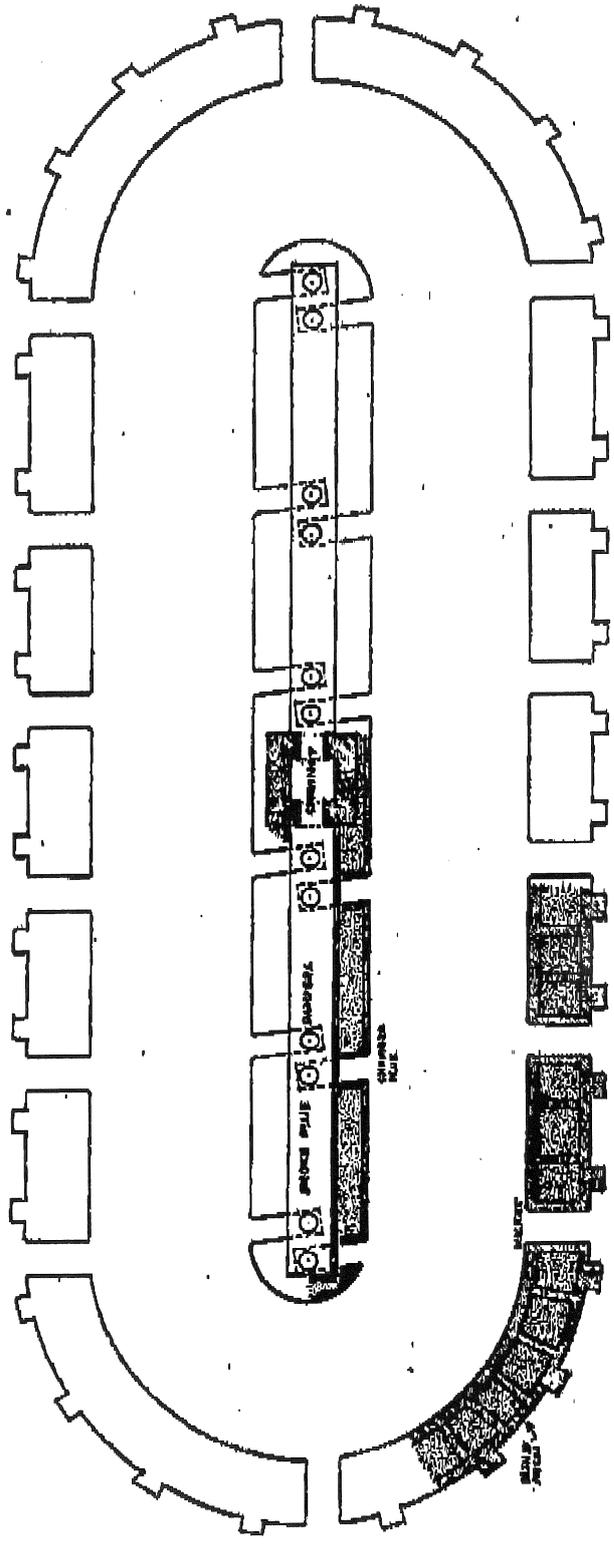
Fig. 8

HOFFMANN CONTINUOUS
 KILN, TUCKER'S CENTRAL
 BRICKYARD, LOUGHBOROUGH
 SURVEYED AND DRAWN BY
 M. D. R. WILSON
 FEBRUARY 1972

PLAN AT GROUND LEVEL
 ONLY THE SHAPED PARTS MAY STANDING AT THE TIME OF THE SURVEY
