Historical archaeological site card

KERANG-QUAMBATOOK ROAD RUIN
H7626-0012

Place name: KERANG-QUAMBATOOK ROAD RUIN

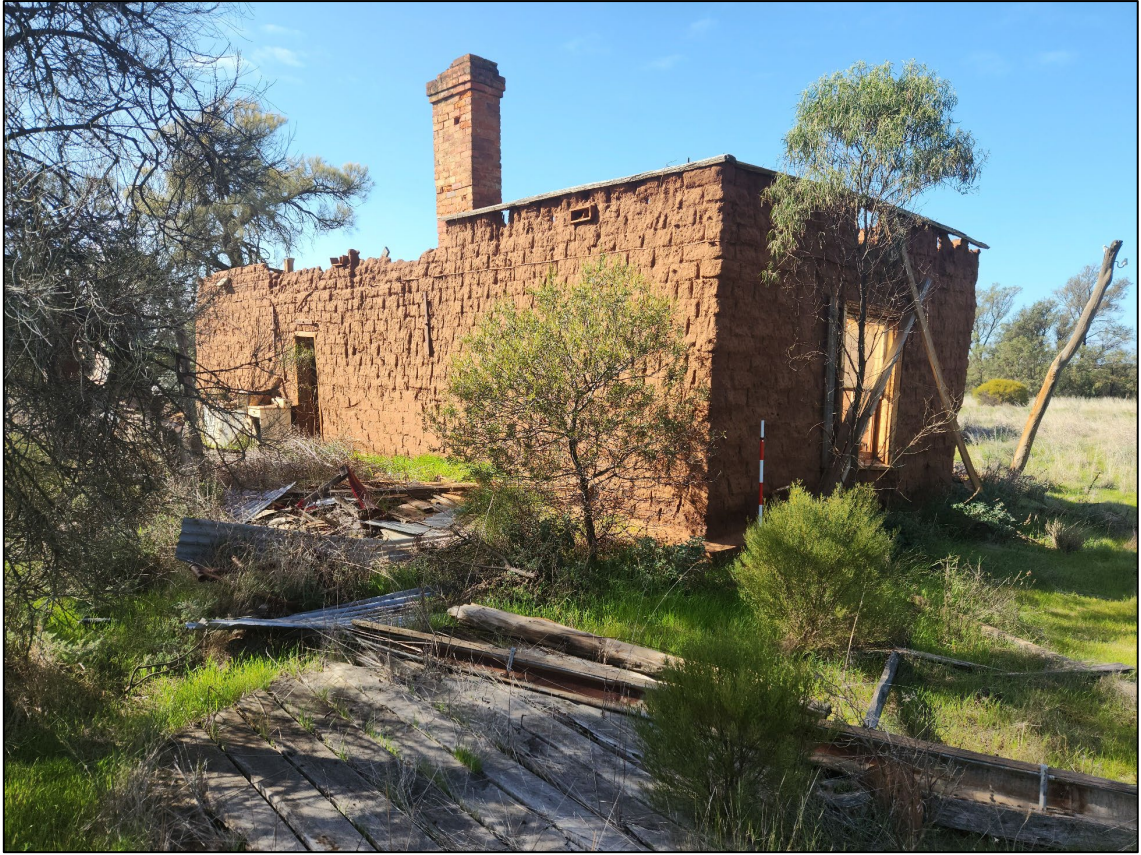
Figure 2: View of the Kerang-Quambatook Road Ruin, view east (C. Lovell, 11/07/2023)

The Kerang-Quambatook Road Ruin comprises the remains of a partially collapsed mudbrick dwelling. The walls and chimney of the structure remain standing, while the roof has collapsed (Figure 2-Figure 3). The structure is rectangular in shape, in a north-eastern to south-western orientation.

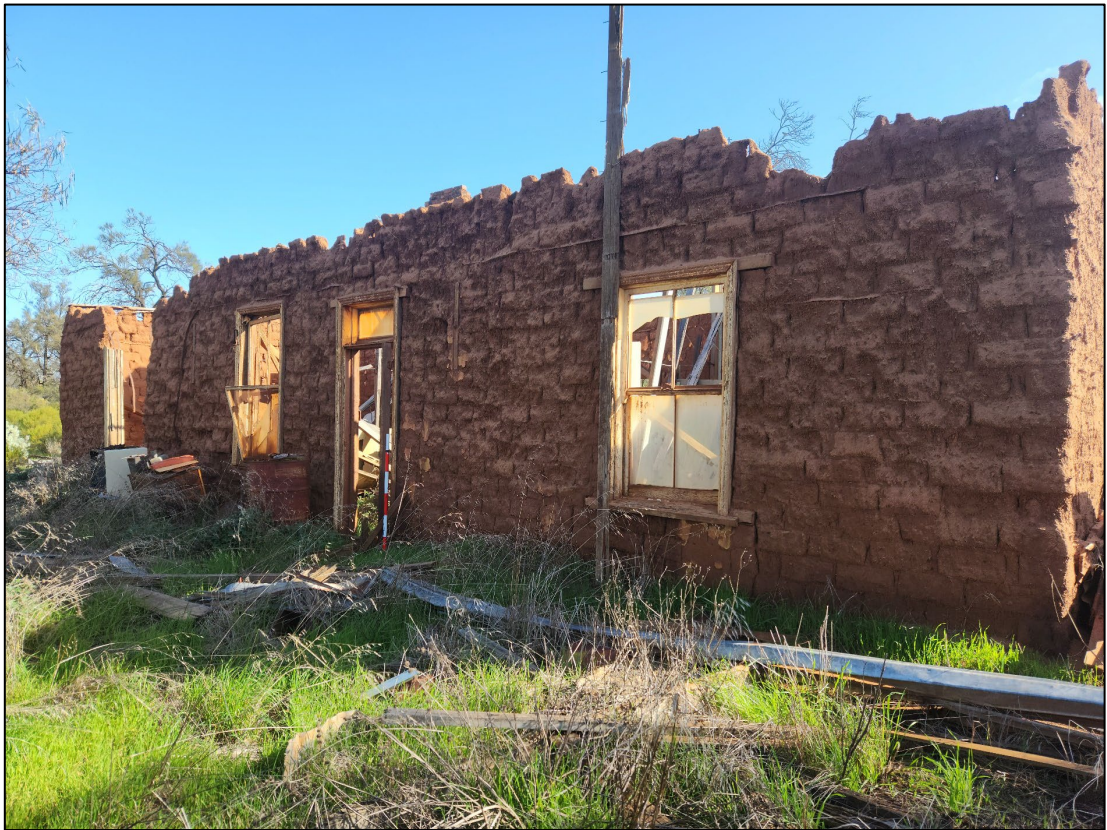
Figure 3: View of the Kerang-Quambatook Road Ruin, view west (C. Lovell, 11/07/2023)

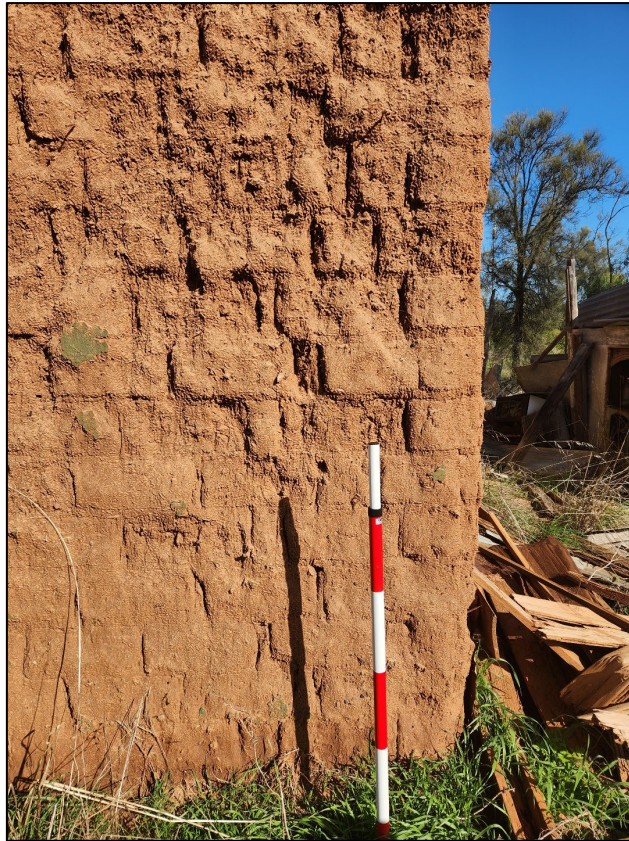
Figure 4: Detail of the mud brick wall construction of the Kerang-Quambatook Road Ruin, with patches of the outer paint coating visible (C. Lovell, 11/07/2023)

The outer walls of the dwelling were constructed using mud brick, with the outline of individual bricks remaining clearly visible. Remnants of olive-green paint are visible on the exterior surface of these walls (Figure 4), suggesting that the façade of the residence was originally painted this colour before being weathered after abandonment. Numerous pieces of corrugated iron sheeting surround the ruin, indicating that these fragments constitute the remains of the roof.

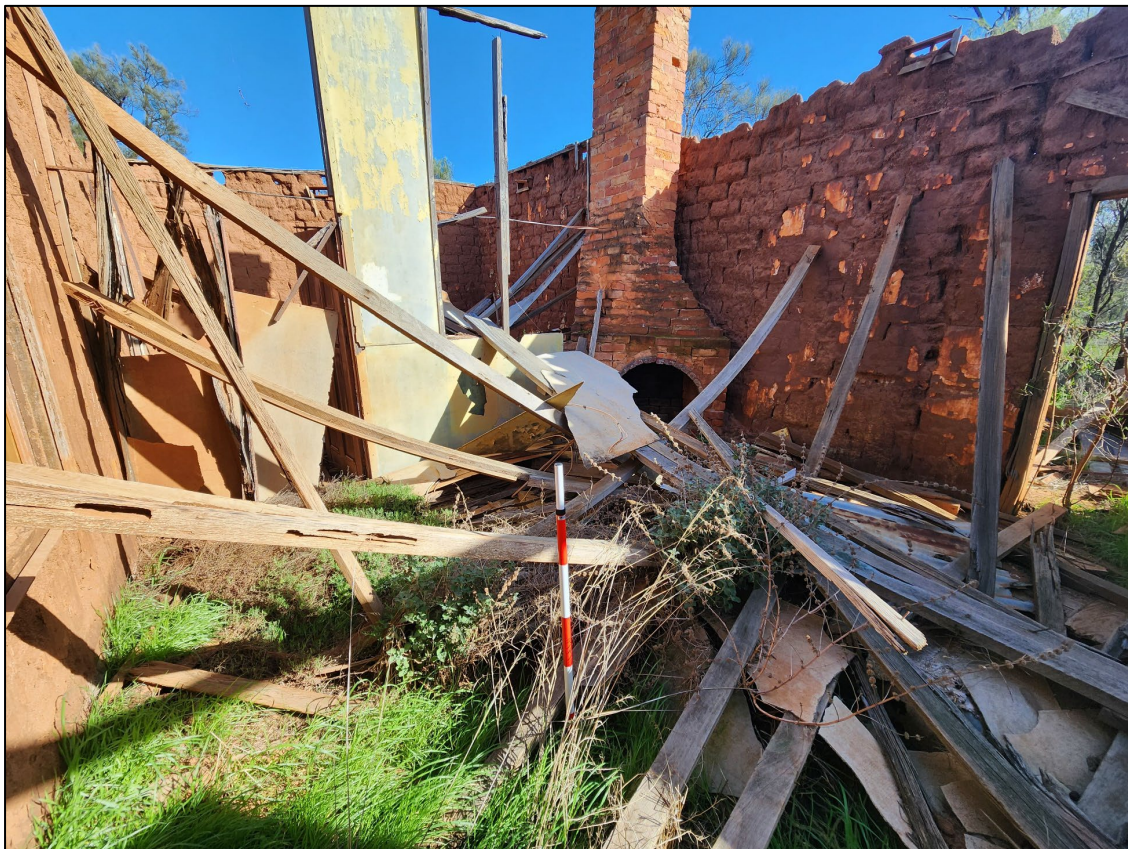
Figure 5: Interior of the Kerang-Quambatook Road Ruin, view south-west (C. Lovell, 11/07/2023)

The interior of the ruin was divided into several rooms by thin, wooden walls, although it is unclear specifically how many rooms the dwelling comprised due to poor state of preservation of the interior features (Figure 5). A red brick fireplace and chimney is also present along the north-western wall of the dwelling.

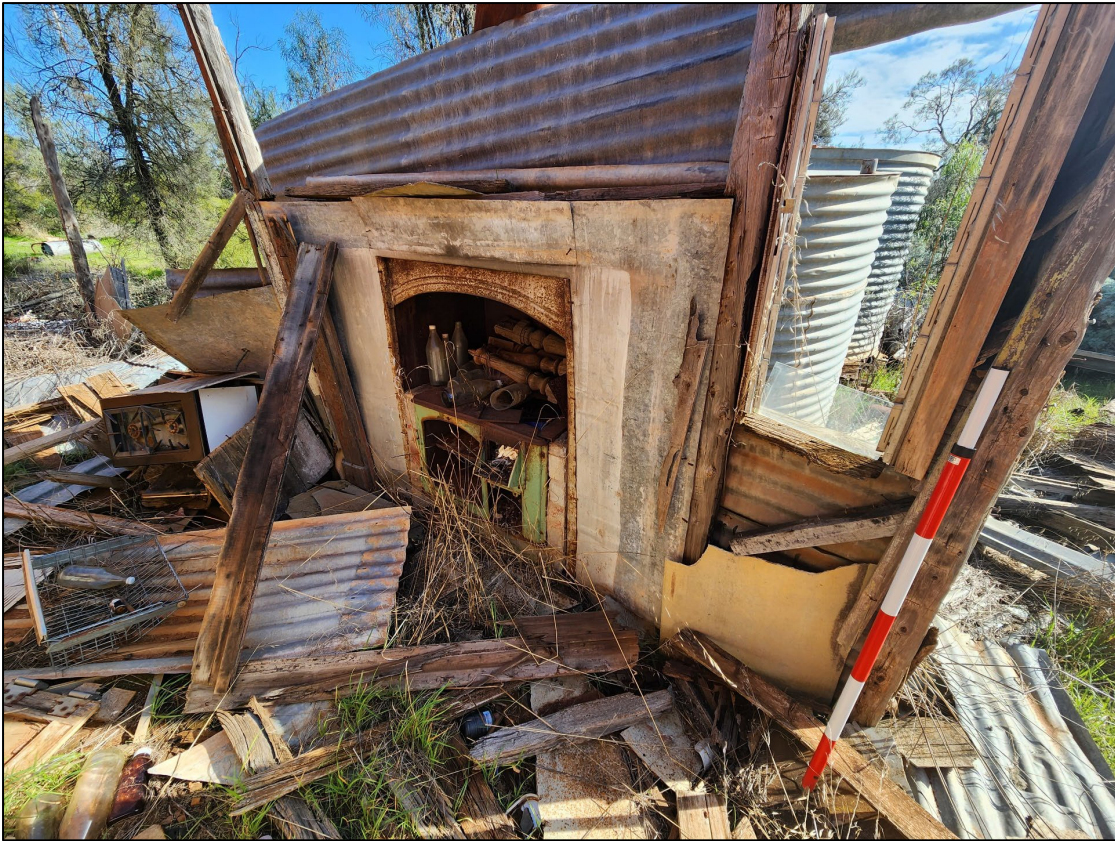
Figure 6: Remains of an oven and cabinet adjacent to the Kerang-Quambatook Road Ruin, view, west (C. Lovell, 11/07/2023)

The ruin is surrounded by numerous discarded appliances and furnishings, including a refrigerator, fridge, manual clothes wringer, gas stove top and a cabinet (Figures 6-8). Large numbers of intact glass bottles are also present on the surface surrounding the ruin, most notably a collection of identical Cohn's lemonade bottles and several Cottles cordial bottles (Figures 8-10).

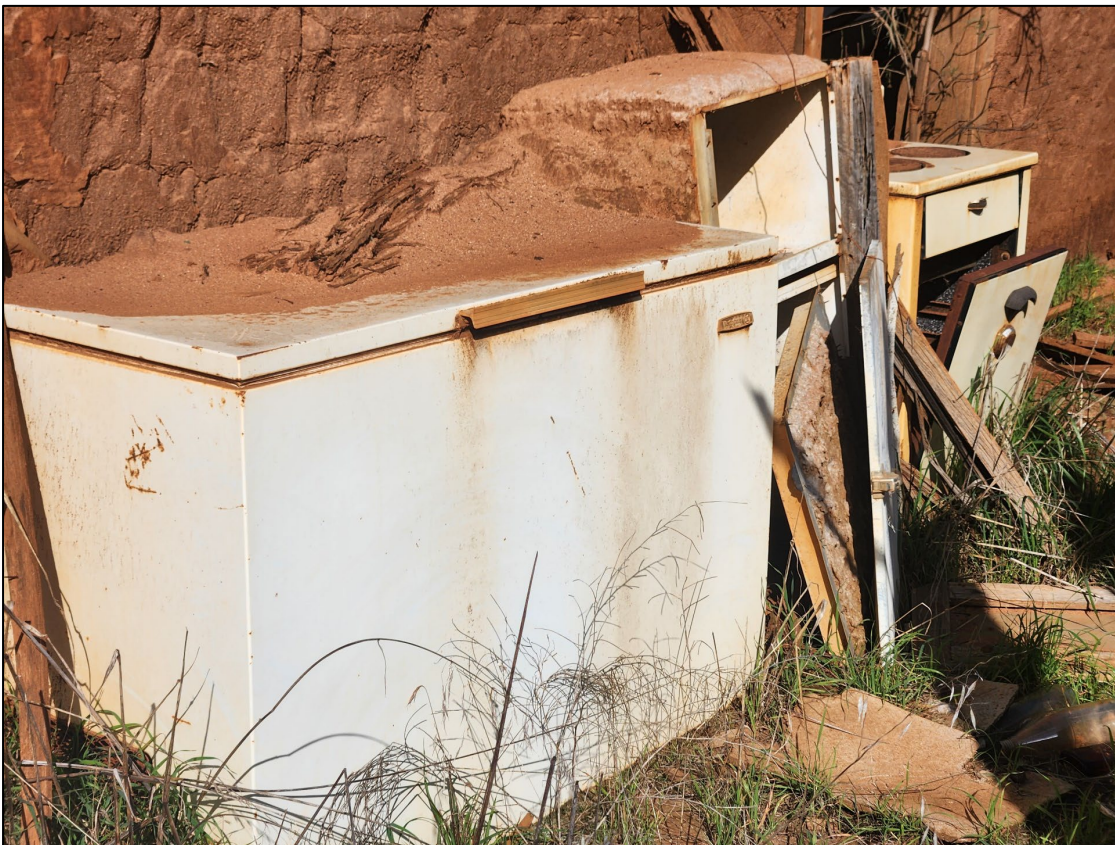
Figure 7: Fridge and refrigerator abandoned at the Kerang-Quambatook Road Ruin (C. Lovell, 11/07/2023)

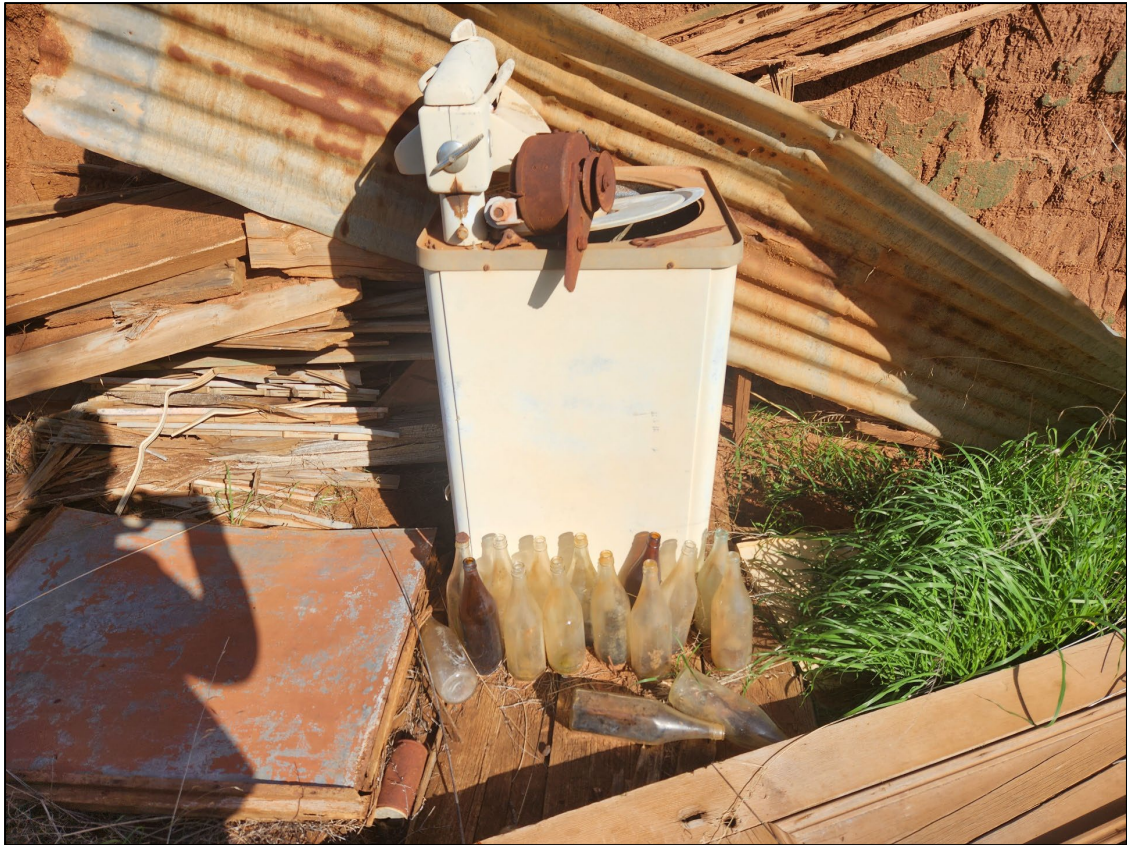
Figure 8: Clothes wringer and collection of glass bottles abandoned at the Kerang-Quambatook Road Ruin (C. Lovell, 11/07/2023)

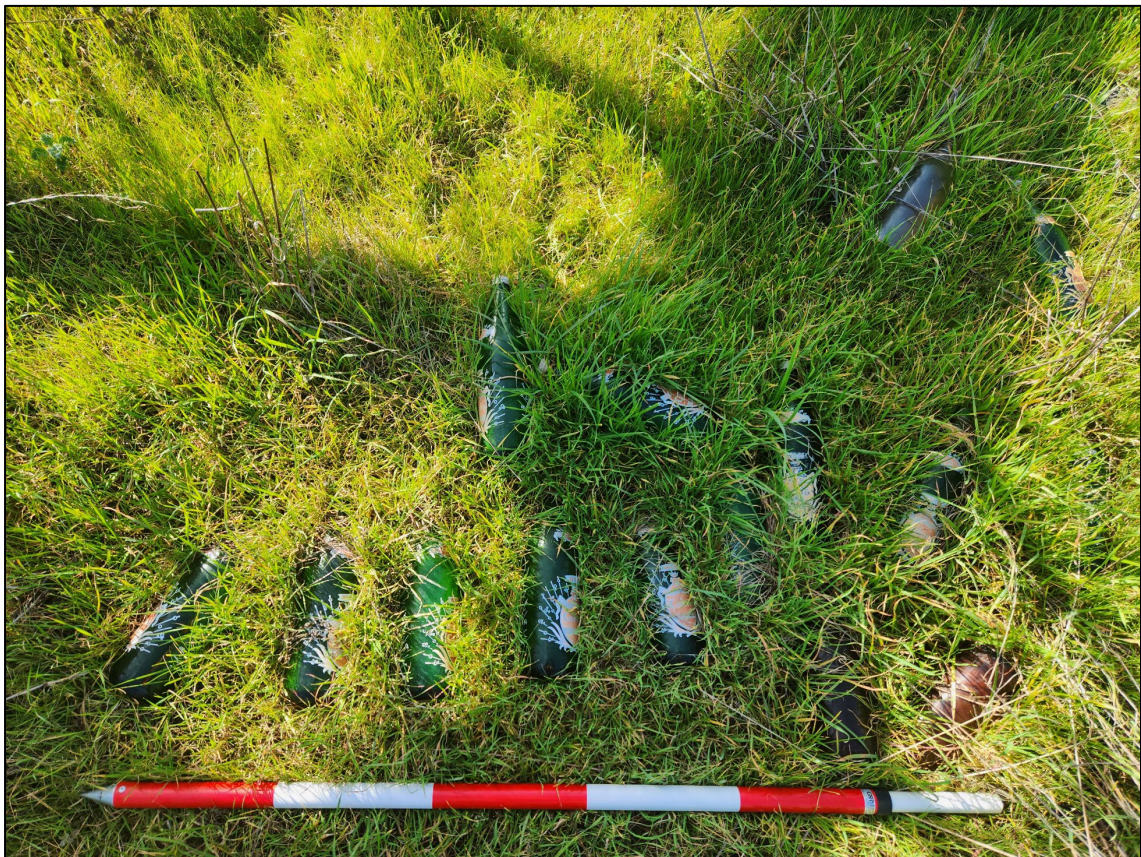
Figure 9: Glass bottles located outside the Kerang-Quambatook Road ruin (C. Lovell, 11/07/2023)

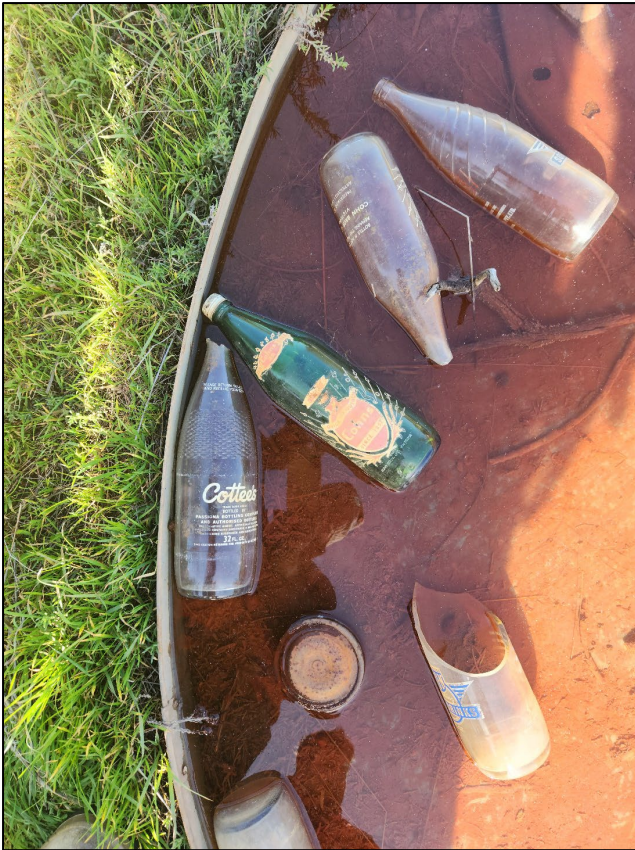
Figure 10: Glass bottles located outside the Kerang-Quambatook Road Ruin (C. Lovell, 11/07/2023)

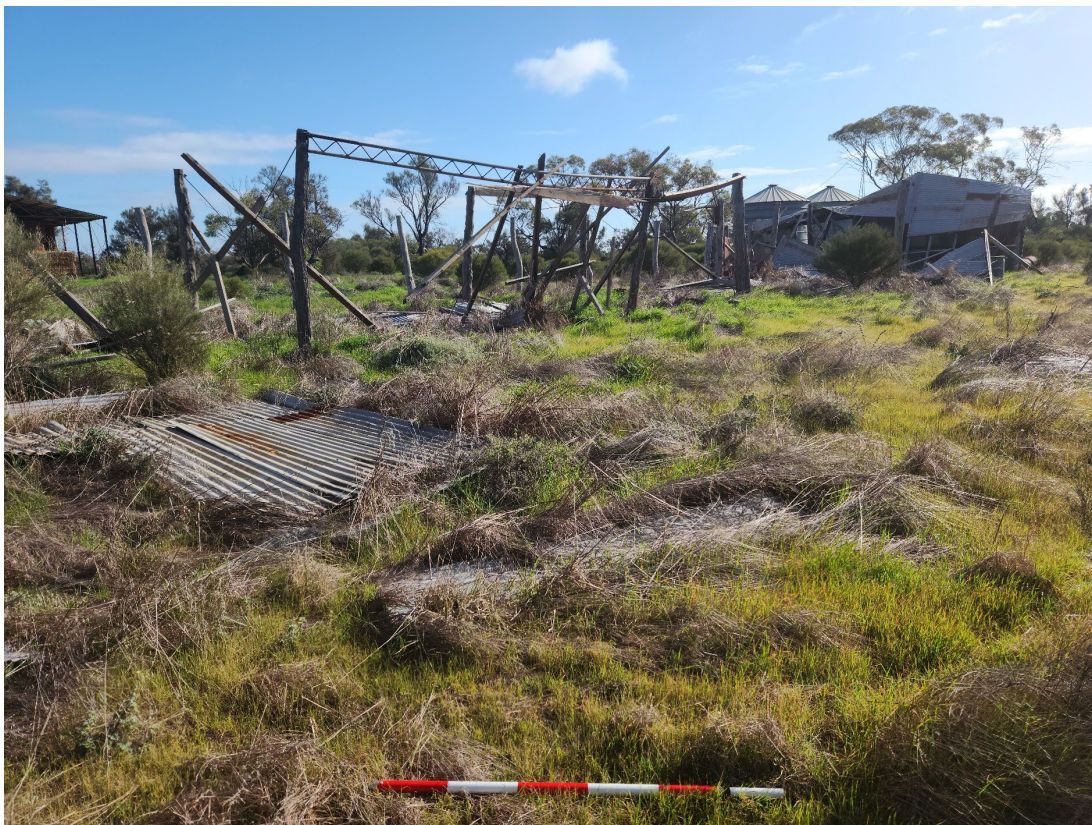
Figure 11: Ruined corrugated iron sheds located near the Kerang-Quambatook Road Ruin, view north-west (C. Lovell, 11/07/2023)

The ruined dwelling is surrounded by five corrugated iron sheds, two of which are also in a ruinous state (Figure 11).

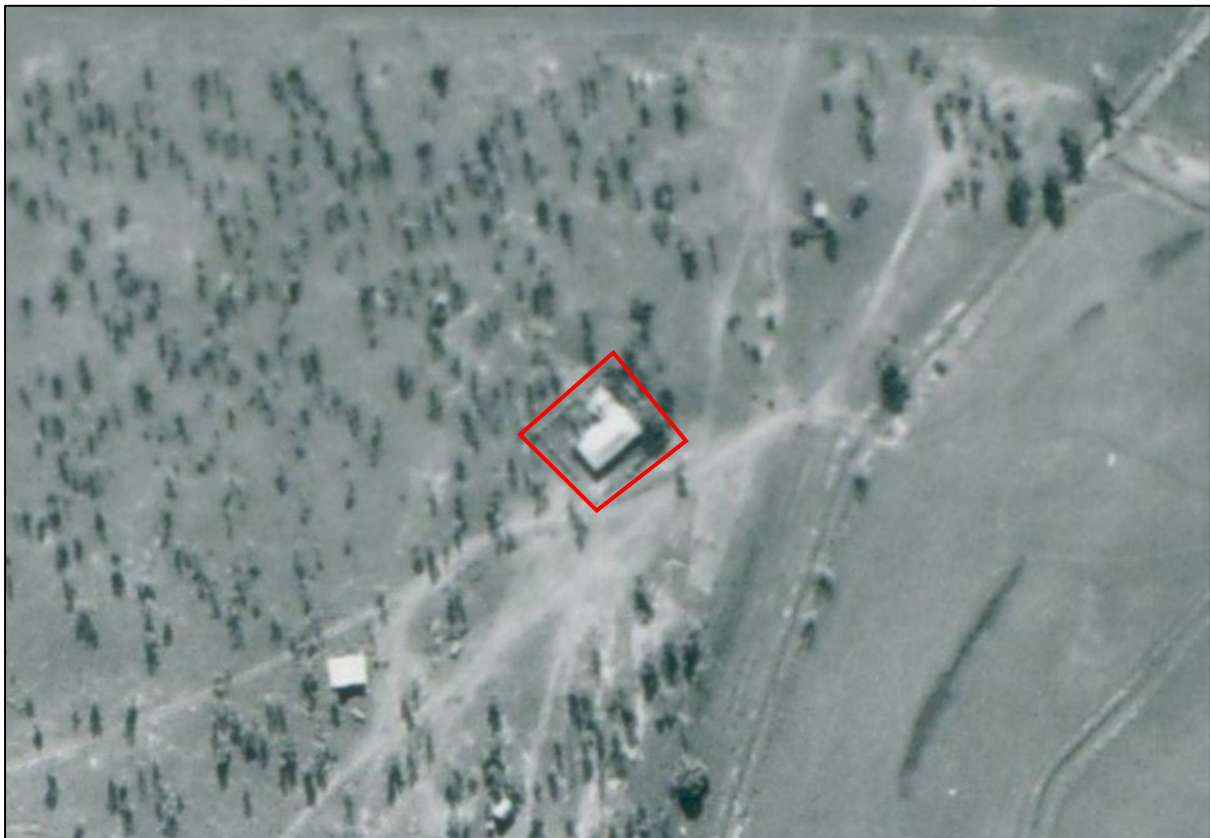
Figure 16: 1945 aerial photograph, with the Kerang-Quambatook Road Ruin highlighted in red

The Kerang-Quambatook Road Ruin is first depicted in a historical aerial photograph from 1945 (Figure 16). A second rectilinear structure, likely a shed or shelter of some variety, is also visible 100 m to the south-west of the residence. The site

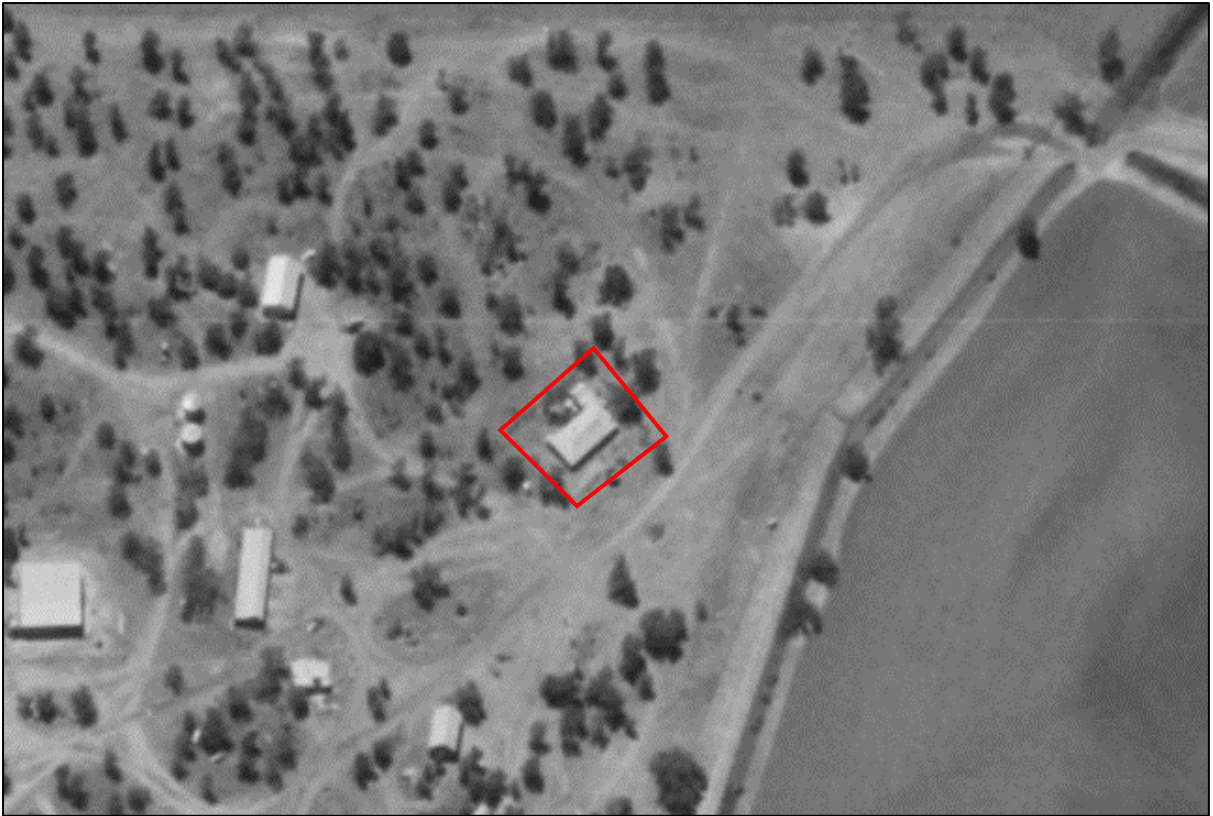
Figure 17: 1979 aerial photograph, with the Kerang-Quambatook Road Ruin highlighted in red

is next depicted in a 1979 photograph (Figure 17), in which the residence and shed are intact. Several additional sheds and grain silos have also been constructed in this photograph.

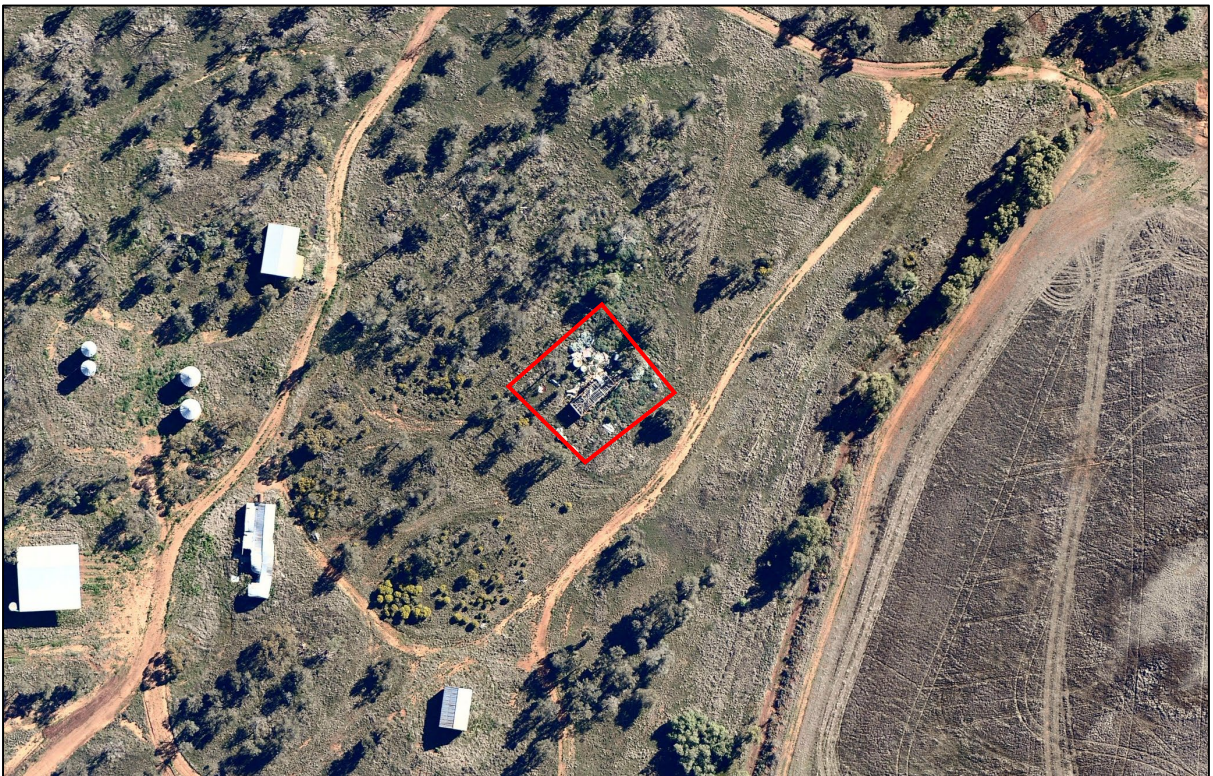
Figure 18: 27 August 2011 satellite image, with the Kerang-Quambatook Road Ruin highlighted in red (NearMap – accessed 14/11/23)

The site is first depicted in its current, ruined state in a 2011 satellite image (Figure 18). The 1945 outbuilding has also been demolished in this capture. A subsequent 2022 satellite image (Figure 19) reveals further decay, with another large shed having collapsed and two of the grain silos removed.

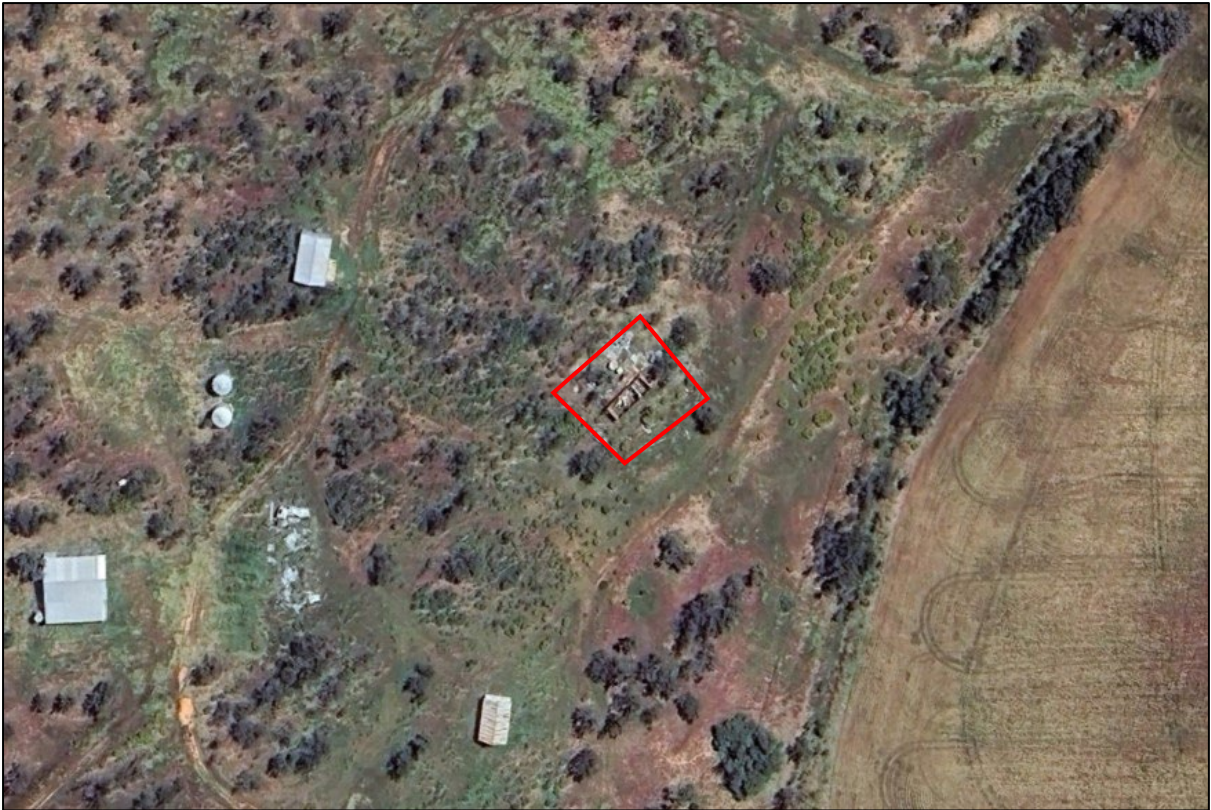
Figure 19: 17 October 2022 satellite image, with the Kerang-Quambatook Road Ruin highlighted in red (Google Earth – accessed 14/11/23)
