Historical archaeological site card

FORMER SACHS BROTHERS COACH FACTORY
H7822-2436

1. Place details

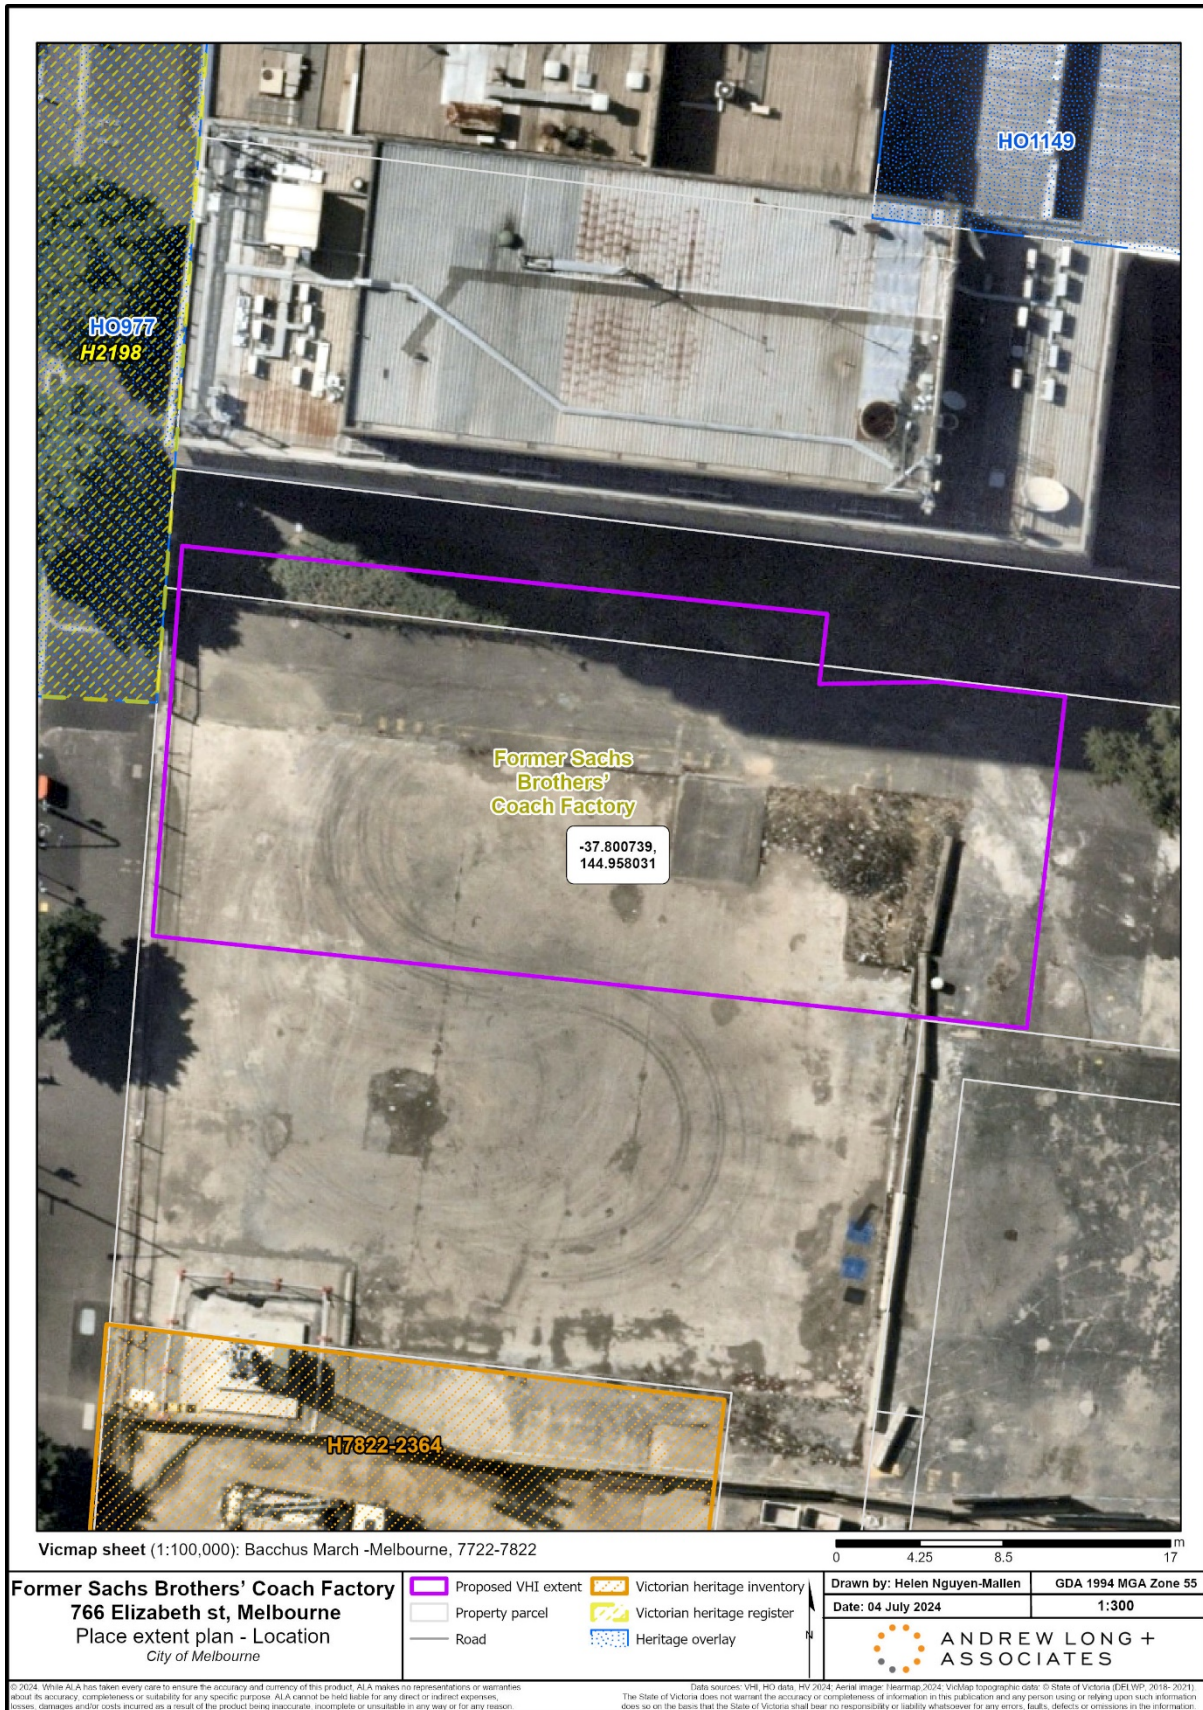
The site extent is depicted in Figure 1. As of July 2024, the majority of the site is located within a laydown and parking lot operated by Kane Constructions Pty Ltd. The north-western corner of the site extends into Haymarket Walk, a publicly accessible pedestrian walkway connecting Elizabeth Street in the west to Berkeley Street in the east.

Figure 1: Proposed site extent for the former Sachs Brothers' Coach Factory

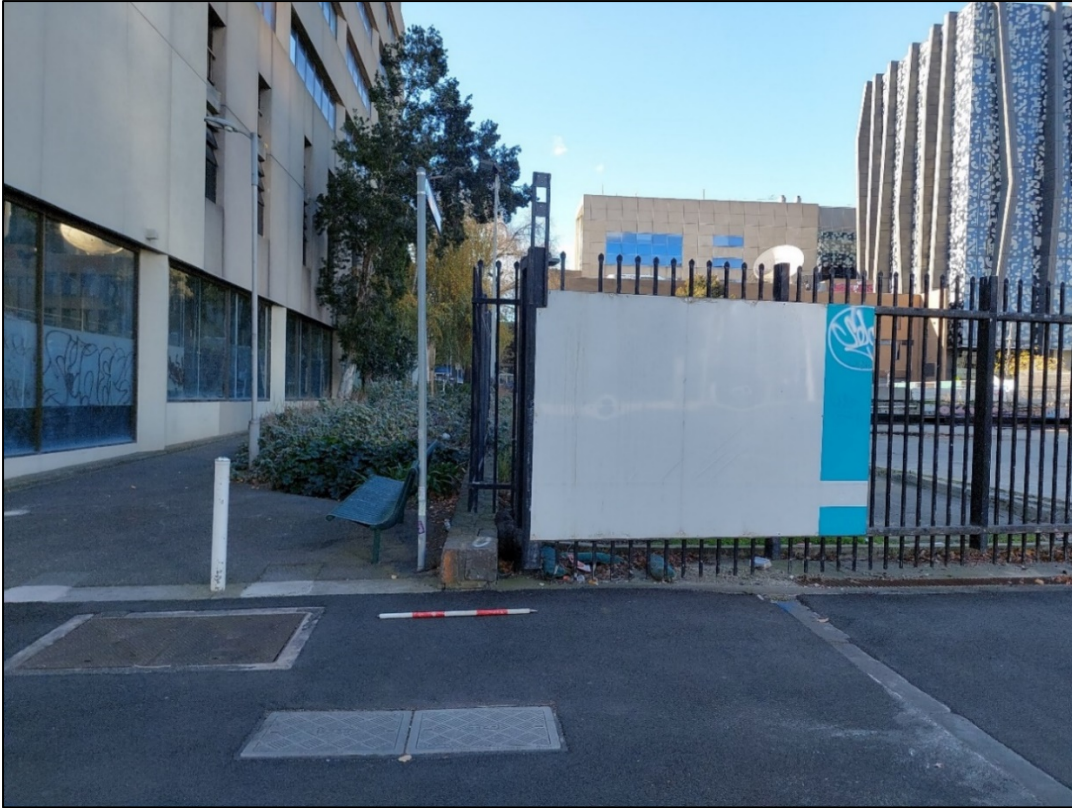
The western end of the site is level with Elizabeth Street (Figure 2). The section of the site within Haymarket Walk is characterised by a tarmac walkway lined by ground-level garden beds (Figure 3). Both Haymarket Walk and the adjacent vehicle access road within the site extent (Figure 4) appear to follow the natural contours of the landscape, gradually sloping upwards from the level of Elizabeth Street to meet the street level of Berkeley Street, which is approximately 1.5 m higher.

In addition to the obvious building, road and pathway construction, disturbances within the site extent include the installation of a park bench and overhead light on Haymarket Walk (Figure 2), as well as the presence of a drainage channel beneath the vehicle access road (Figure 8). A spoil heap filled with debris was also noted at the north-eastern edge of the 1980s cut, likely representing leftover rubble associated with the 2018 demolition of this building.

Figure 2: The northwestern corner of the Former Sachs Brothers' Coach Factory, view south- east (A. Valka, 26/06/2024)

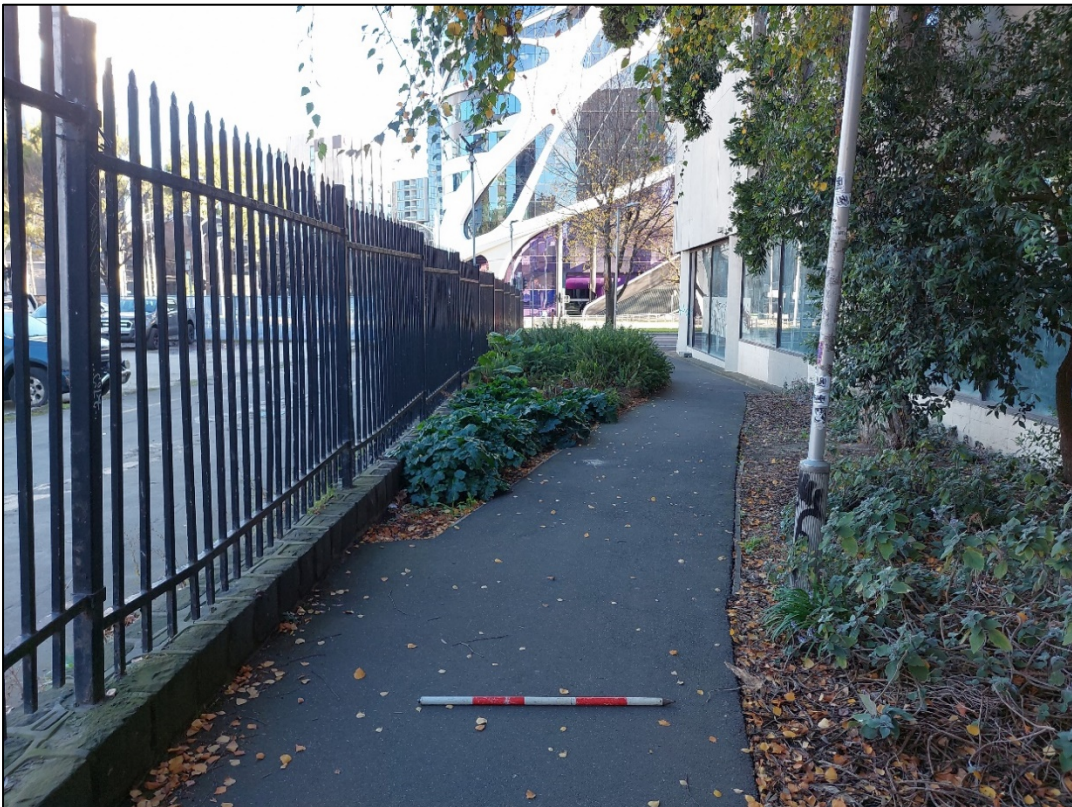
Figure 3: View of the north-eastern corner of the Former Sachs Brothers' Coach Factory from Haymarket Walk, view north-west (A. Valka, 26/06/2024)

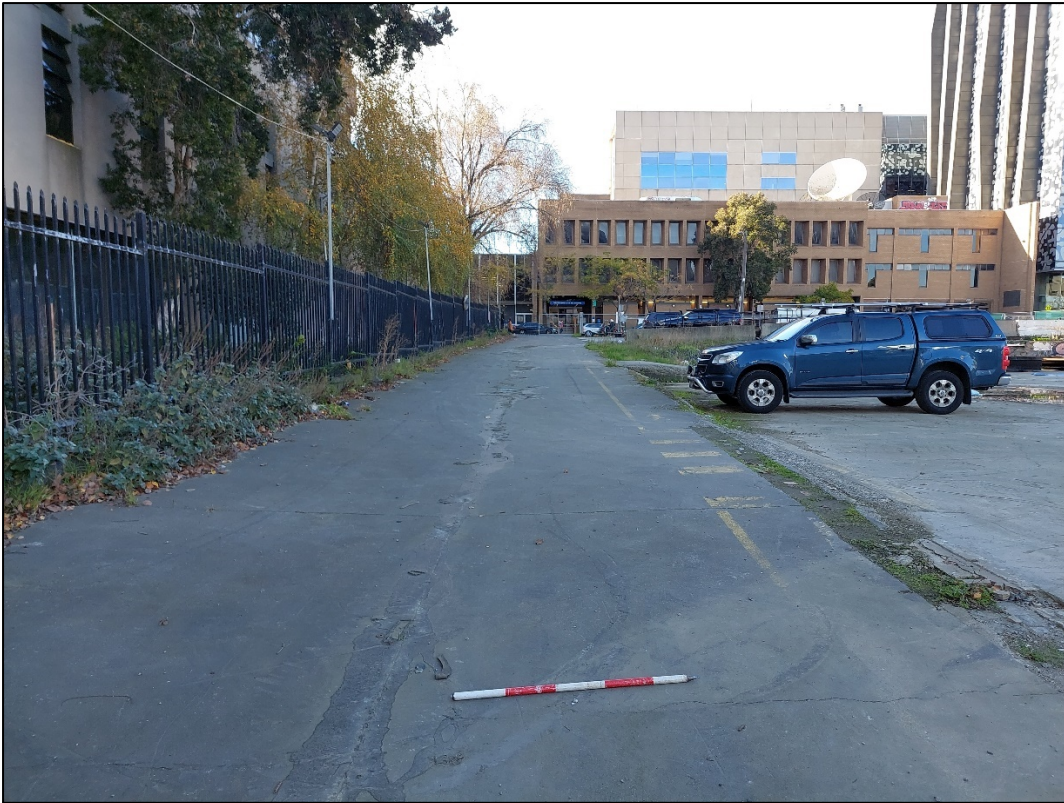
Figure 4: View across the Former Sachs Brothers' Coach Factory, view south-east, with the 1980s cut visible on the right hand side (A. Valka, 26/06/2024)

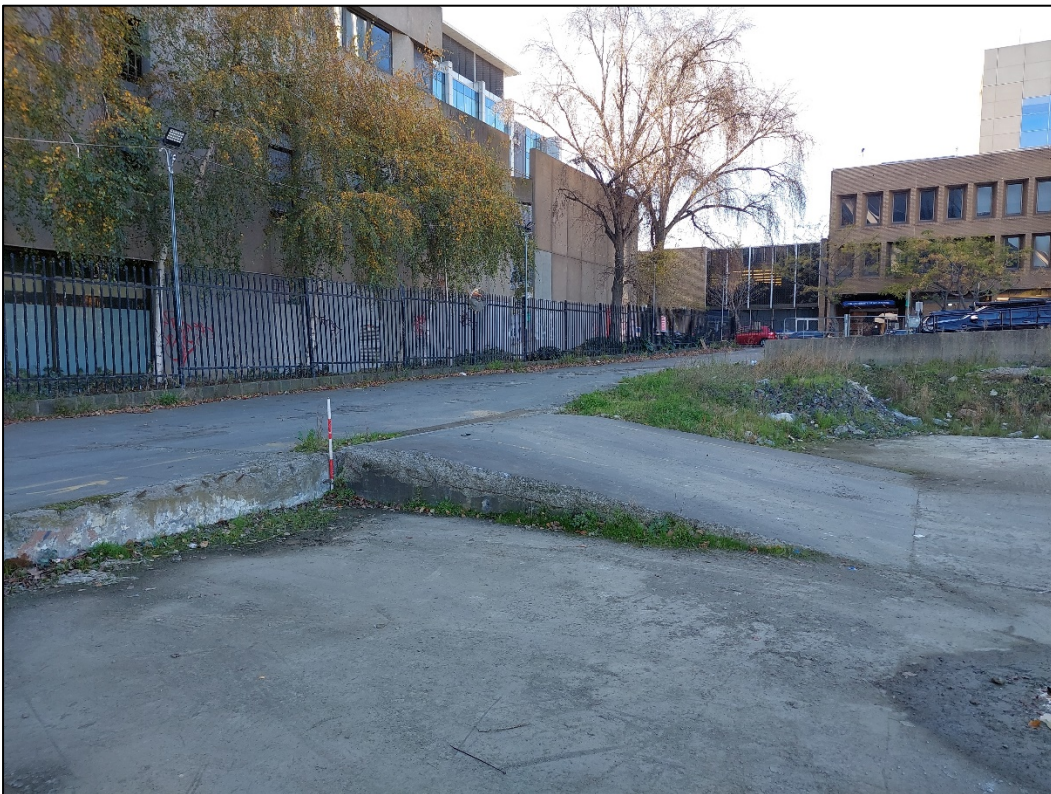
Figure 5: Modern vehicle access ramp between the naturally sloping access road (background) and the 1980s cut (foreground), view east (A.Valka, 26/06/2024)

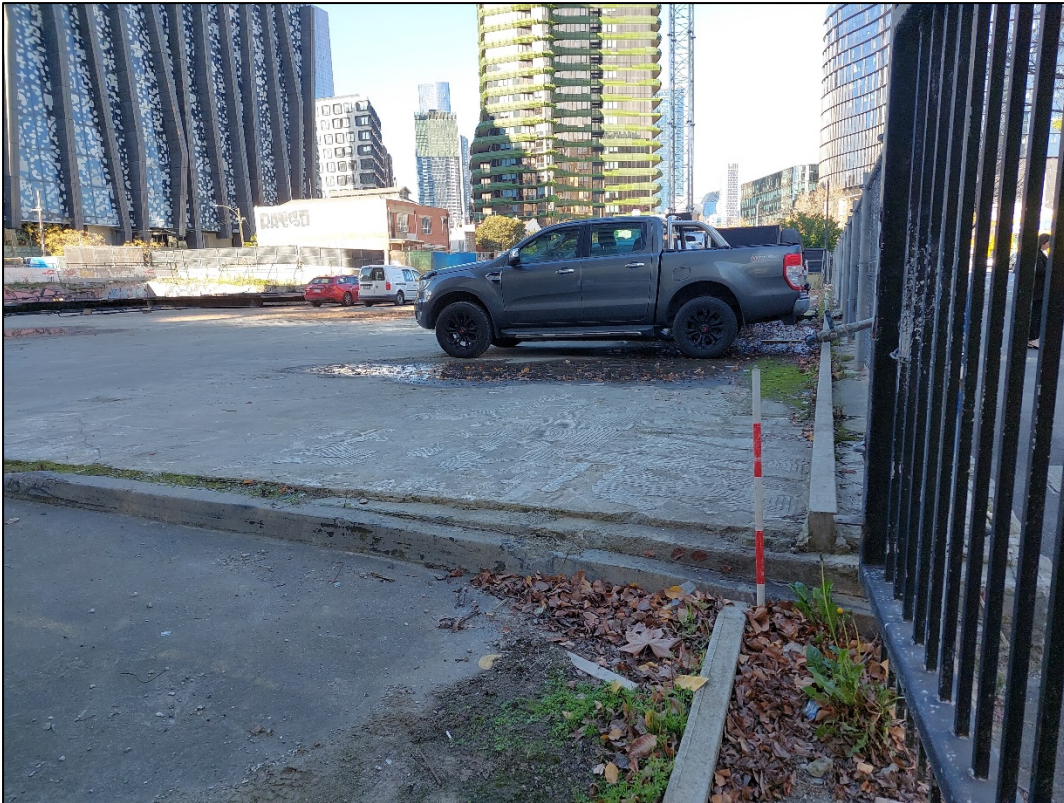
Figure 6: The western end of the Former Sachs Brothers' Coach Factory, view south, showing the difference in elevation between the naturally sloping access road (foreground) and the 1980s cut (background)

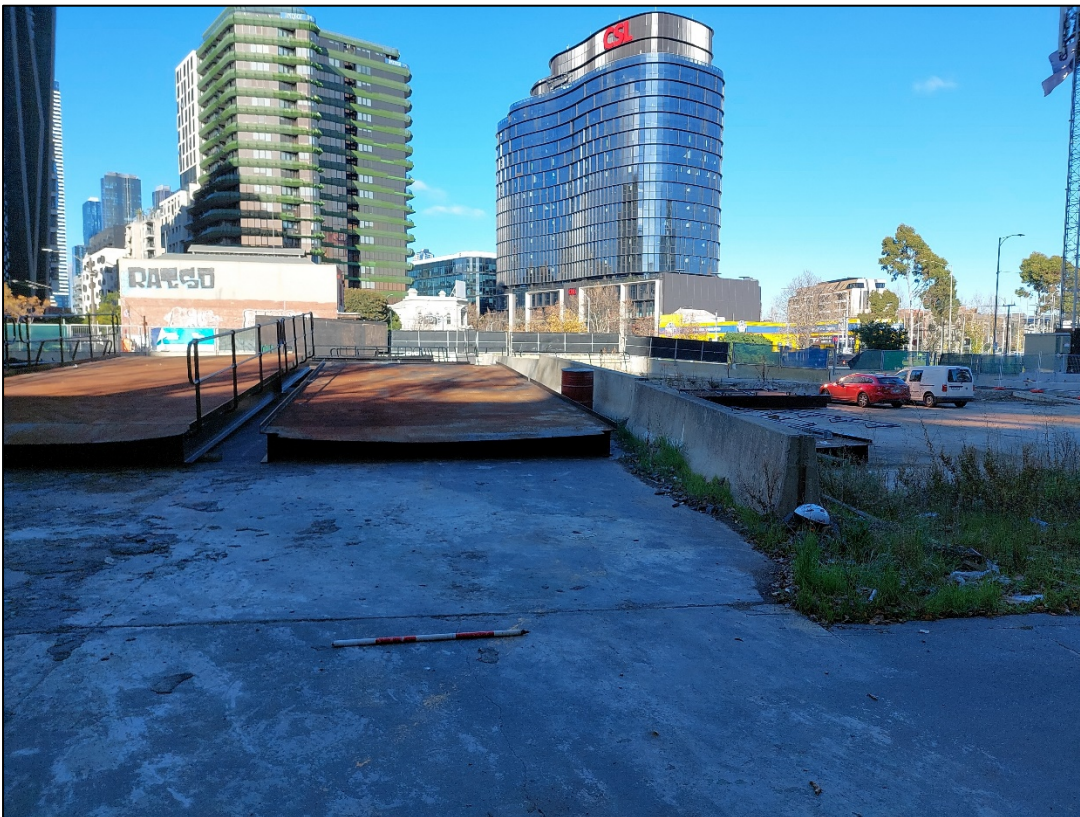
Most of the southern end of the site is covered by the footprint of a 1980s car showroom which formerly occupied the site (see Site History section). This footprint is associated with a cut into underlying deposits in order to create a surface level with Elizabeth Street. Accordingly, the cut is deepest at its eastern end (Figure 5), before trailing off towards Elizabeth Street, where the ground level is raised approximately 30 cm above the surrounding footpath and access road (Figure 6). The easternmost end of the site is located outside the cut, with modern ground surface subsequently being level with Berkeley Street in this area (Figure 7).

Figure 7: The eastern end of the Former Sachs Brothers' Coach Factory, view south-west, showing the section of the site located above the 1980s cut (A. Valka, 26/06/2024)

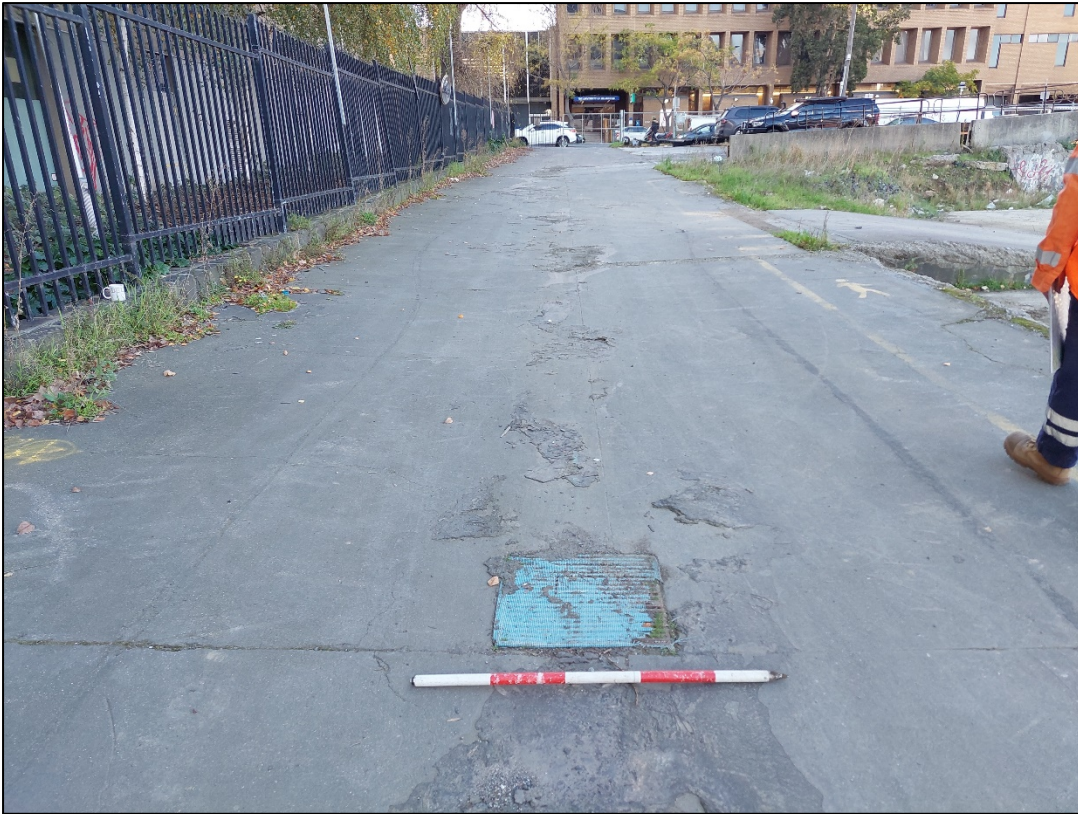
Figure 8: Drainage grate on the naturally sloping access road, view south-east (A. Valka, 26/06/2024)

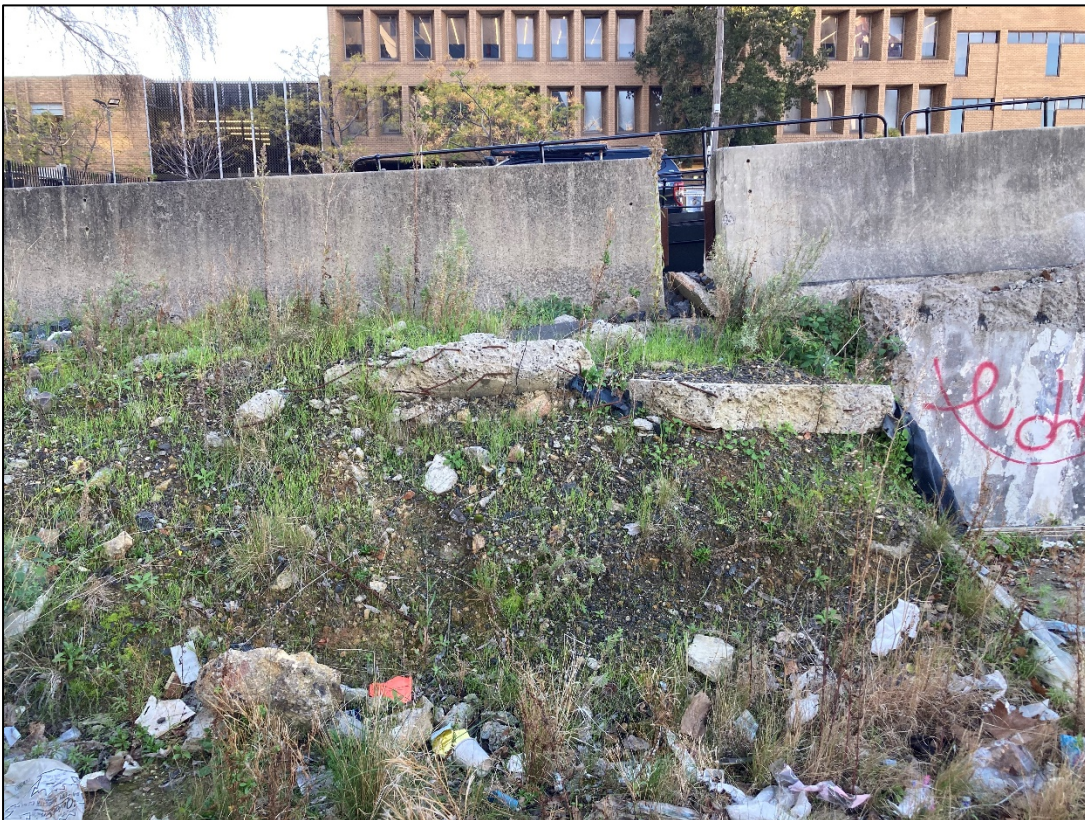
Figure 9: Spoil heap located within the site extent, at the north-eastern corner of the 1980s cut (R. Hocking, 26/06/2024)

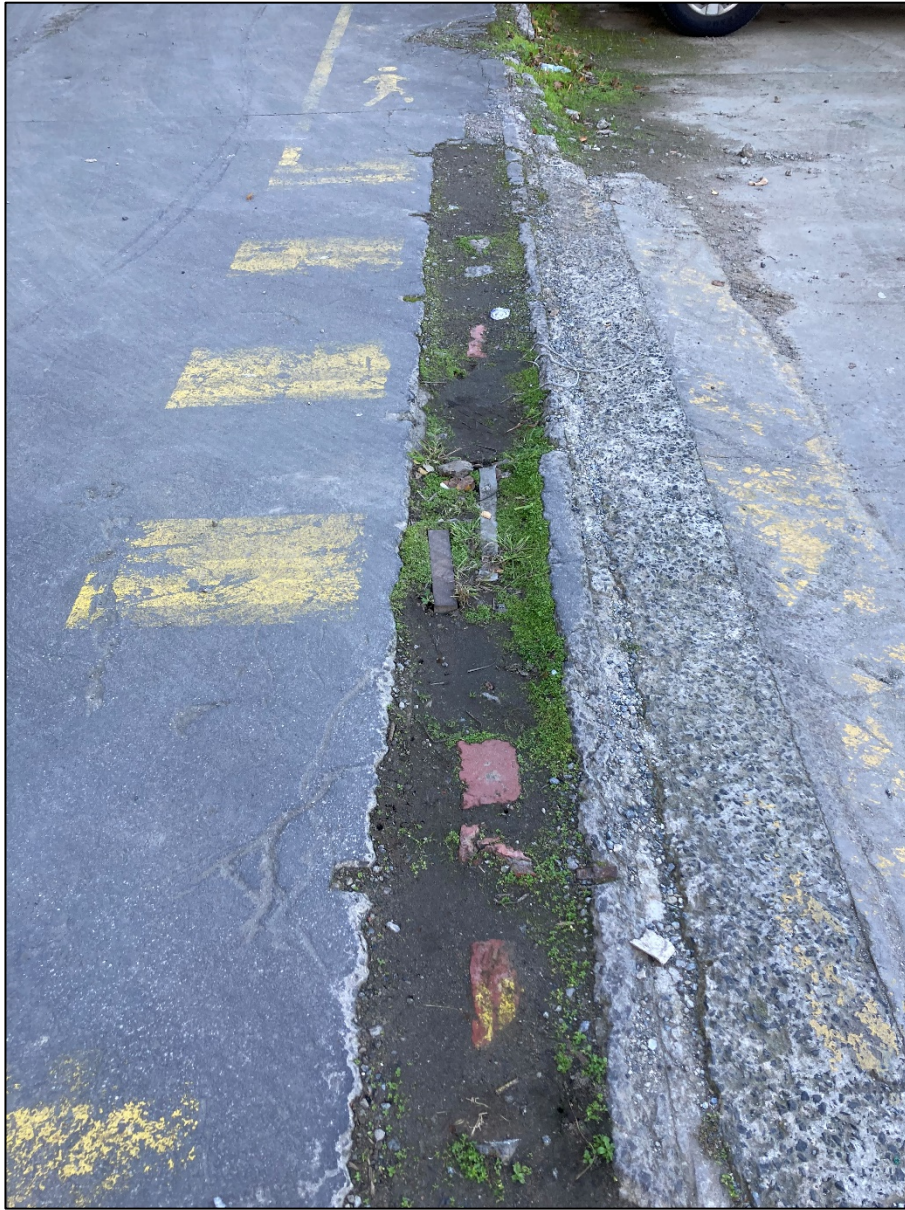
While no historically significant artefacts or features were identified during the site inspection, a loose row of red bricks was observed within a section of exposed ground in between the access road and 1980s cut (Figure 10).

Figure 10: Row of bricks in between the concrete access road and 1980s cut, view north-east (R. Hocking, 26/06/2024)

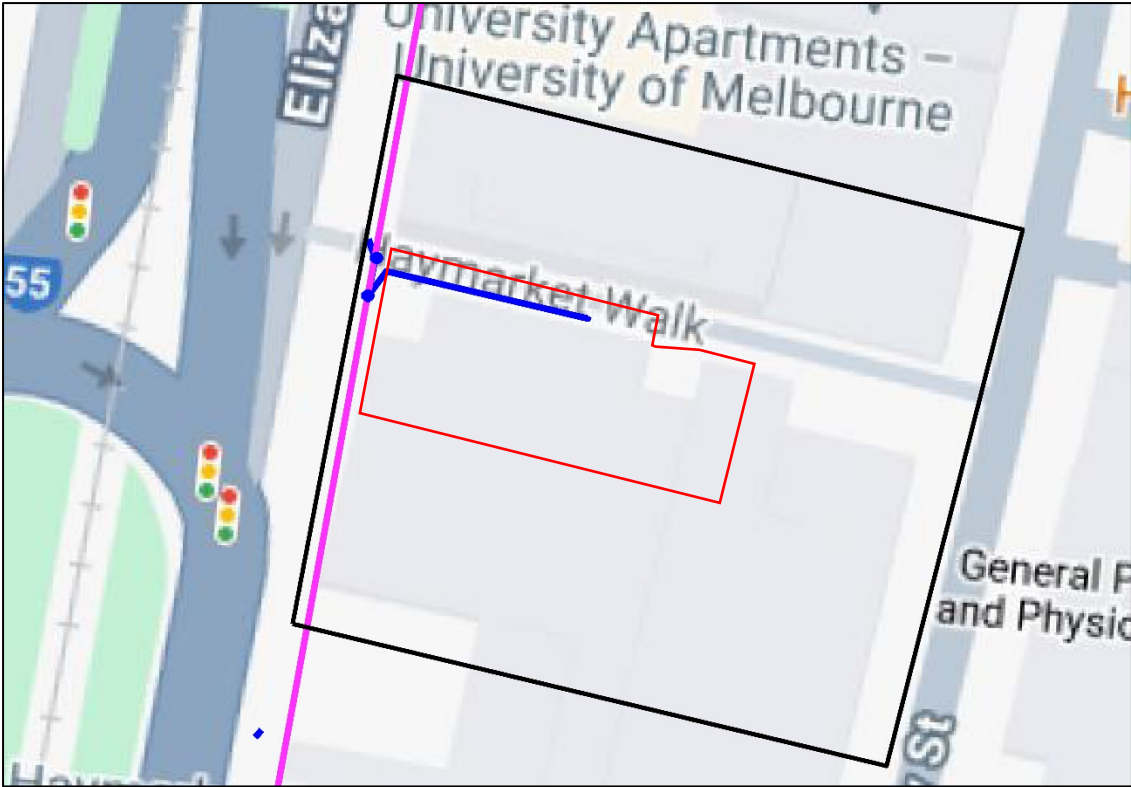
Figure 11: Results of a Before You Dig Australia search undertaken on 04/07/2024, showing the intersection of a TPG telecommunications cable (in blue) with the proposed site extent (in red)

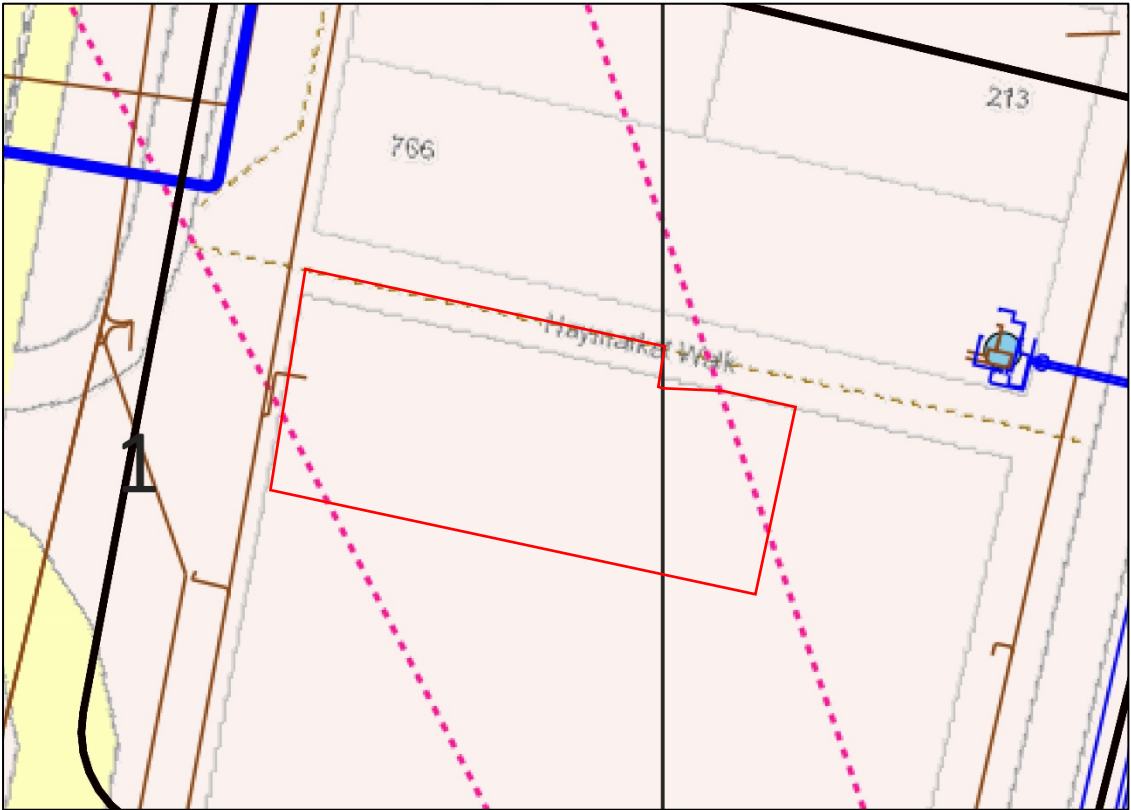
A Before You Dig Australia search (conducted on 04/07/2024) revealed that there are some subsurface utilities intersecting with the site extent. These utilities comprise a TPG telecommunications cable, which extends south-eastward from Elizabeth Street along the south edge of Haymarket Walk (Figure 11), as well as several Powercor utilities slightly overlapping with the site extent (Figure 12).

Figure 12: Results of a Before You Dig Australia search undertaken on 04/07/2024, showing the intersection of Powercor communications cables (dotted in purple) and a low voltage cable (in brown) with the proposed site extent (in red)

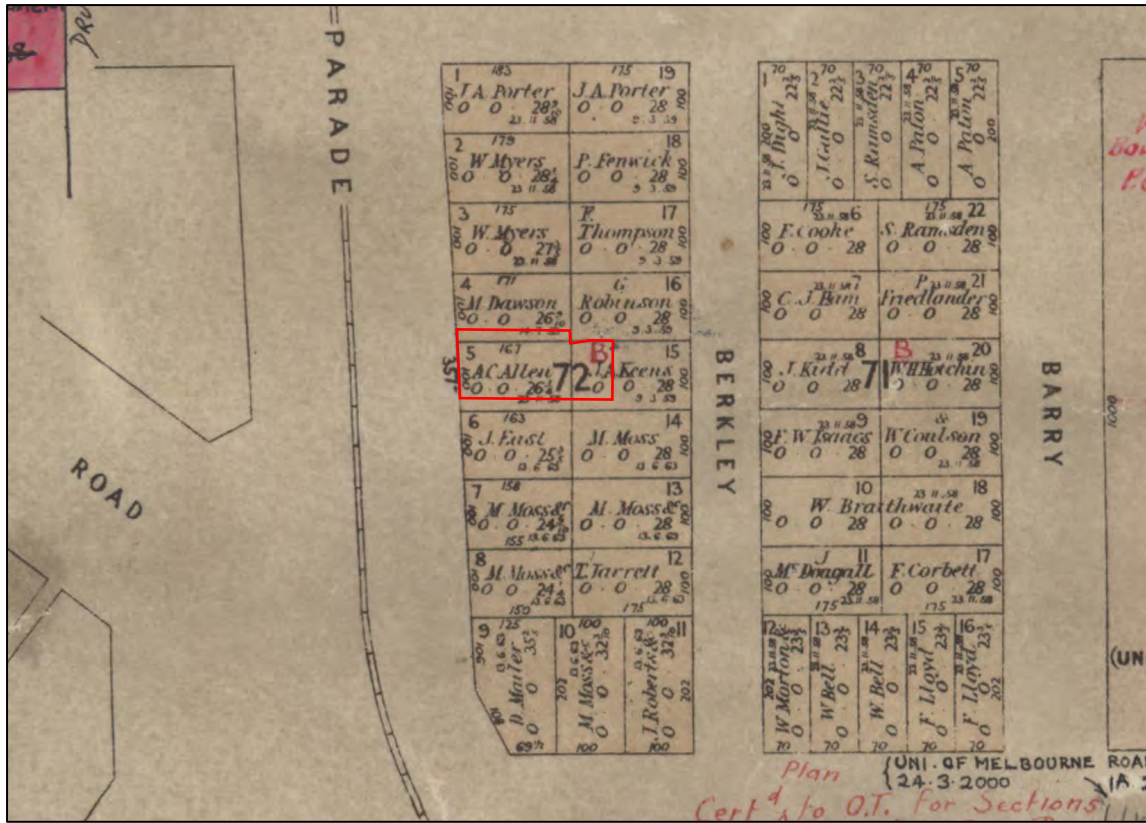
Figure 13: Proposed site extent of the Former Sachs Brothers' Coach Factory (in red) on an undated Parish plan (Source: Public Records Office of Victoria)

The area to the south of Grattan Street and west of the Carlton Gardens was surveyed by Robert Hoddle in 1852 (Chambers & Mayne 2004: 15). An undated subdivision plan (Figure 13) reveals the majority of the site extent corresponds with lot 5 selected by A.C. Allen on 23 November 1858, suggesting either that this lot was selected relatively later, or that it was further subdivided and resold several years after the original land selection.

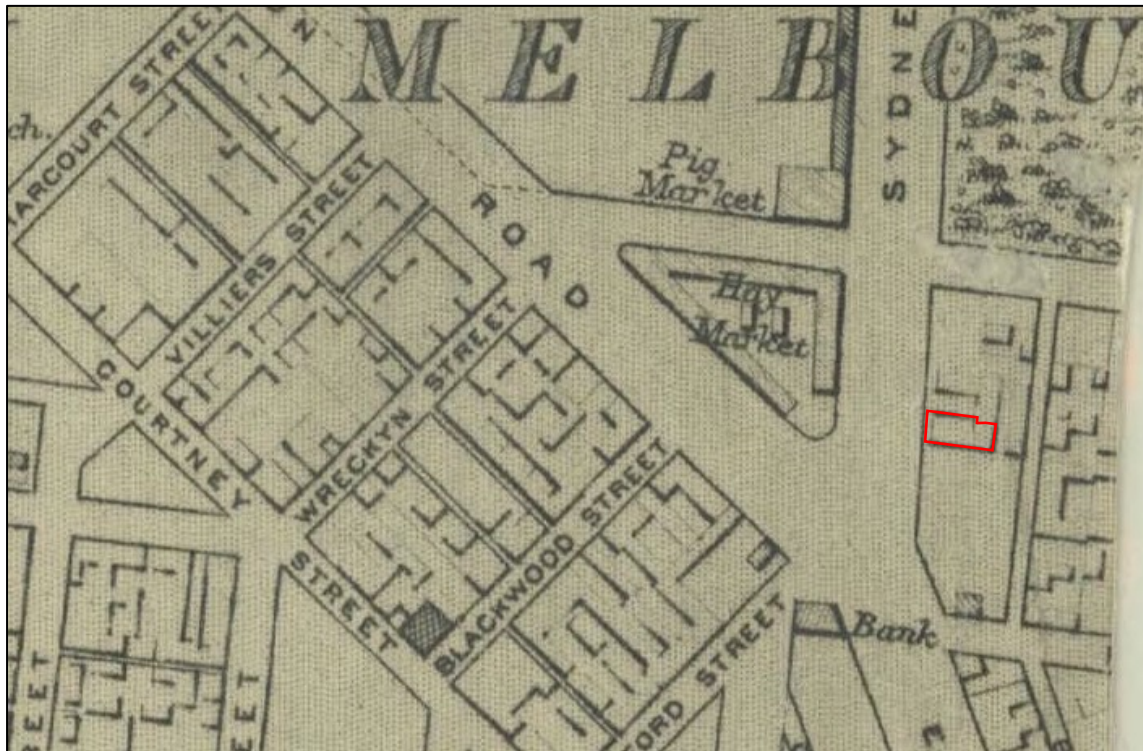
J.G. Sachs' Coach Factory is first depicted in an 1864 map by Commander H.L. Cox, revealing a rectangular building at the north-western end of the site (Figure 14). The 1875 Sands & McDougall's street directory lists the site as being occupied by a wheelwright and blacksmith operated by John G. Sachs (Sands & McDougall 1875: 113). J. G. Sachs died on 20 February 1883, having moved from Carlton to Ascot Vale in the final years of his life (The Argus 1883: 6). At the time of his death, J.G. Sachs' wheelwright shop was described as comprising two sheds made from wood and iron, with a brick storefront facing the Hay Market (PROV 1883: VPRS 28/P0002).

Figure 14: The Sachs Brothers' Coach Factory (in red), as depicted in an 1864 map by Commander H.L. Cox (Source: Public Records Office of Victoria)

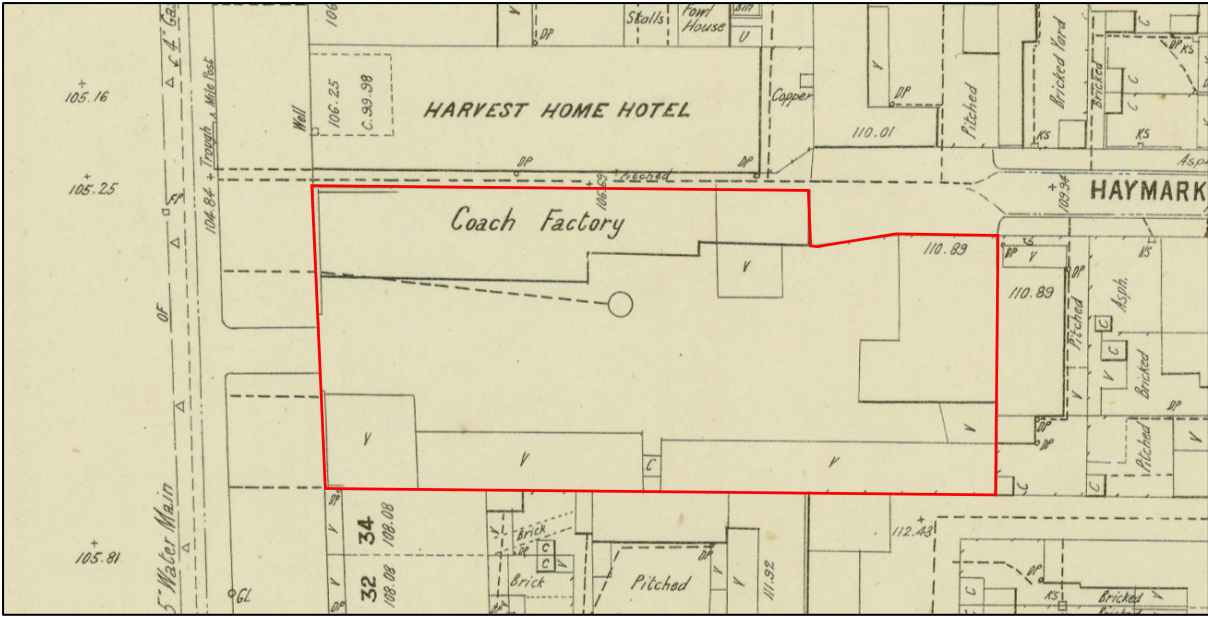
The Coach Factory at the time of its ownership by Schuster & Glaser is depicted in an 1896 Melbourne and Metropolitan Board of Works (MMBW) plan (Figure 15). An elongated, staggered building running along the north-eastern edge of the site is labelled as the main factory building and may represent the same rectangular building as depicted in the 1864 map. An unmarked L-shaped building is also present at the western end of the site, while the southern side of the site is lined by verandas and a water closet.

Figure 15: The Former Sachs Brothers' Coach Factory (then operating as Schuster & Glaser) (in red) in an 1896 Melbourne and Metropolitan Board of Works Plan (Source: State Library of Victoria)

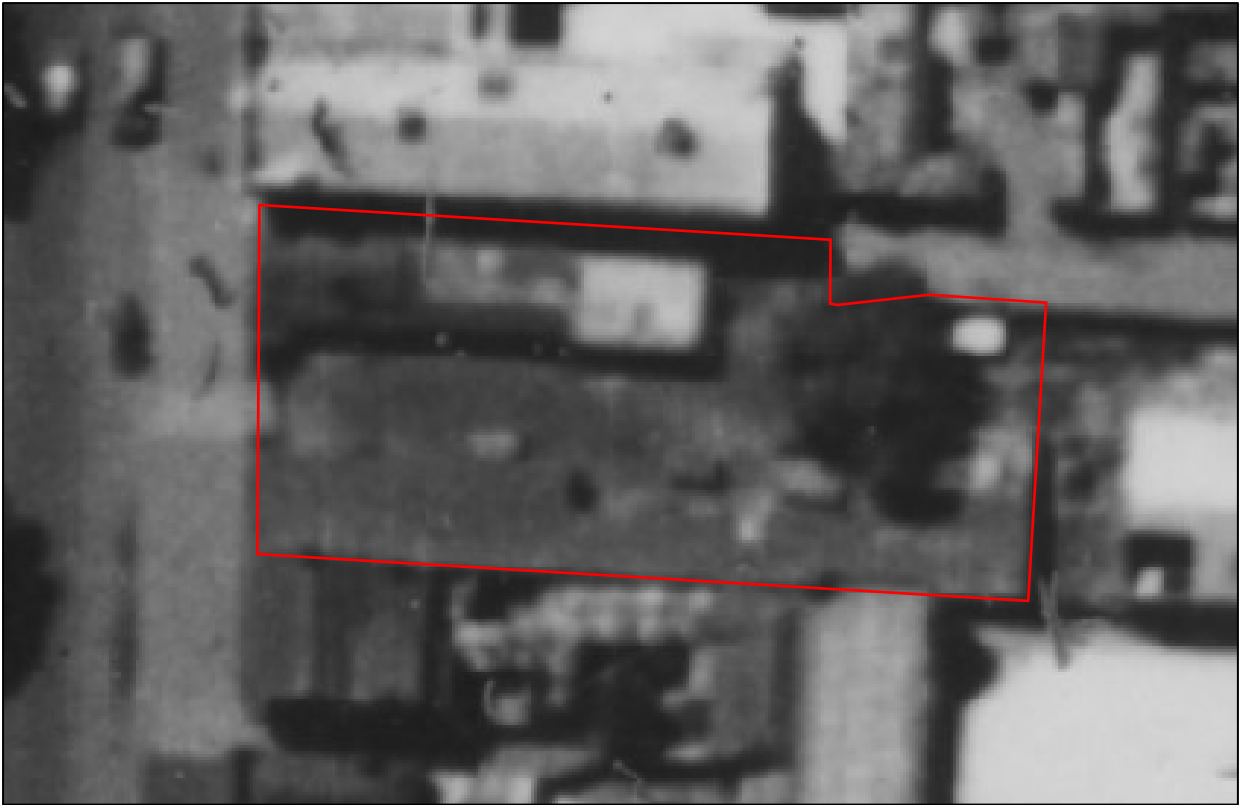
Figure 17: The Former Sachs Brothers' Coach Factory (then operating as W. Schuster & Co.) (in red) in a 1945 aerial photograph (Source: Landata)

The coach factory at 36-42 Sydney Road, Carlton, was subsequently listed as the W. Schuster & Co. wheelwrights in the 1905 and 1915 Sands and McDougall’s directories (Sands & McDougall 1905: 205; 1915: 203). W. Schuster & Co. operated from same location in 1935 and 1945, with the address now listed as 758-64 Elizabeth Street (Sands & McDougall 1935: 16; 1945: 19). The W. Schuster and Co. coach factory is depicted in aerial images taken in 1931 (Figure 16) and 1945 (Figure 17). The layout of the site in 1931 appears similar to that of the 1896 plan, with the north-western rectangular building and eastern L-shaped building both being visible. The site layout also remains largely consistent in the 1945 photograph to the 1896 plan, albeit with the removal of the eastern L-shaped building.

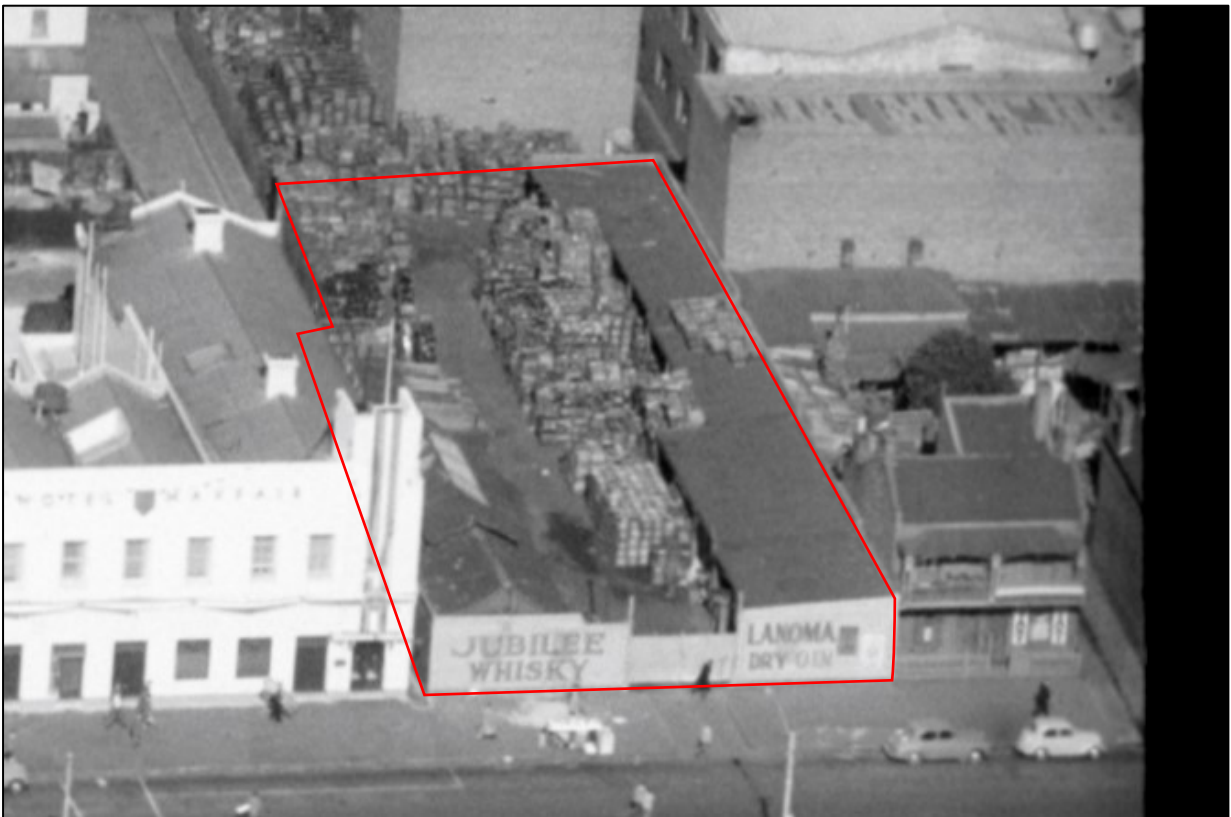
Figure 18: The Former Sachs Brothers' Coach Factory (then owned by Stephen King Pty. Ltd.) (in red) in a 1952 Airspy aerial photograph, view south-east (Source: State Library of Victoria)

The acquisition of the lot by Stephen King Pty Ltd is supported by advertisements for “Jubilee Whiskey” and “Lanoma Dry Gin” lining the Elizabeth Street façade in a subsequent 1954 Airspy aerial photograph (Figure 18) and a 1956-1965 ground-level photograph (Figure 19), as Lanoma Gin was a product distilled by Stephen King Pty Ltd in the 1950s (Webb’s 2024). The 1954 aerial photograph is also notable in that the buildings appear largely unchanged from 1945, despite the change in land use. The acquisition of the site by Stephen King Pty Ltd is confirmed by its listing in the 1955 Sands and McDougall directory, wherein it is identified as a storage lot for the company (Sands & McDougall 1955: 19).

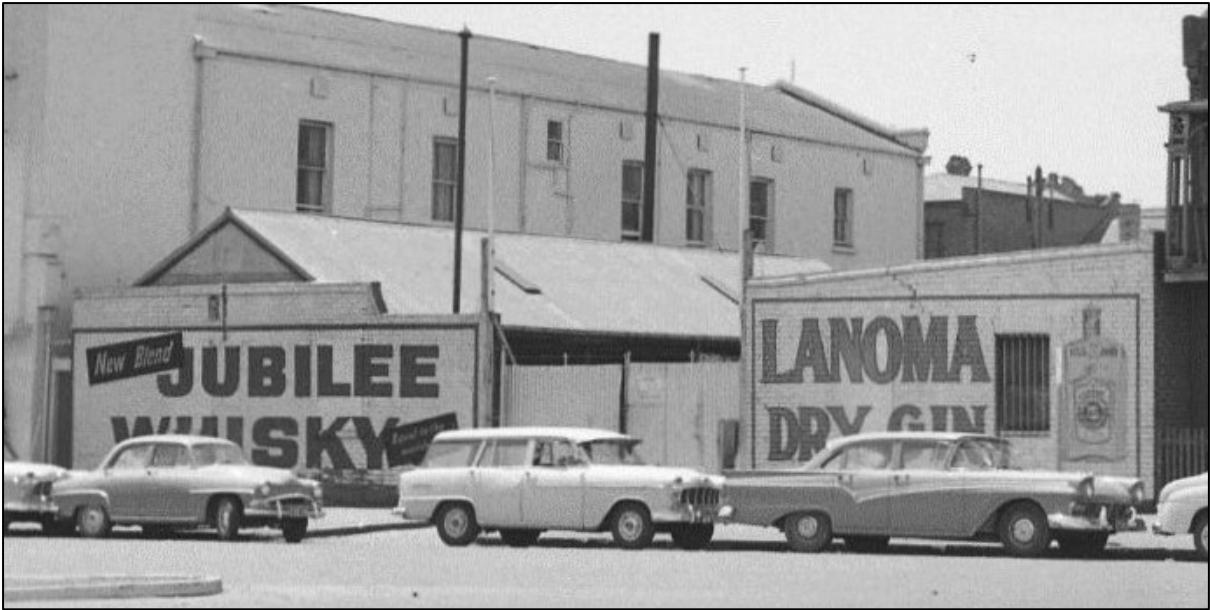
Figure 19: Ca. 1956-1965 photograph of the Former Sachs Brothers' Coach Factory (then owned by Stephen King Pty. Ltd.) taken from Elizabeth Street, view north-east (Source: City of Melbourne Collections)

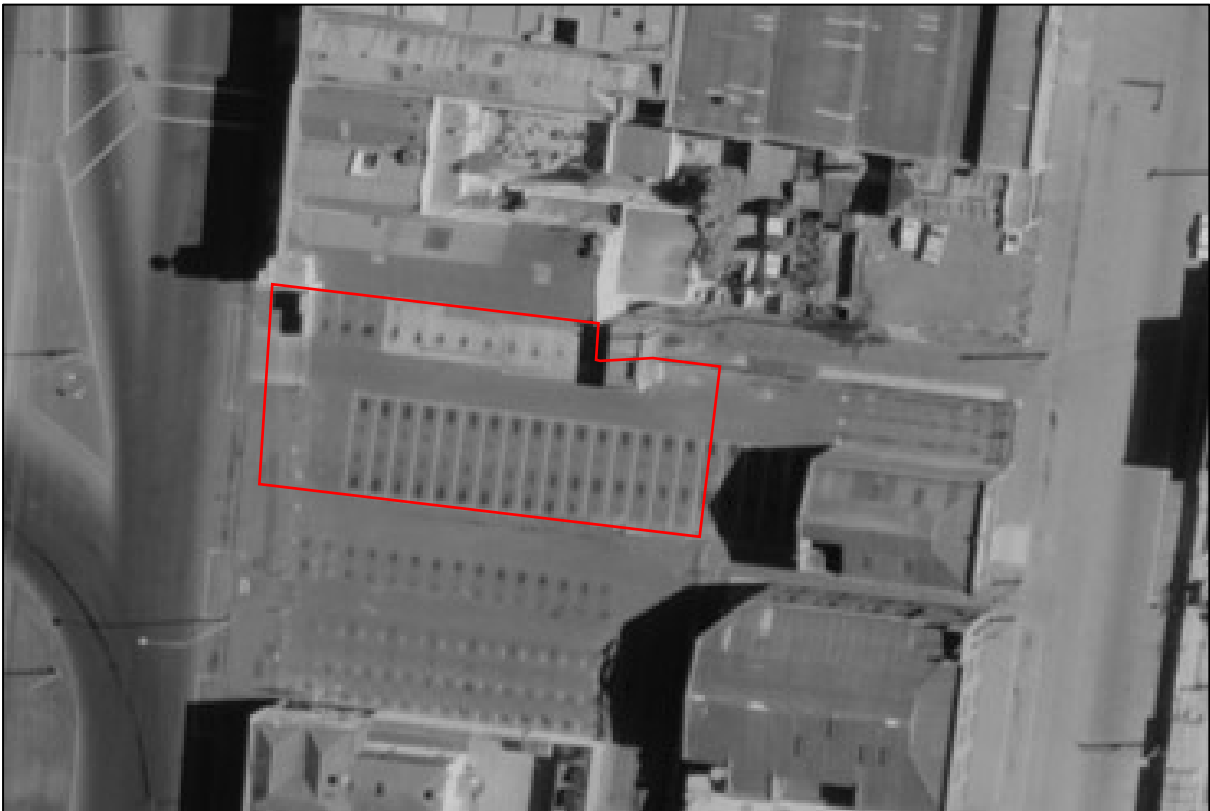
The site is subsequently depicted as a ground-level parking lot in aerial photographs taken in 1969 (Figure 20) and 1975 (Figure 21). As such, it can be demonstrated that the remaining historically significant buildings were demolished between 1956 and 1969. A car showroom is depicted as covering most of the southern half of the site in a subsequent 1985 aerial photograph (Figure 22), demonstrating that the construction of this building and its associated cut was made between 1975 and 1985.

Figure 20: The Former Sachs Brothers' Coach Factory (in red) in a 1969 aerial photograph (Source: Landata)

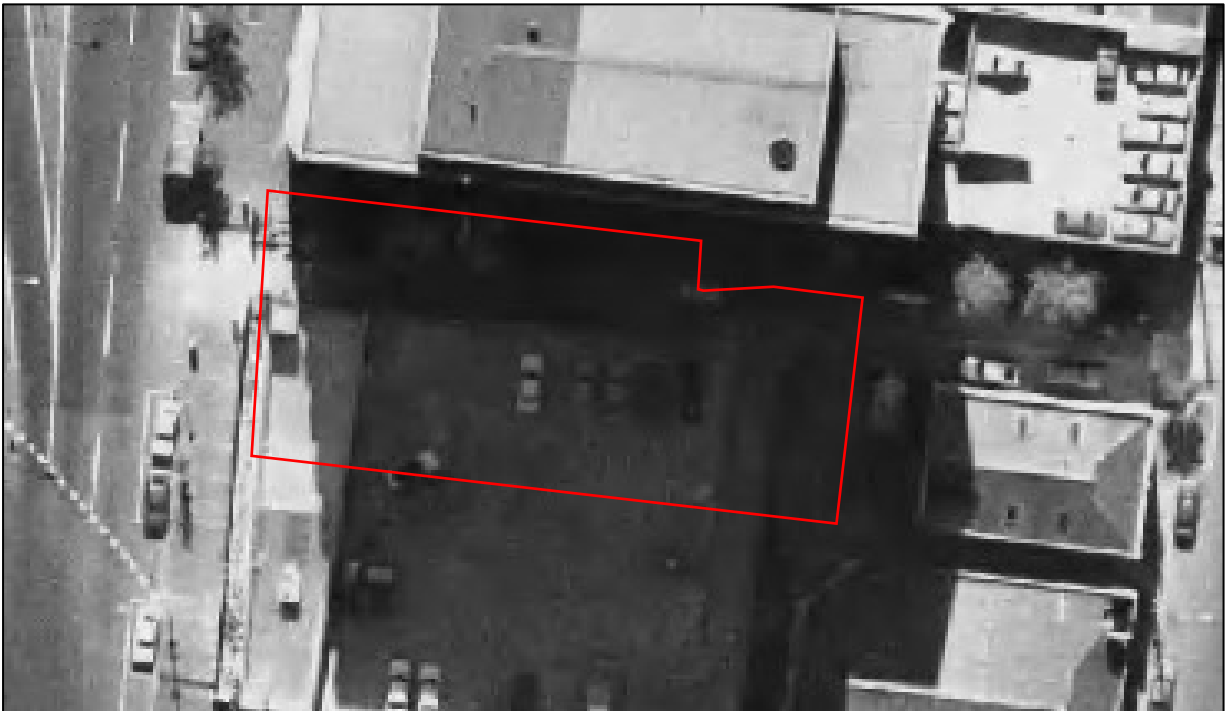
Figure 22: The Former Sachs Brothers' Coach Factory (in red) in a 1985 aerial photograph (Source: Landata)

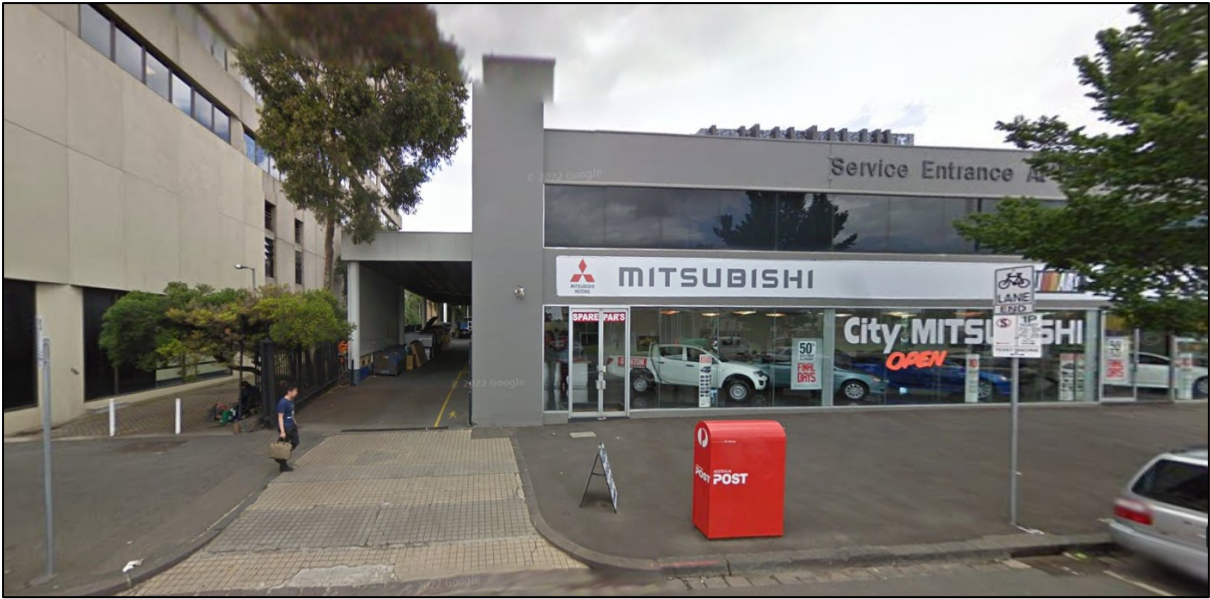
The car showroom is depicted from the Elizabeth Street in a February 2009 Google Street View image (Figure 23) revealing that Haymarket Walk and the adjacent access road appearing as they did during the 2024 site inspection. As such, is likely that Haymarket Walk and adjacent vehicle access road were also established at the same time as the construction of the car showroom.

Figure 23: The location of the Former Sachs Brothers Coach Factory in November 2009, view east (Source: Google Street View)
