Historical archaeological site card

FORMER SACHS BROTHERS COACH FACTORY
H7822-2436

1. Place details

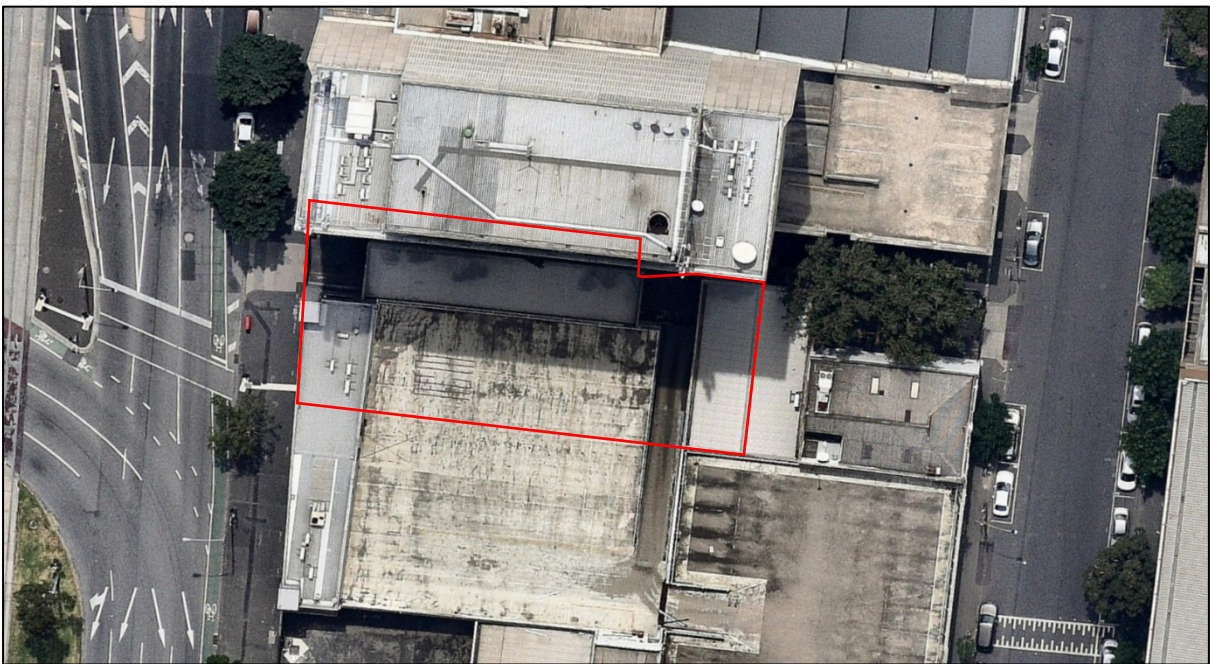
The site is depicted shortly before the demolition of the car showroom and adjacent buildings in a February 2018 satellite image (Figure 24), revealing the same structures occupying the site as in 1985. Finally, the layout of the site following the late 2018 demolition works is depicted in a February 2024 satellite image, with the footprint of the former car showroom still being clearly visible (Figure 25).

Figure 24: The Former Sachs Brothers' Coach Factory (in red) in a 17 February 2018 satellite image (Source: NearMap)

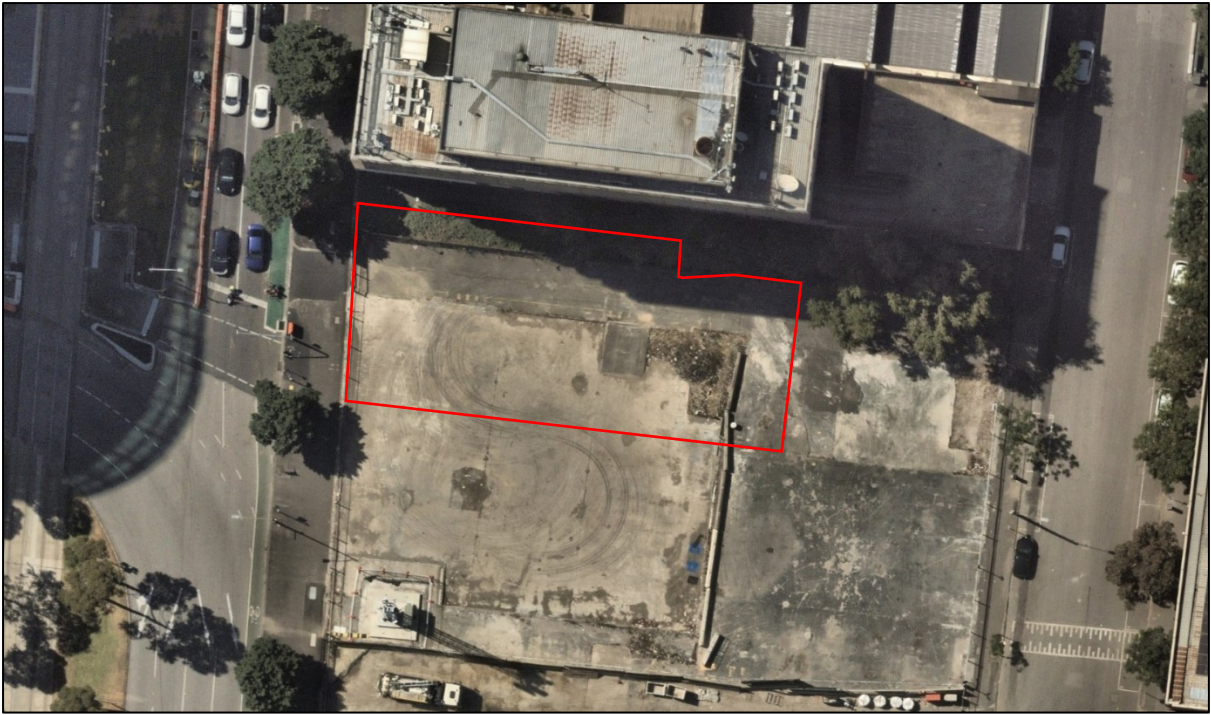
Figure 25: The Former Sachs Brothers' Coach Factory (in red) in a 3 February 2024 satellite image (Source: NearMap)

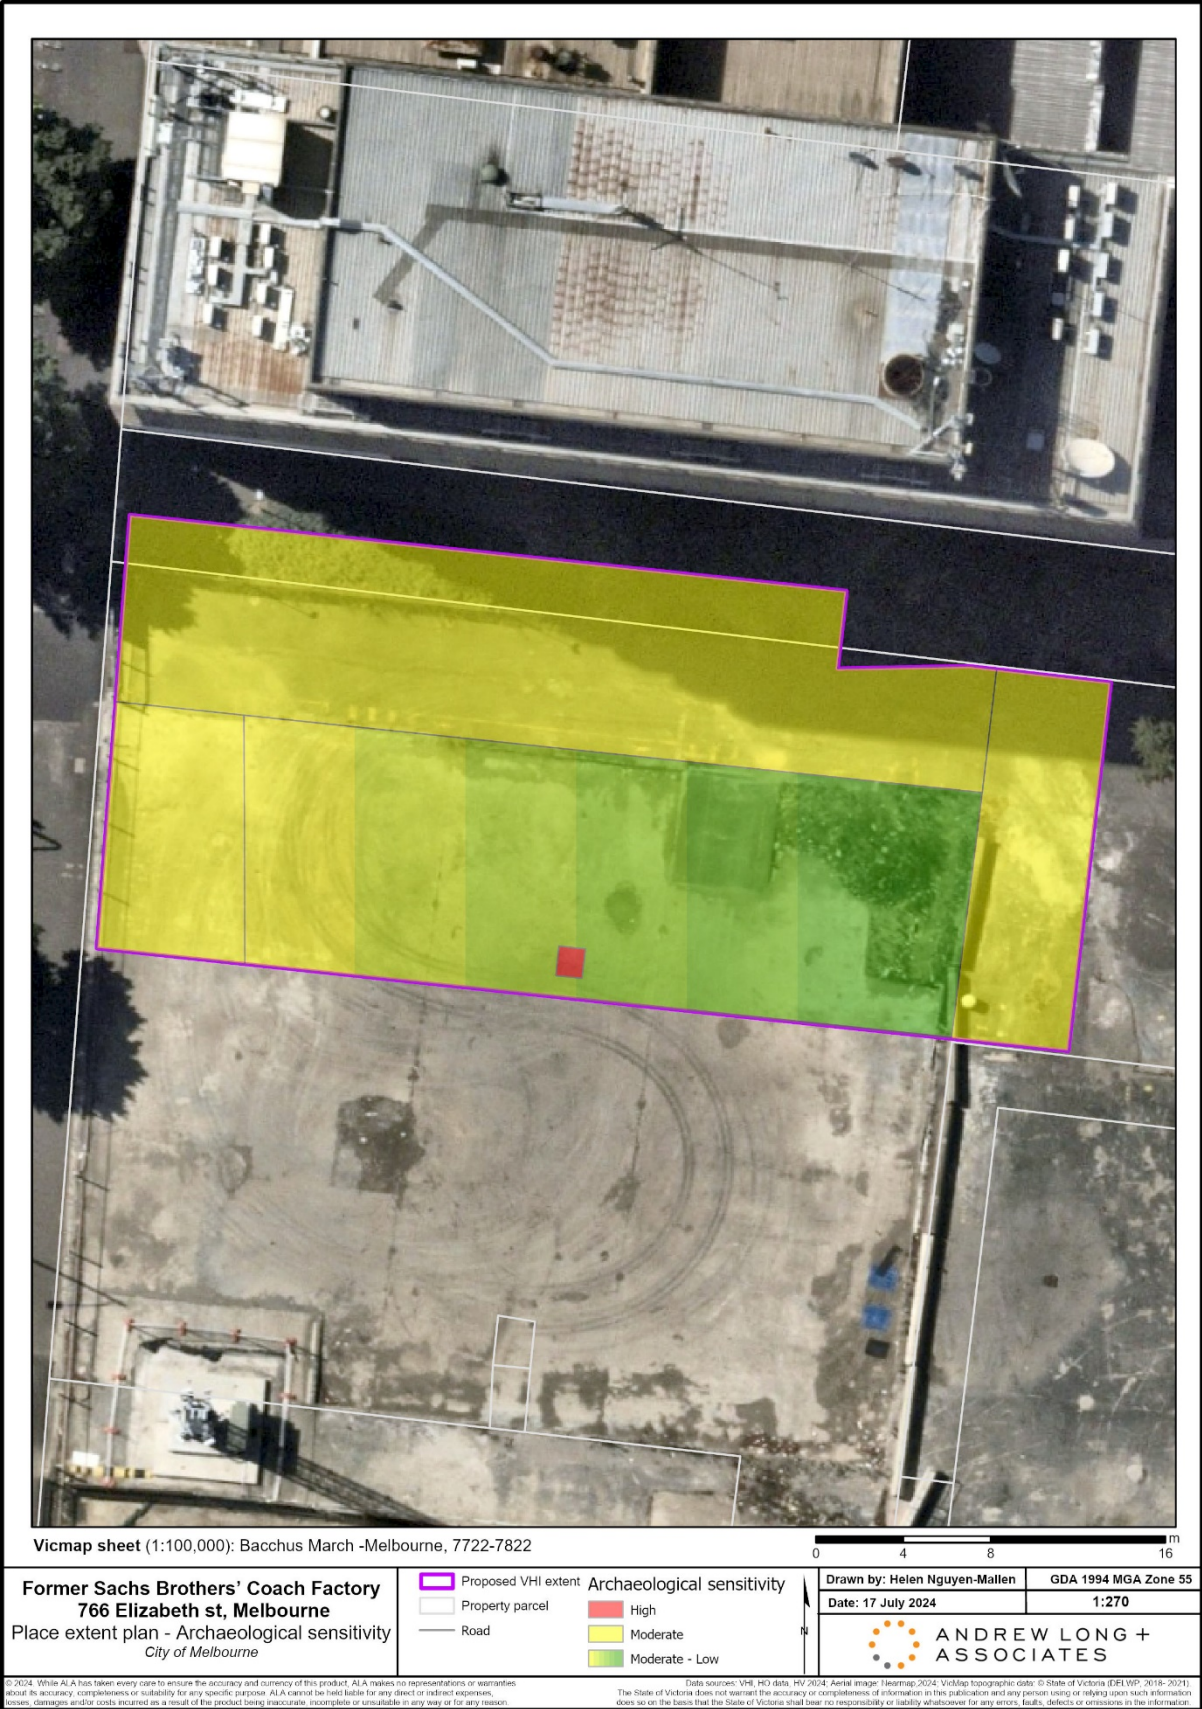
The site is of archaeological significance due to the likelihood of archaeological deposits remaining at the site. The probability of archaeological deposits ranges from 'low' to 'high' across the site (Figure 26), being lowest towards the deepest sections of the 1980s cut and 'moderate' in sections where the modern ground surface is level with the adjacent street level or where it follows the natural hillslope. The location of the water closet on the 1896 MMBW map has been marked as 'high', due to the potential of cesspit deposits being located in this area. Any archaeological deposits or features are anticipated to shed light on coachmaking activity undertaken onsite between the mid 19th century to mid 20th century, as well as potentially personal effects and recreational items associated with the workers employed at this site throughout this period.

Figure 26: Areas of archaeological sensitivity within the Former Sachs Brothers Coach Factory
