# Historical archaeological site card

CLOVER DAM CONSTRUCTION CAMP SOUTH  
H8324-0044

# Clover Dam Camps (North and South) Historic Survey Report

Prepared for Heritage Victoria and AGL

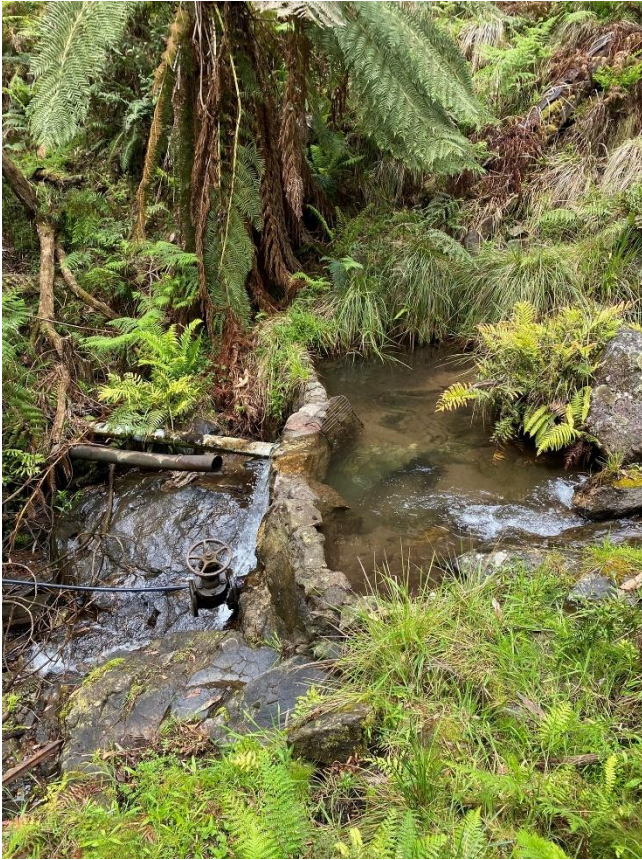
**Figure 4 Photograph of small weir (supplied by AGL)**

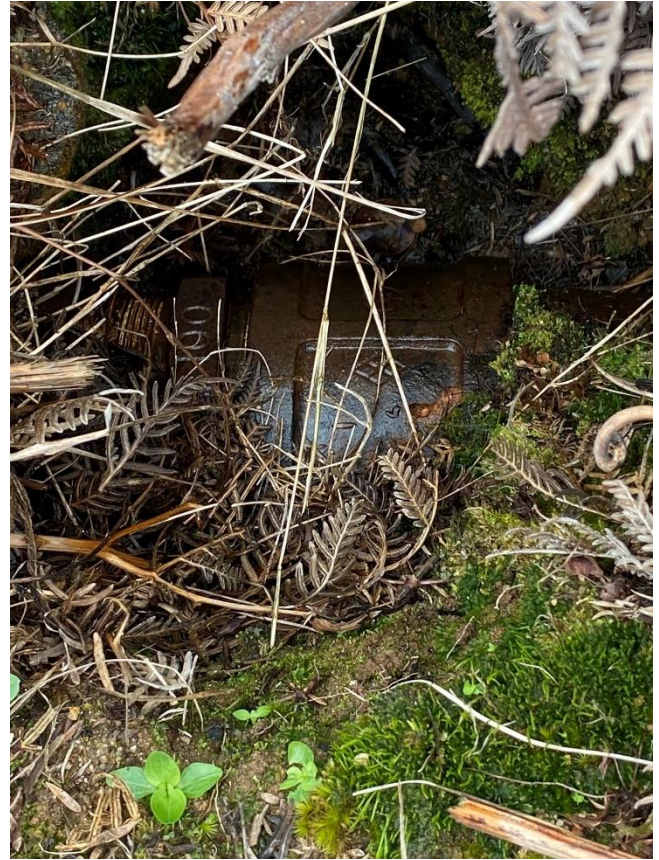
**Figure 5 Photograph of pipe associated with small weir (supplied by AGL)**

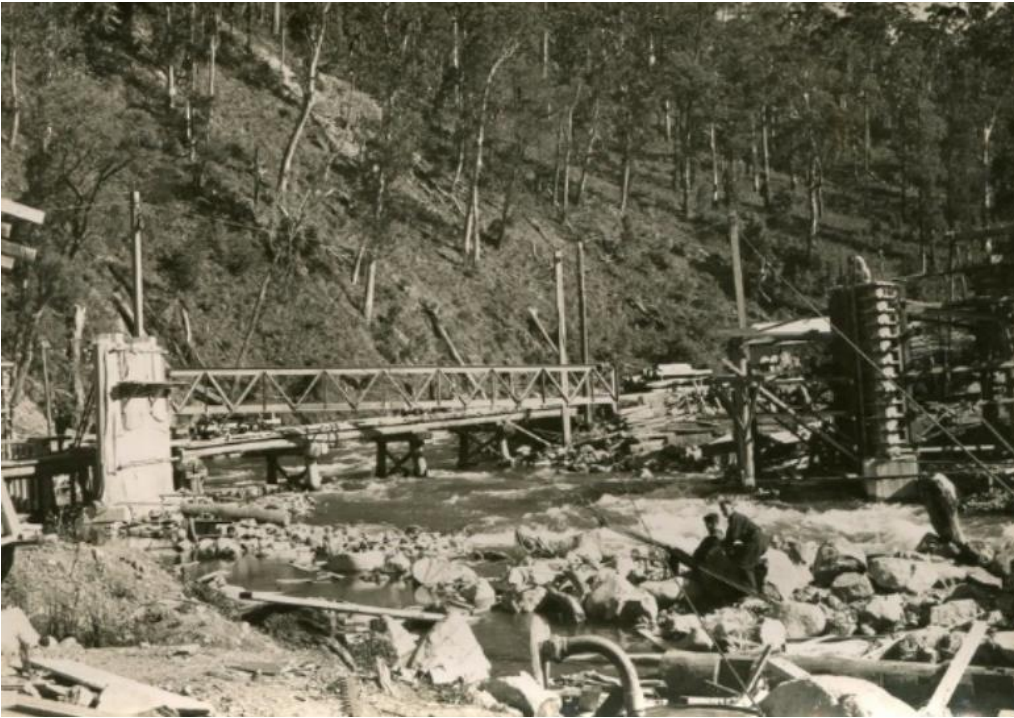
**Figure 7** Construction of Clover Dam Power Station bridge, with the power station site to the right of the photograph and the piles for the bridge under construction (Photographs - SECV - Clover Power Station, 1940s)

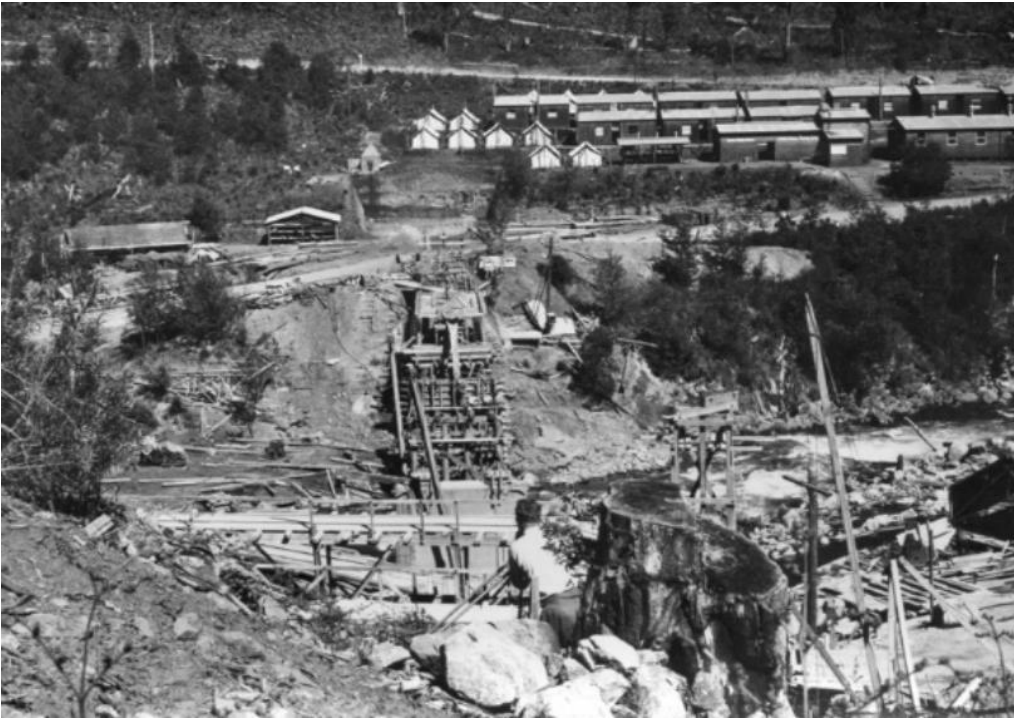
**Figure 9** Construction of Clover Power Station from the early 1940s facing west and overlooking worker accommodation (Photographs - SECV - Clover Power Station, 1940s)

Upon review of the plans of Clover Dam Camp (North) the benched area from the plan appeared to correlate with features visible from the satellite image. A review of photographs from the construction of the Kiewa system also revealed structures to the west of the Clover Dam Power Station (Figure 9).

There are two layers of benching between the Bogong High Plains Road and the power station, each approximately 1.5 metres high at the southern extent but converge to the same level at the access track to the north. The benches are overgrown with grass, obscuring the ground surface. There is no evidence of erosion or further modification. Concrete steps are present that lead from the lower benched area down to the level of the power plant. The location of these steps cannot be seen in Figure 9.

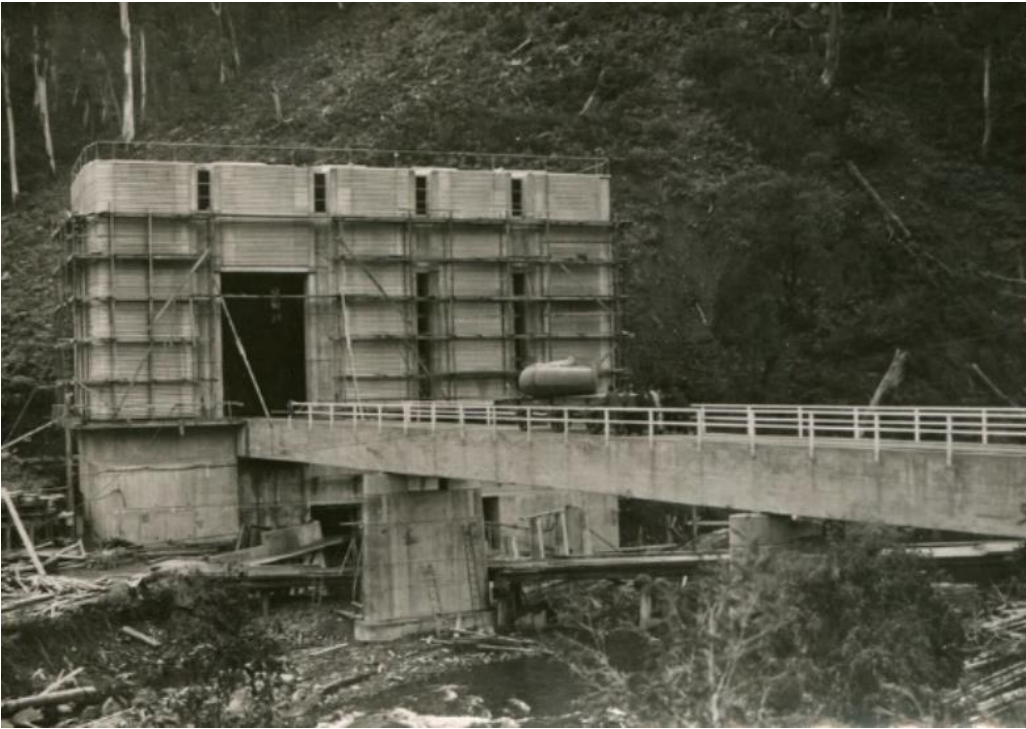
**Figure 11** Clover Dam Power Station nearing completion, with the tail-bay location at the bottom of the photograph (Photographs - SECV - Clover Power Station, 1940s)

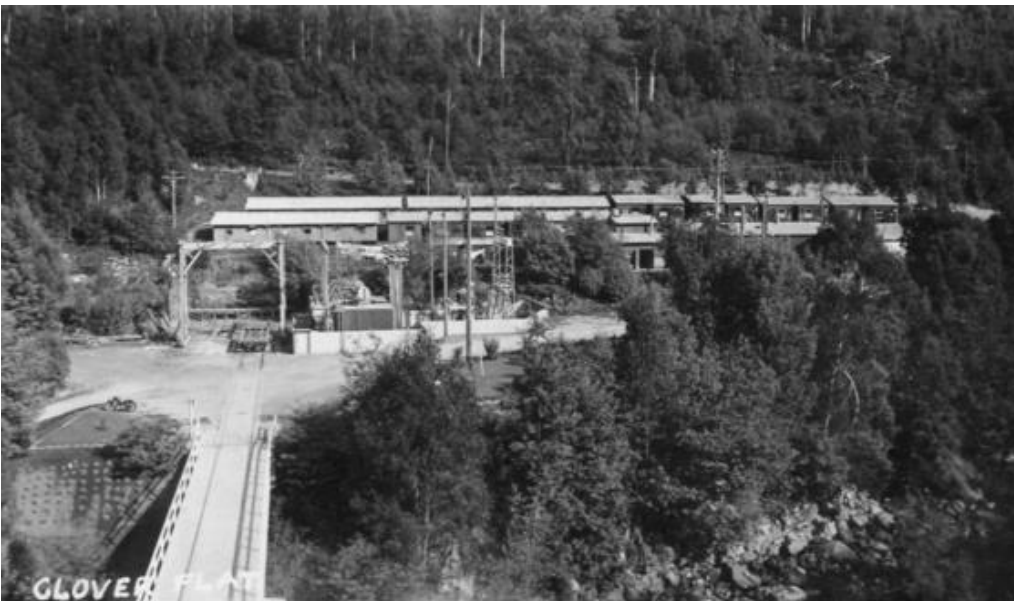
**Figure 12** Workers' camp location with the electrical infrastructure installed (Photographs - SECV - Clover Power Station, 1940s)

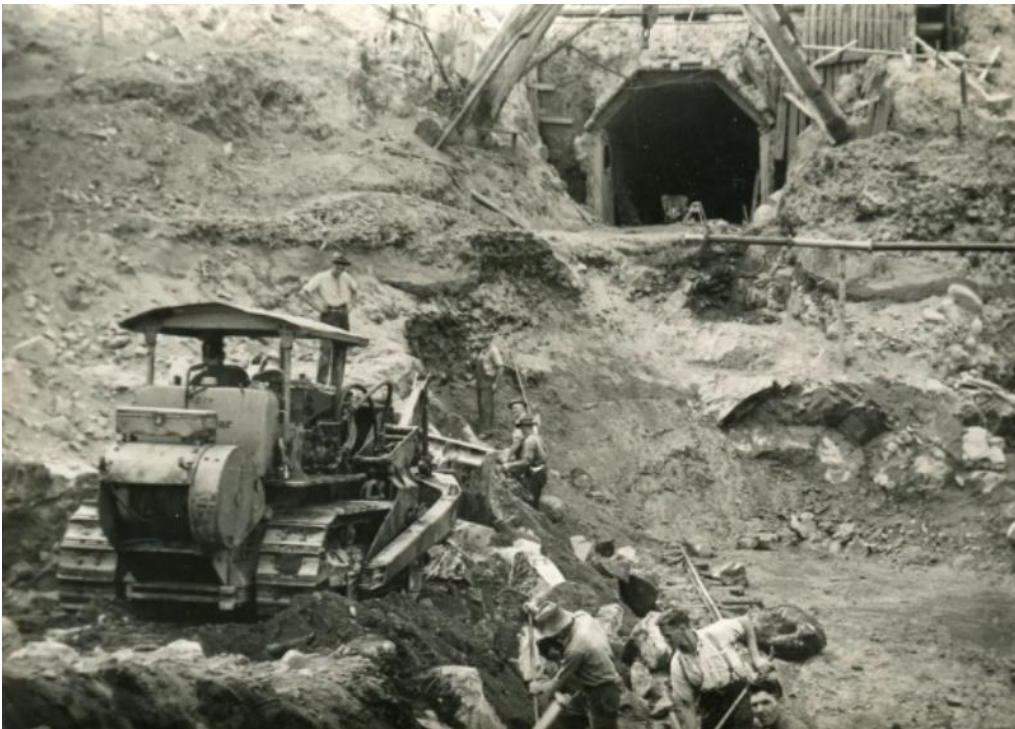
**Figure 13** Image of combined manual and mechanical excavation occurring during the Kiewa Hydro Scheme construction (Photographs - SECV - Clover Power Station, 1940s)

Figure 13 shows works on the tunnel and although does not include the study area has been included to show the use of machinery for excavation works. Given the scale of the work involved, mechanical excavation supported by manual excavation would have been a likely in most parts of the scheme.

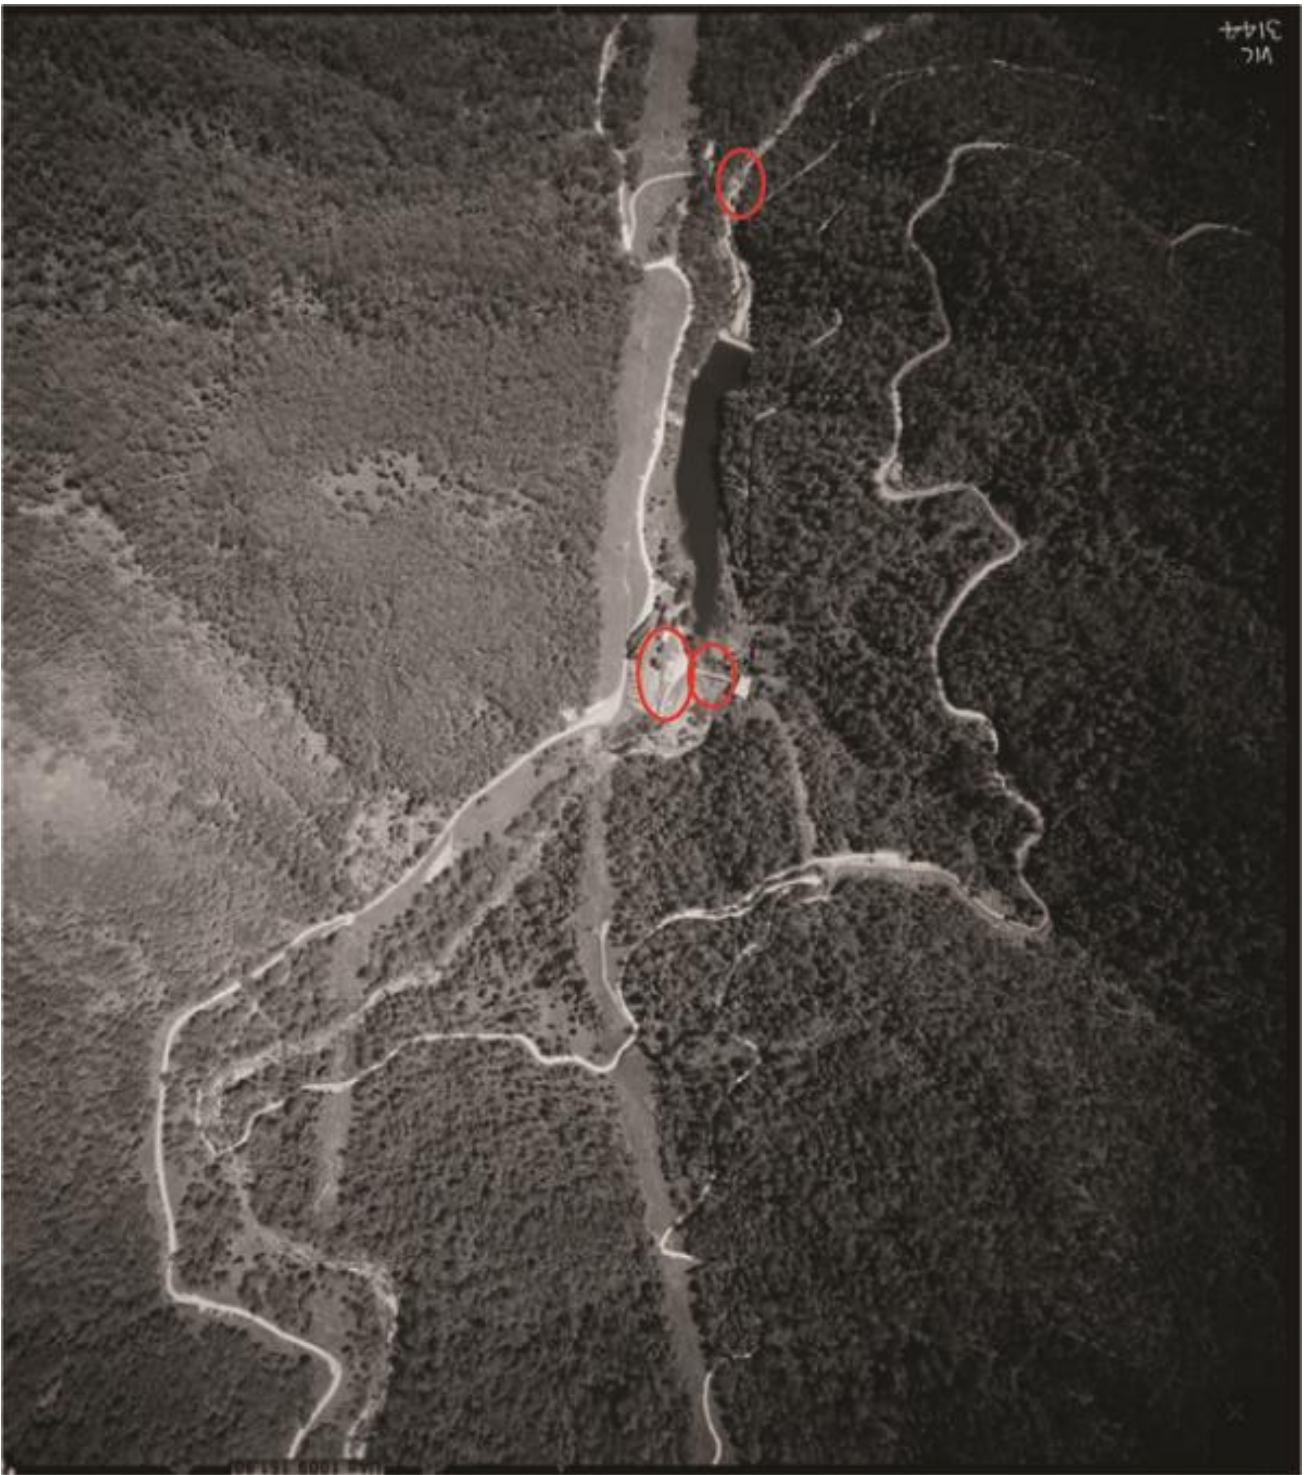
Figure 15 Aerial imagery of Clover Dam with the approximate study areas highlighted in red (Department of Land 1976)

The aerial images presented are from 1945 (Figure 14) and 1976 (Figure 15). While neither area of sufficient quality to gain much detail, there is obvious tree clearance in the study area in 1945 and likely ground disturbance also. The 1976 image shows a time where the power station would have been operational for some 30 years and the infrastructure seen in the photograph in Figure 15 can be seen.

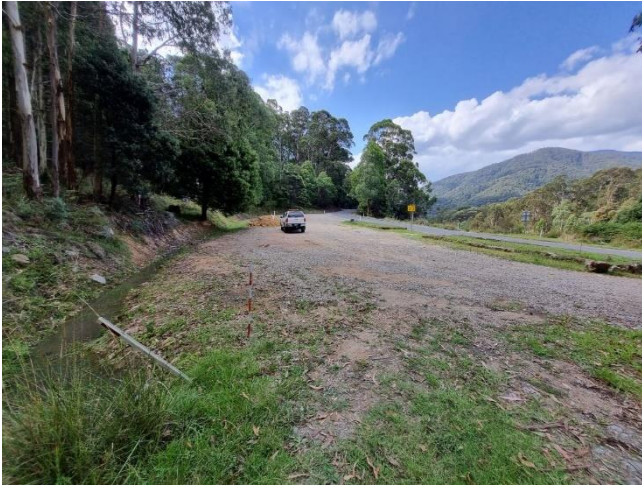
**Photograph 1** Carpark to the west of the Bongong High Plains Road in the Clover Dam Camp (North) area (marked as Playing Area in the original designs) (facing north, D.Carpenter 14 February 2024).

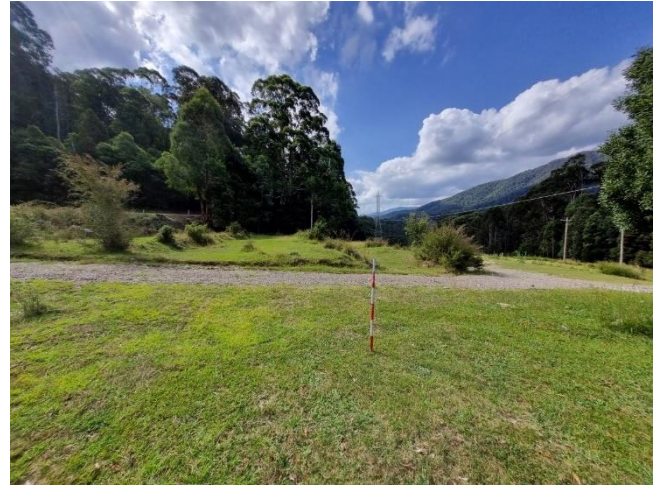
**Photograph 2** Northern part of Clover Dam Camp (North) area (marked as Recreation Hut and Hut 7 in the original designs) (facing north, D.Carpenter 14 February 2024).

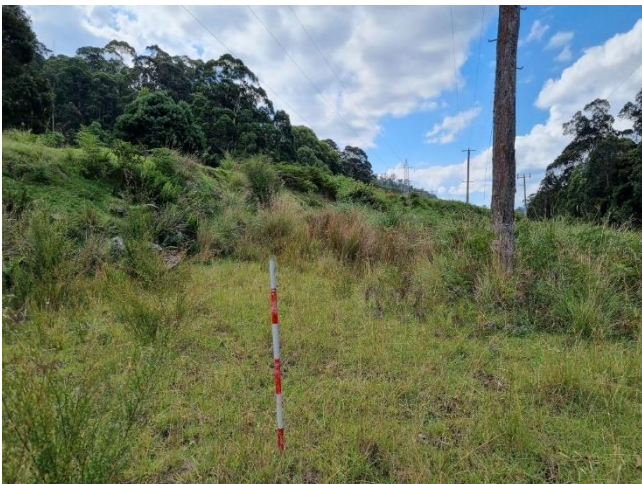
**Photograph 3** Northern part of Clover Dam Camp (North) area (marked as Huts 1 and 2 in the original designs) (facing north, D.Carpenter 14 February 2024).

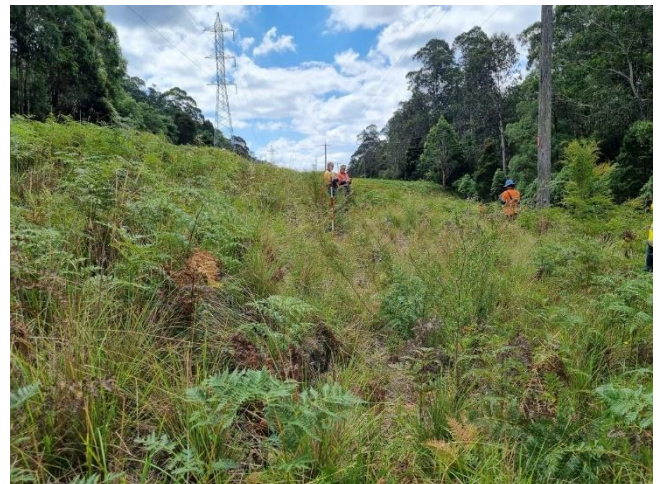
**Photograph 4** Northern part of Clover Dam Camp (North) area (marked as Huts 1 and 2 in the original designs) (facing north, D.Carpenter 14 February 2024).

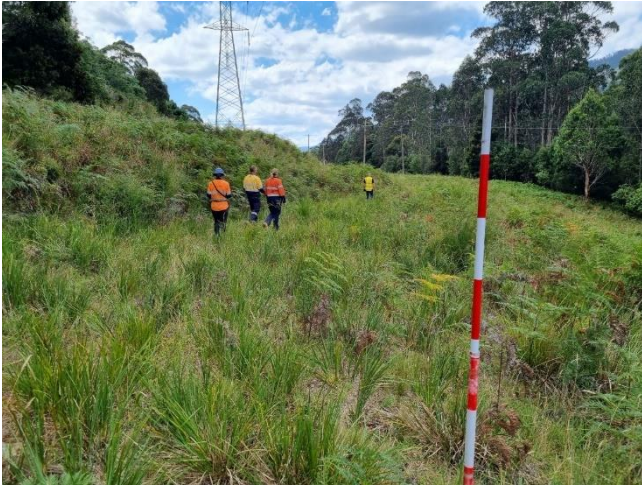
**Photograph 5 Northern part of Clover Dam Camp (North) area (marked as Huts 4 and 5 in the original designs) (facing north, D.Carpenter 14 February 2024).**

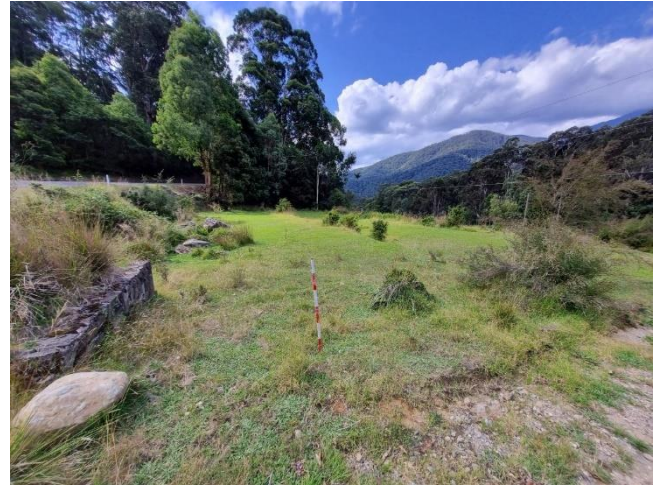
**Photograph 6 Vehicle entry to Clover Dam Camp (North) area (to the west of Mess Room and Kitchens in the original designs) (facing north, D.Carpenter 14 February 2024).**

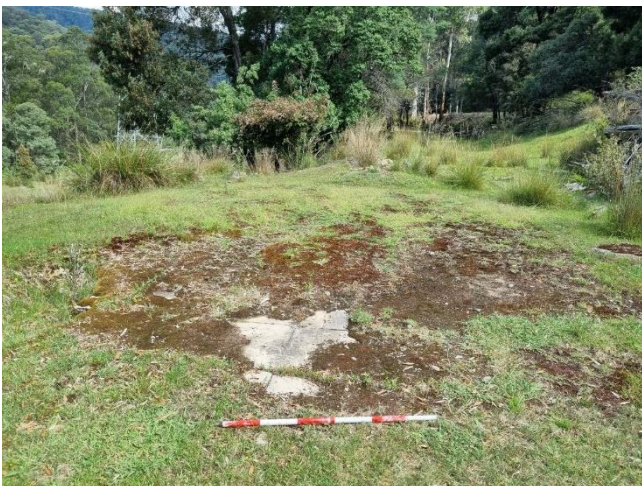
**Photograph 7 Concrete slab near vehicle entry to Clover Dam Camp (North) area. Possibly the base of the canteen (facing south, D.Carpenter 14 February 2024).**

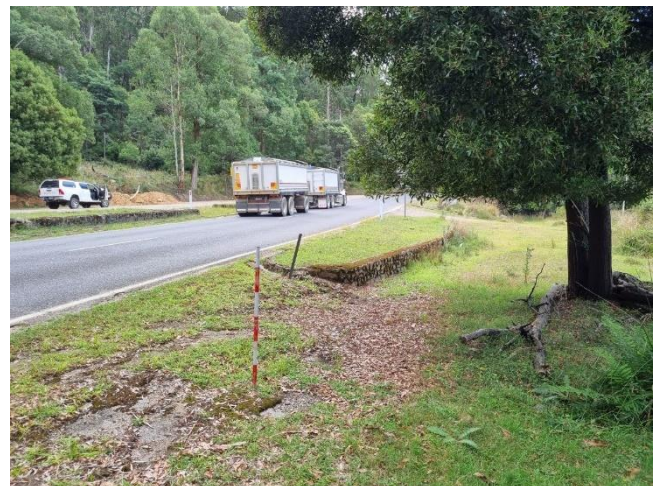
**Photograph 8 Vehicle entry to Clover Dam Camp (North) area (to the west of Mess Room and Kitchens in the original designs) (facing north-west, D.Carpenter 14 February 2024).**

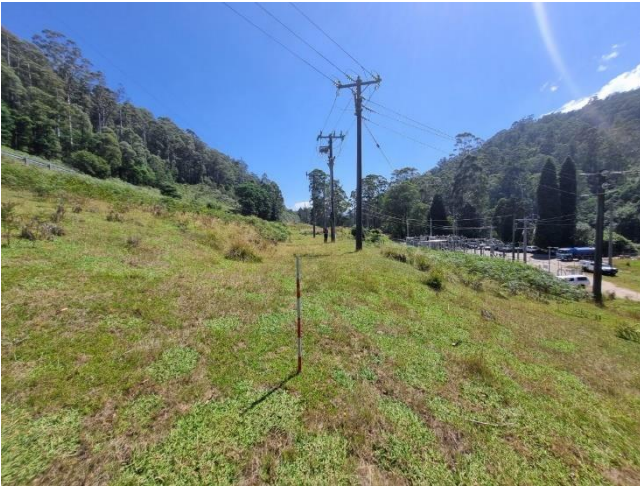
**Photograph 9** Benched area of Clover Dam Camp (South) area, taken from the south of the camp area (facing north, D.Carpenter, 14 February 2024).

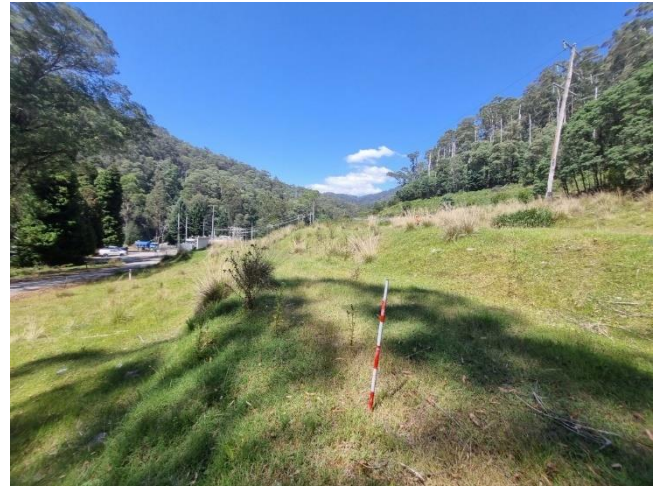
**Photograph 10** Benched area of Clover Dam Camp (South) area, taken from the north of the camp area (facing south, D.Carpenter, 14 February 2024).

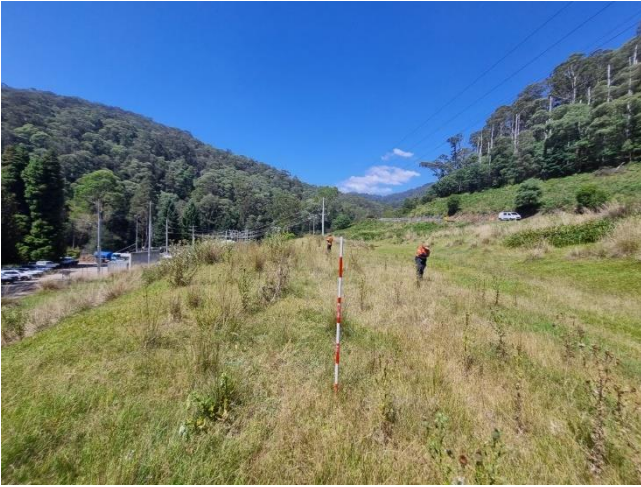
**Photograph 11 Benched area of Clover Dam Camp (South) area, taken from the north of the camp area (facing south, D.Carpenter, 14 February 2024).**

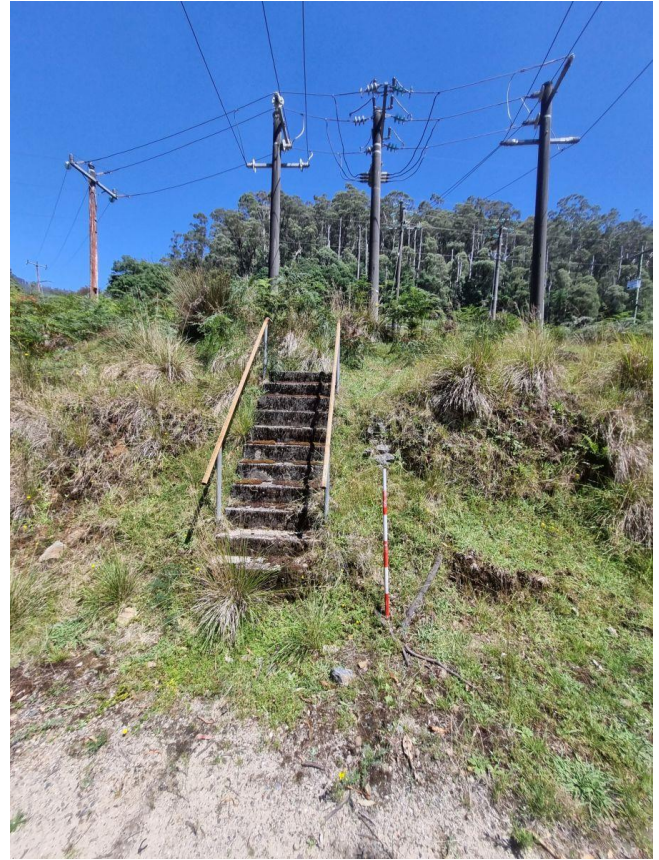
**Photograph 12 Existing concrete steps leading down from the lower benched area to the level of the power station (facing west, D.Carpenter, 14 February 2024).**

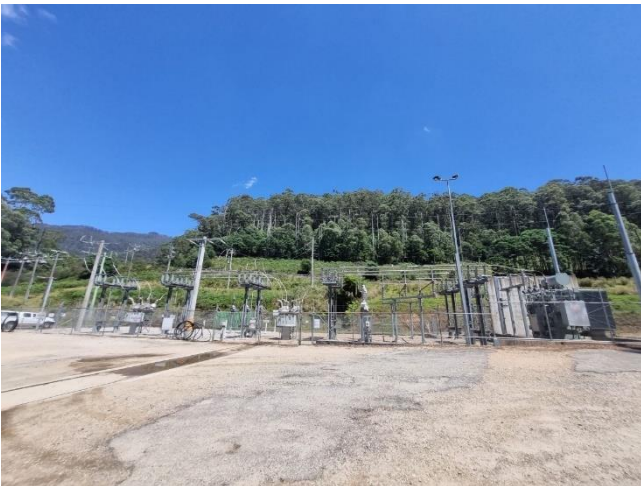
**Photograph 13 Benched area of Clover Dam Camp (South) area, taken from the east of the camp area near the power station with existing electricity infrastructure in the foreground (facing west, D.Carpenter, 14 February 2024).**

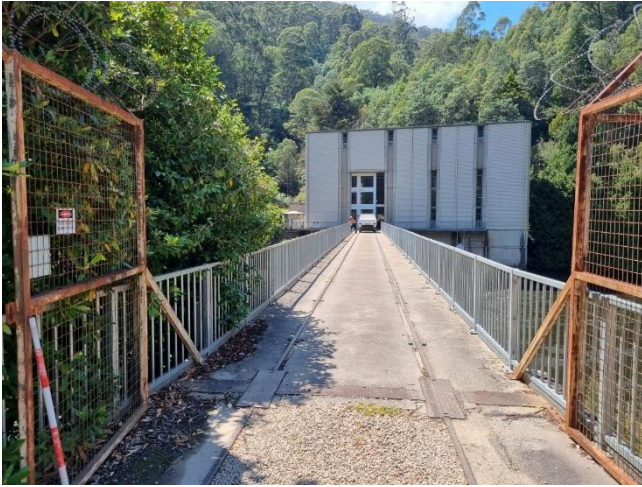
**Photograph 14 Clover Power Station, picture provided for context and reference purposes (facing east, D.Carpenter, 14 February 2024).**

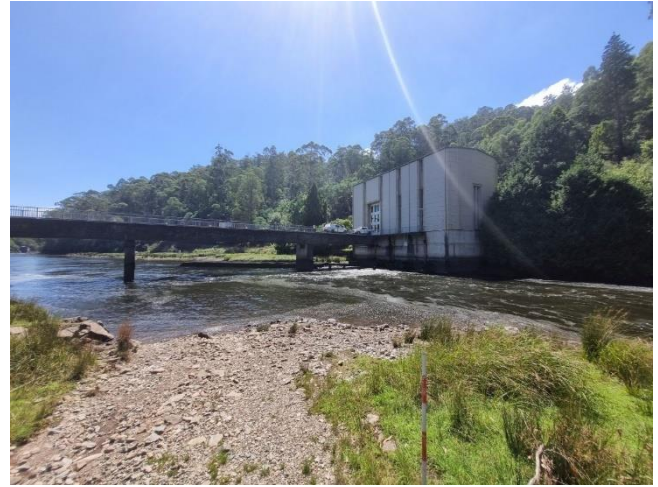
**Photograph 15 Clover Power Station, picture provided for context and reference purposes (facing south-east, D.Carpenter, 14 February 2024).**

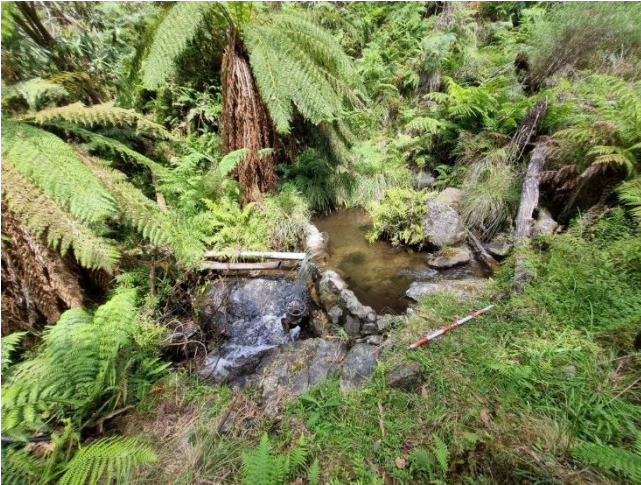
**Photograph 16** Small weir to the west of Clover Dam Camps (North) (facing south, D.Carpenter, 14 February 2024).

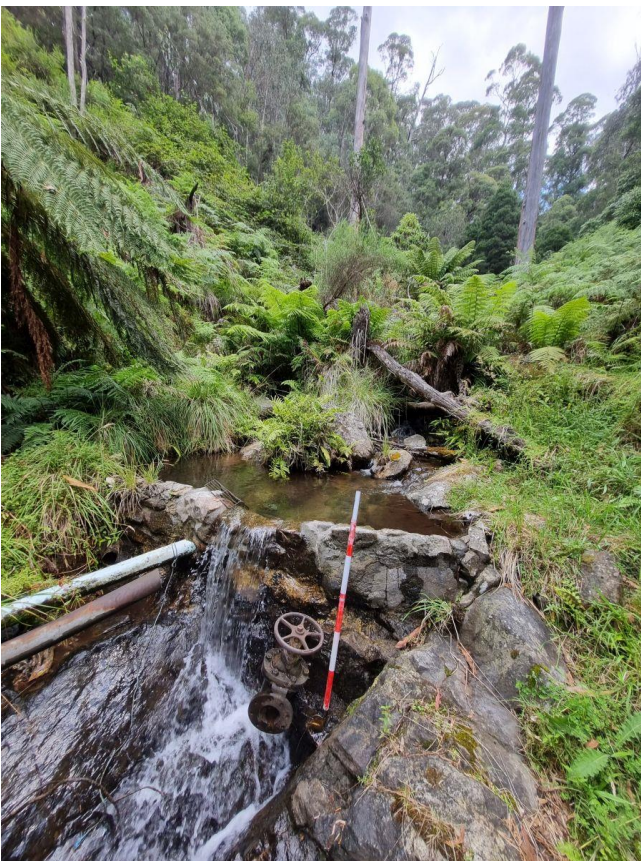
**Photograph 17** Small weir to the west of Clover Dam Camps (North) (facing south-west, D.Carpenter, 14 February 2024).

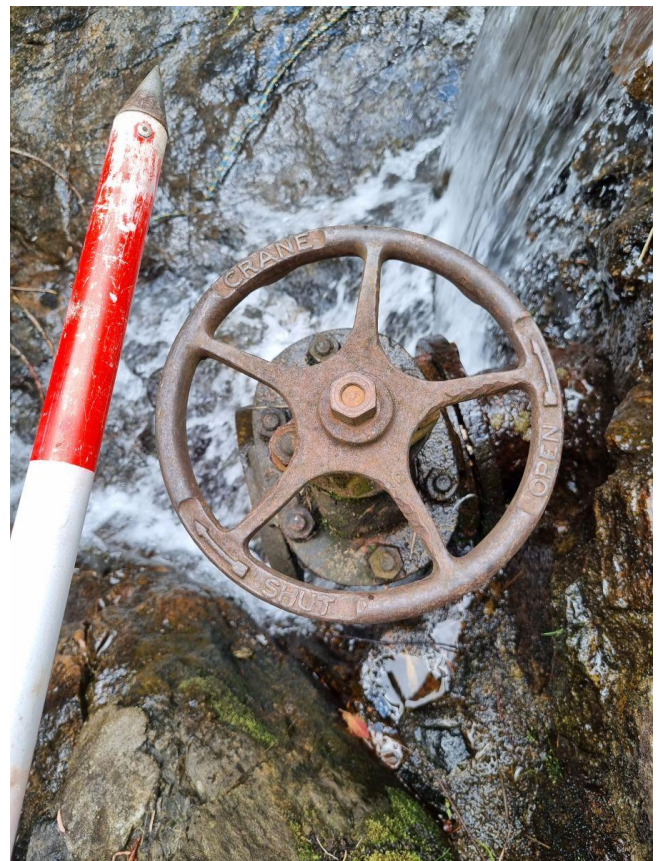
**Photograph 18** Disused scour valve embedded in small weir to the west of Clover Dam Camps (North) (D.Carpenter, 14 February 2024).

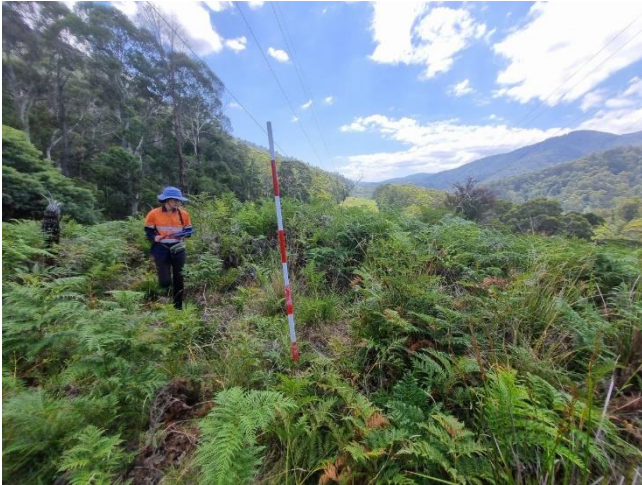
**Photograph 19 Context of location of exposed pipe (facing north, D. Carpenter, 14 February 2024).**

Approximately 150 metres to the north-east of the small weir, exposed sections of pipe were noted. The sound of running water could clearly be heard from these pipes indicating that they are still in use. This location is lower than the weir and it is likely this is the source of the water. The exposed pipe location is between the northern extent of the Clover Dam and it is possible that this water contributes to the dam.

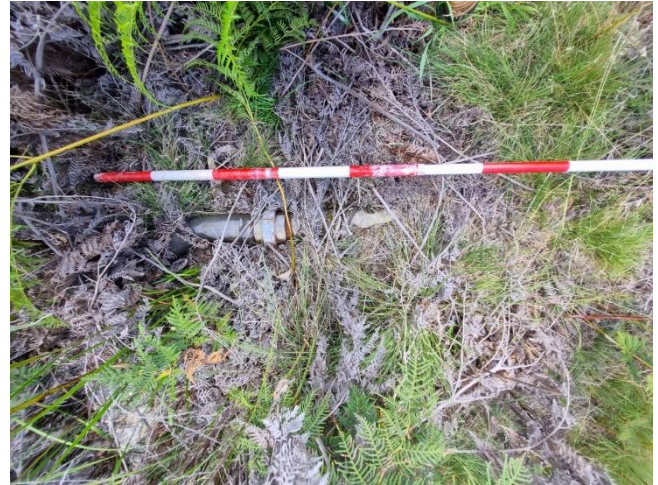
**Photograph 20 Exposed pipe (D. Carpenter, 14 February 2024).**

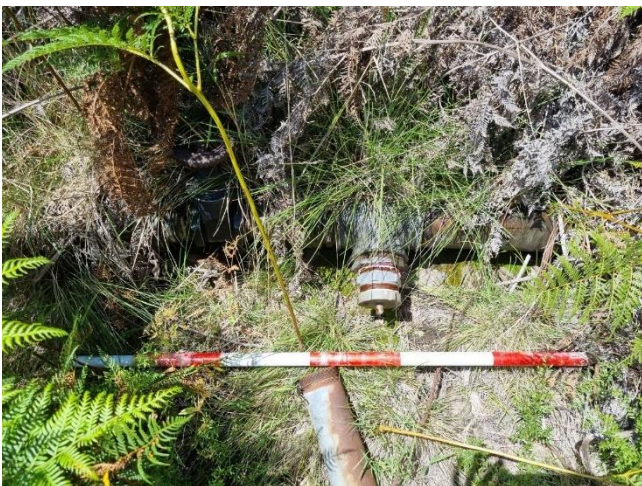
**Photograph 21 Exposed pipe (D. Carpenter, 14 February 2024).**

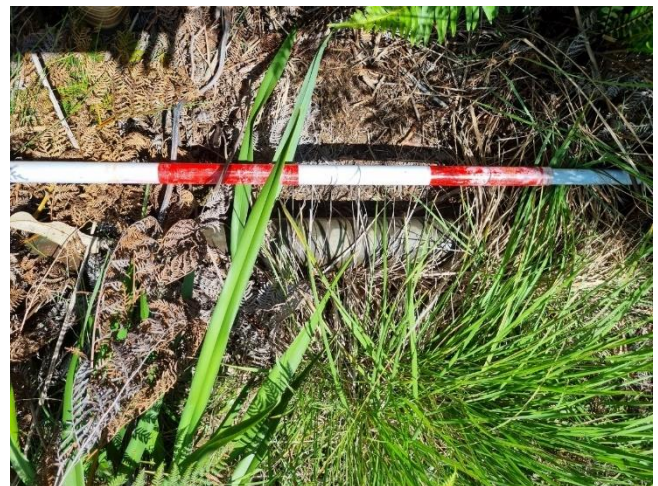
**Photograph 22 Exposed pipe (D. Carpenter, 14 February 2024).**
