FORMER OLYMPIC TYRE & RUBBER FACTORY 56 – 84 CROSS STREET, FOOTSCRAY

CONSERVATION MANAGEMENT PLAN

FINAL REPORT

JANUARY 2005

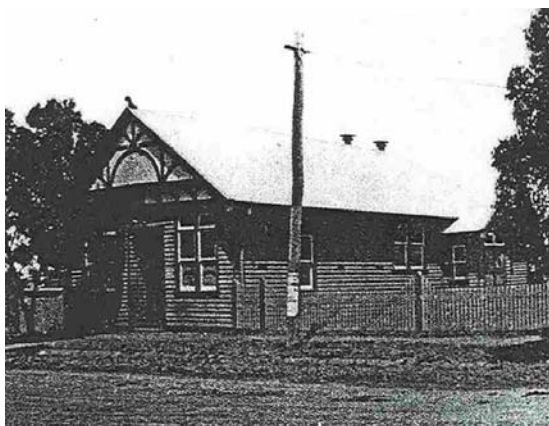
Image 2 Former Sunshine Mechanic Institute Library
Source: Olwen Ford, *Harvester Town*, p.146

The first Sunshine Library (Image 2) was built next to the Mechanics Institute Hall in 1912 to a design by J. Raymond Robinson. In the early 1920s it was moved across the road to Corio Street. It remained in use as the main Sunshine library until the late 1960s when a new library was opened in McCracken Street. The old building then became a branch library. From the 1970s it was used as a library store.⁷¹

Robinson designed the library when he was 21 years old in 1912 and although minor, is the first recorded example of his work. The simple rectangular weatherboard building displays some Old English Revival elements with gables projecting on brackets and curved half timbering in the gables.

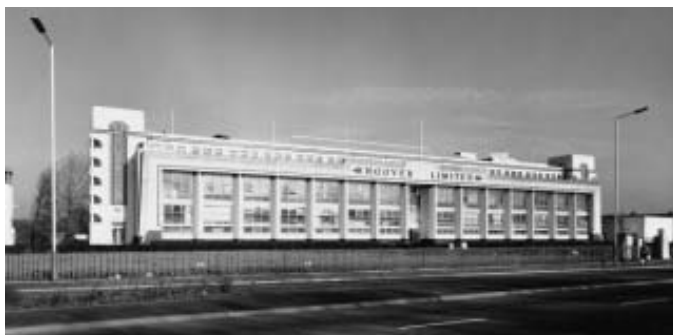
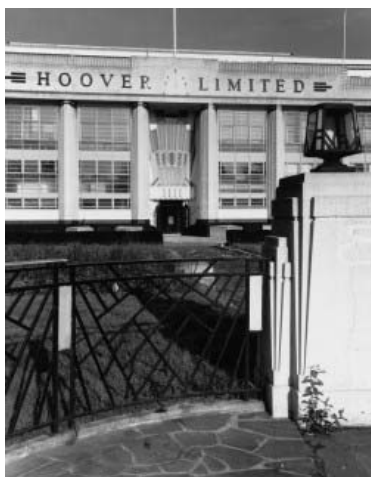
The Hoover Factory, designed by Wallis Gilbert and Partners (Images 15 & 16), was the office and factory for the Hoover Company from 1933. The glazed facade gives the appearance of a floorless expanse, although in fact it has several floors. The whole area of the ground floor was used as a workshop. The building was decorated with bright coloured faience (glazed ceramic) inspired by ancient Egypt. The floodlighting, which it still has today, was part of the original design scheme.

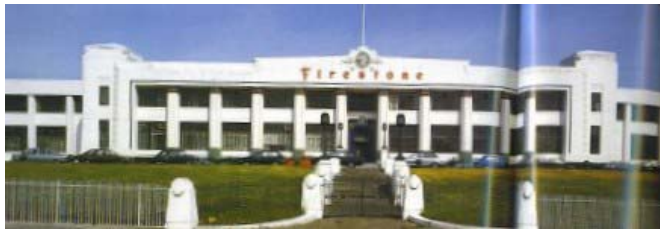
Image 17. Firestone Factory, London

Wallis Gilbert and Partners also designed the Firestone Tyre Factory (demolished, Image 17) and the India Tyre Factories of the same period. The Firestone Tyre Factory displayed a similar long facade to one of the Hoover buildings and a similar Art Deco Egyptian forms and detailing. The factories were known as Fancy Factories and represented a change in attitude overseas towards the design of factories, whereby the factory buildings played a part in promoting the and contributing to the successful pursuit of business.⁸⁸ Both factories were on sites on new main roads on the outskirts of London. Both were designed to catch the eye of passing motorists, who were potential customers.

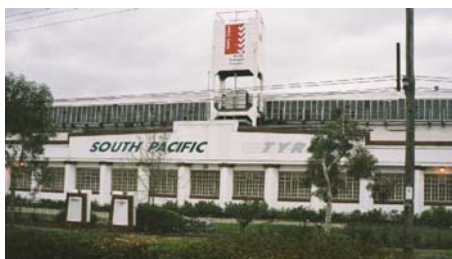
The showroom at the factory is designed in the art deco style with use of the Egyptian pylon motif. The use of Egyptian motifs in Art Deco buildings is generally attributed to public interest in the opening of the tomb of Tutankhamen in 1922. There are only a few known examples of Art Deco buildings in Victoria, which display Egyptian motifs. Some of these are quite elaborate with extensive use of Egyptian details such as papyrus capitals. The Emulation Hall Masonic Lodge, Rochester Road Canterbury and the Westpac Bank in Bourke Street (Godfrey and Spowers, 1929, VHR799) fall into this category. Another response was the more abstracted use of Egyptian massing derived from Egyptian temples, and particularly the motif of pylons flanking an entrance. The Wimmera Stock Bazaar is closely comparable to the showroom of the South Pacific Tyre Factory mainly in the use of the pylon motif.

Image 18. The showroom at the former Olympic Tyre and Rubber Factory showing the use of the pylon motif and the similarities with the two UK factories

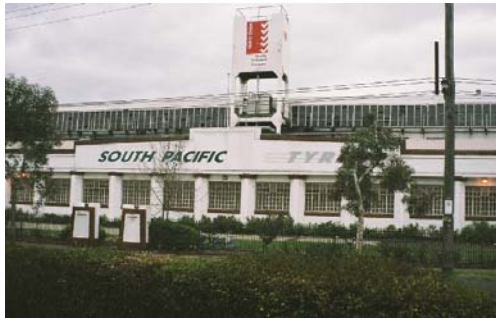
Photo 1. 1934 Showroom

The showroom extends along Cross Street now at the centre of the site (Site Plan Area 1). This section of the building is constructed of rendered brick in the Egyptian revival Moderne style (App. 2, Photo.1). It has a band of wrought iron windows along the front divided by brick corbelled fins with an entry door at either end. These entries have tapered brickwork articulation in an Egyptian style. Above the central windows is a pediment with the title South Pacific Tyres. It is assumed that this pediment originally contained the title Olympic Tyres. Face redbrick is used in the facade to highlight features in contrast to the substantially rendered walls. The render has been painted white. On the roof of this building, set back from the front is a tall concrete water tower on stilts.

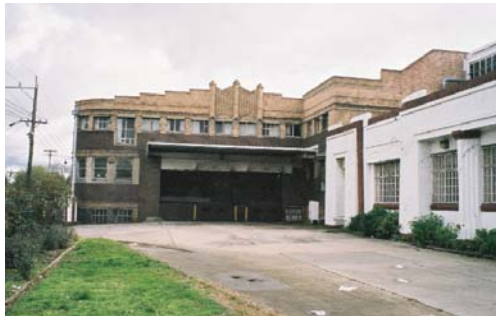
Photo 2. 1934 Office Building

Attached to this showroom at the western end is a three storey (one storey is a partially concealed basement) office building (Site Plan Area 2) constructed in cream and brown brick (App. 2, Photos 2 & 3). The cream brick is used around the windows while the brown brick is used in bands extending between the bands of windows. The building has a stepped parapet to the east elevation roof with cream brick corbelling and articulation like castellation in the Art Deco style at the centre of the elevation. The east elevation also includes a large loading bay (App. 2, Photo. 2). The centre of the south elevation contains the same detail. The corners to the building are curved. Other than the loading bay there are no access points from the Cross Street frontage directly into this building.

The front facade to the extent shown on the Section 5.5 Significance plan should be retained. The rhythm of openings to masonry is important to the design and should not be altered. Some window openings (refer to Photo 3, Appendix 2) have been extended downwards. This may be acceptable in other parts of this facade. The iron window frames to windows in this facade are corroding and causing cracking in the masonry. These windows may require replacement if corrosion treatment is unsuccessful. This is acceptable if the replacement windows reflect the patterning of the existing windows. Replacement windows would also give an opportunity to provide double glazing to this facade which would provide better blocking out of train noise.

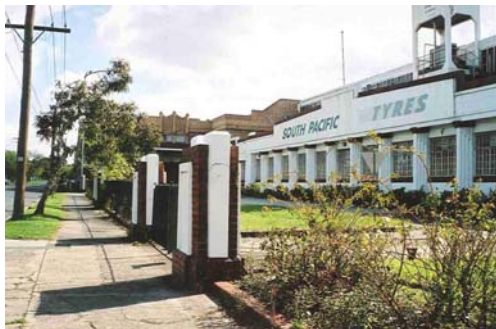
Photo 4. Front garden and fence

In front of the showroom are remnants of a formal garden and lawn area that is described in early accounts of the factory. A low fence also extends across the Cross Street boundary covering the length of the showroom. The fence infill is recent and appears to have replaced an earlier wrought iron fence infill. The original brick base to this survives with pillars in a similar style to the showroom exterior (App. 2, Photo. 4).

Conserve the existing interwar Egyptian Revival style fence pillars and the brick fence plinth. Although not shown with a fence infill between the pillars on the 1939 and 1951 sketches, the brick plinth provides evidence of an earlier fence in this location. If evidence of it can be found, it may be reinstated, if desired. Otherwise keep the fence infill between the pillars as a secondary visual element. This will be achieved by the following:

The missing fence pillars can be reinstated, if desired. Oral evidence⁹⁰ supports the fact that they were in place as shown on the 1939 sketch until relatively recently.

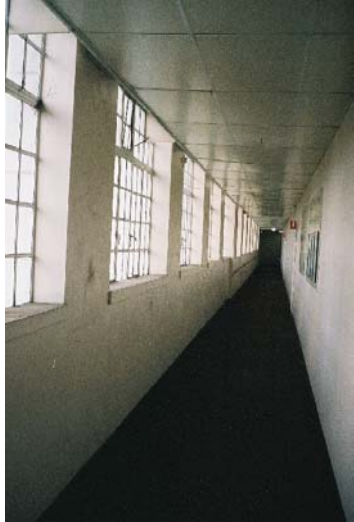
Photo 5. Interior view of the front windows to the showroom

The interior of the showroom building contains a passageway to the front (App. 2, Photo. 5) and a long showroom behind extending across the length of the building. The passageway has a recent suspended ceiling while the ceiling to the showroom is pressed metal (App. 2, Photo. 5). It is likely that the passageway and showroom were originally one space. The floor to the showroom building is timber. In the passageway the floor is covered with carpet but in the showroom the timber boards are currently exposed.

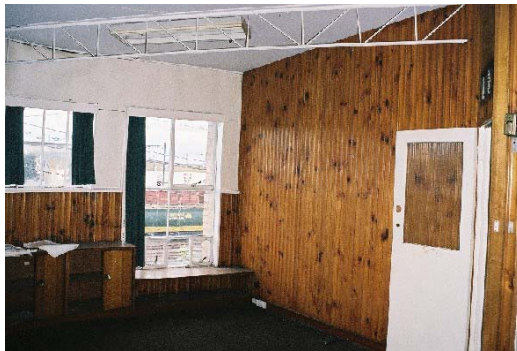
Photo 7. Main office in 1934 Office Building

The interior of this building is mainly open office space with little decoration (App. 2, Photo. 8). The south east corner on the first floor appears to be the main office. It has timber lining and commands views across the front of the factory site (App. 2, Photo. 7). Some of the office partitioning is likely to be original.

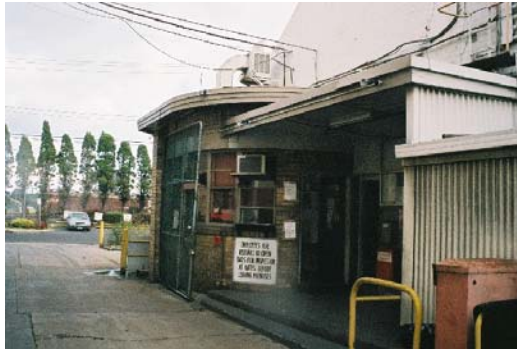
Photo 9. The Gatehouse

At the east end of the showroom is a cream brick curved gatehouse with a flat roof. This is the security office for the site (App. 2, Photo. 9).

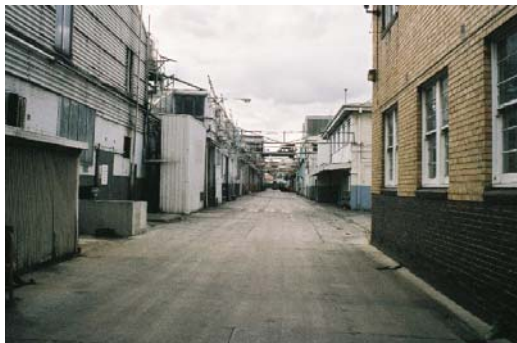
Photo 10. View down main roadway from the entrance

Generally the earlier area of workshops consists of an open area formed by sawtooth roofed bays. The roof is supported by a grid of square Oregon posts with saddle beams and half timber trusses and some areas have fibre board or asbestos ceiling lining with timber strapping (App. 2, Photo. 11). This detail appears to date from the 1930s. The exterior walls to the workshop sections are clad in a combination of brick and corrugated iron or corrugated asbestos sheet. It is assumed that the sheet cladding would have been progressively removed and replaced as required (App. 2, Photo. 10).

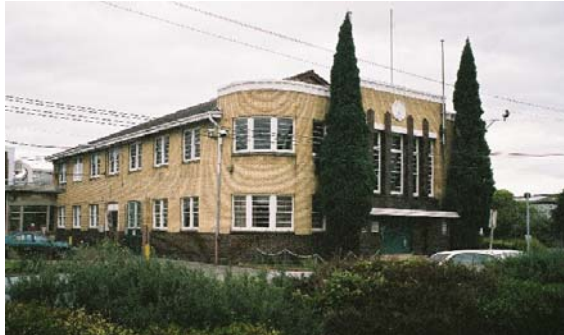
Photo 14 1939 Administration Building

The administration building is detached from any other buildings and is located at the east end of the site (Site Plan Area 6). It is a Streamlined Moderne building at the front with curved corners and some stripped classical detailing. The rear of the building has simpler detailing with square corners and less detailed brickwork (App. 2, Photo. 14).

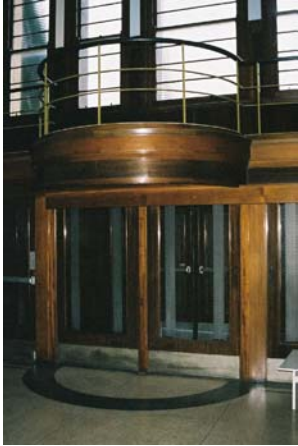
Photo 17 Revolving door and landing in foyer of 1939 Administration Building

Photo. 17). This revolving door leads to a double storey foyer space with two mezzanine stair landing levels. The first stair landing level is mid-way between the ground and first floor and provides a platform across the front of the building. This was probably used for presentations as there is a semi circular balcony following the line of the revolving door below. The second mezzanine landing provides entry and access to the first floor offices (App. 2, Photo. 15 & 18). The walls to the foyer space are timber panel lined to door head height with Art Deco style capping to the panelling. The panelling follows the line of the stairs and continues across the mid landing and there is also panelling to the extent of the landing space on the first floor. The remainder of the walls are painted plaster. Doors leading off the foyer are timber panel with circular windows in the upper section (visible in App. 2, Photo. 16).

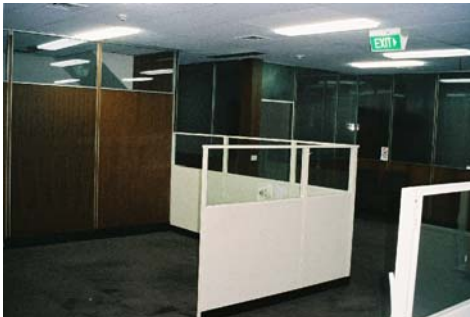
Photo 19 Open plan office space with partitions behind the foyer of the 1939 Administration Building

The office area behind the foyer is a generally open plan office with some glazed partitioning dividing the space into offices. The walls are painted plaster and a false panel ceiling has been installed in more recent times. Generally the original features remain, such as the timber panel doors with circular windows in the top part, the cornices and the window details. The original strongrooms still remain in the building. Later changes like the office partitioning and dropped panel ceilings (App. 2, Photo. 19) could be removed with little damage to the original building fabric. The timber floor of the ground floor offices, particularly in the southwest side is badly cupped and distorted due to moisture penetration.

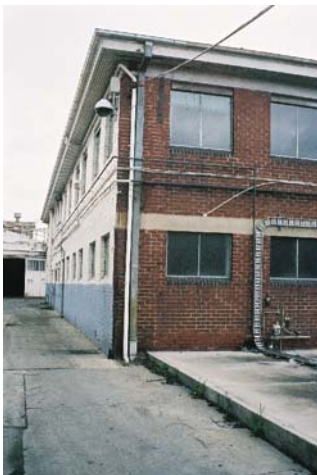
Photo 20 Staff Amenities Building

There is a two storey brick staff amenities building located behind the 1939 administration building. This has been painted white to three sides however the east side of the building remains unpainted. It is assumed that the building was originally unpainted revealing the details of render banding at window head height and the dark tile brick sills contrasting with the red brick. This is the only architectural detailing of note to this building as it remains substantially unadorned. The windows are aluminium framed; but these appear to have replaced the original windows which are likely to have been timber. The roof to this building is hipped with corrugated sheet cladding.

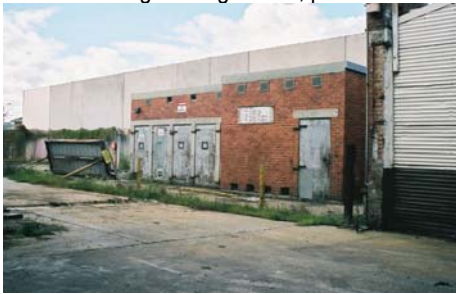
Photo 22 Brick Storage Building (labelled 11 on site plan)

There is a chemical storage building towards the rear of the site on the east side of the main factory roadway (Site Plan Area 11). This is a standard storage building found on a number of industrial sites and not of architectural value (App. 2, Photo. 22). It provided storage for dangerous materials that need to be stored separately with limited exposure to the exterior environment.
