CITY OF GEELONG WEST

URBAN CONSERVATION STUDY: BUILDING IDENTIFICATION FORM.

BUILDING ADDRESS <i>302 Autumn Street</i>	Type <i>Residence</i>	Original Use <i>residence</i>
---	--------------------------	----------------------------------

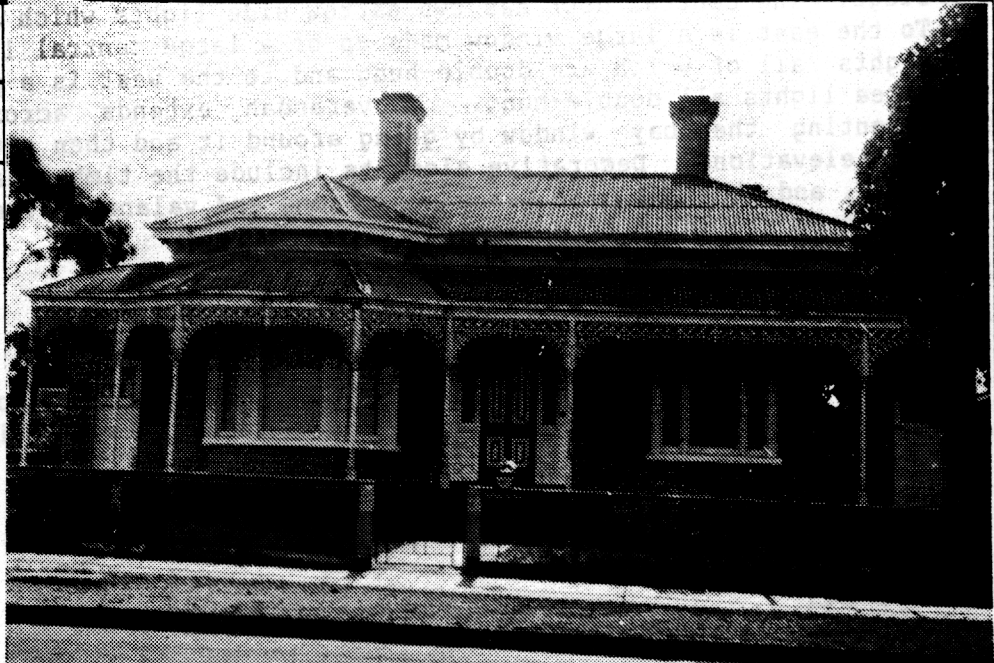
MATERIALS
 walls *weatherboard* roof *corrugated iron*

CONSTRUCTION DATE *c. 1890* source *stylistic features*

The single storey building is clad in weatherboards and the hipped roof is clad in corrugated iron. Two imposing stuccoed chimney's protrude from behind the roof ridge. The central door has two narrow side lights which are made of stained glass. To the east is a large window made up of a large central light and two narrow side lights all of which are double-hung and to the west is a projecting bay window with three lights all double-hung. A verandah extends across the front elevation accenting the bay window by going around it and then returning along the east and west elevations. Decorative elements include the timber eaves brackets and fascia board, and the cast iron verandah columns and valance. The east and west verandahs have been filled in at a later date.

302 Autumn Street is a substantial circa 1890's timber house with a good degree of integrity. It is a typical design for the period however it is unusual in Geelong West. It is of local significance.

Restoration of the east and west verandahs would greatly enhance the character of this building as would a more appropriate fence.
