## 3.0 PHYSICAL SURVEY

### 3.3 Hard Landscape Features

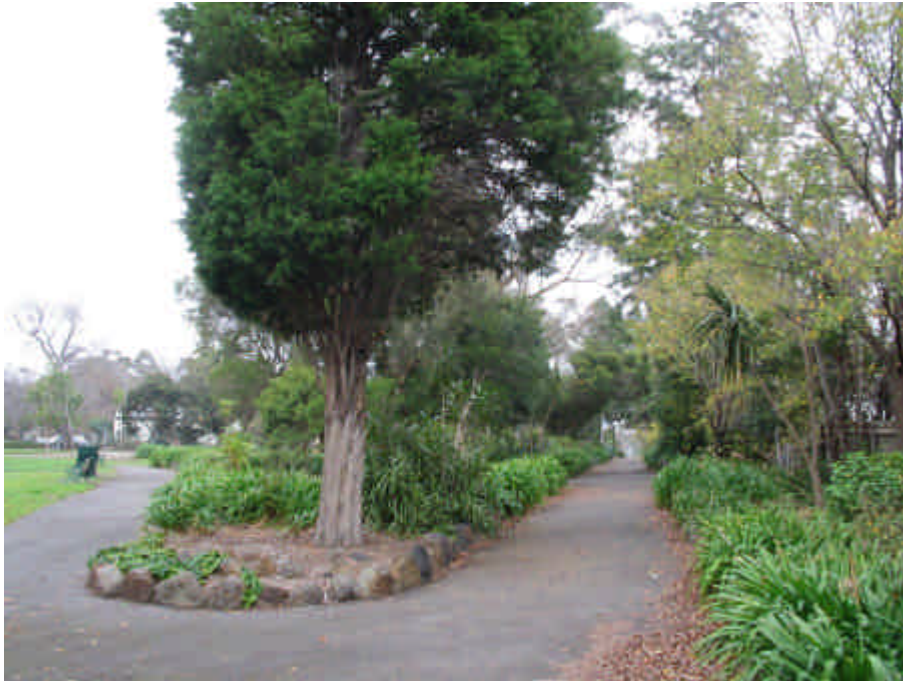
### 3.5.3 Triangular Bed

There are a number of mature elms (*Ulmus x hollandica*) and Eucalypts (*Eucalyptus cladocalyx*, *E. camaldulensis*) located within this section in varying condition. The elms appear to be contemporary with those located in the elm avenue immediately to the east.

Assess, manage and replace the mature trees as part of an ongoing tree management plan for the Park.

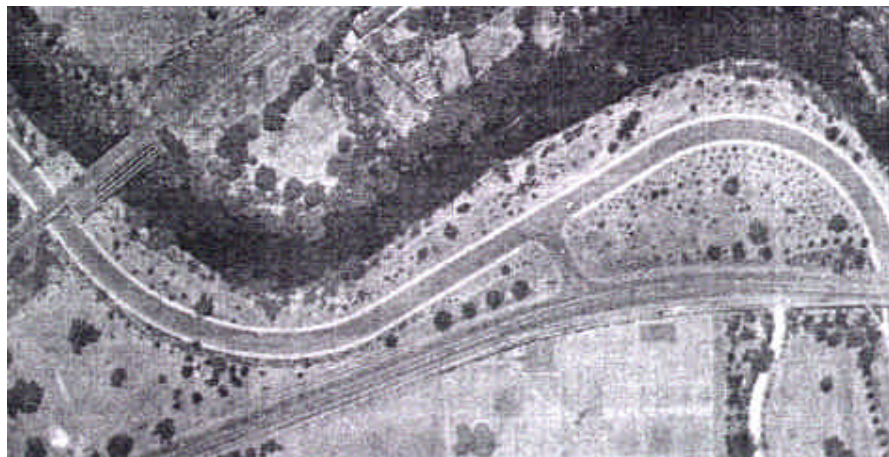
*Figure 20 Detail of 1945 aerial photograph.*

Aerial photographs dated 1945 show very few mature trees were present in this area, though regular rows of smaller plantings are visible. The majority of mature trees are therefore likely to be associated with the Yarra Boulevard construction works.

Manage all mature trees within the area in accordance with a Tree Management Plan to ensure their ongoing contribution to the amenity of Burnley Park and the adjacent streetscape.

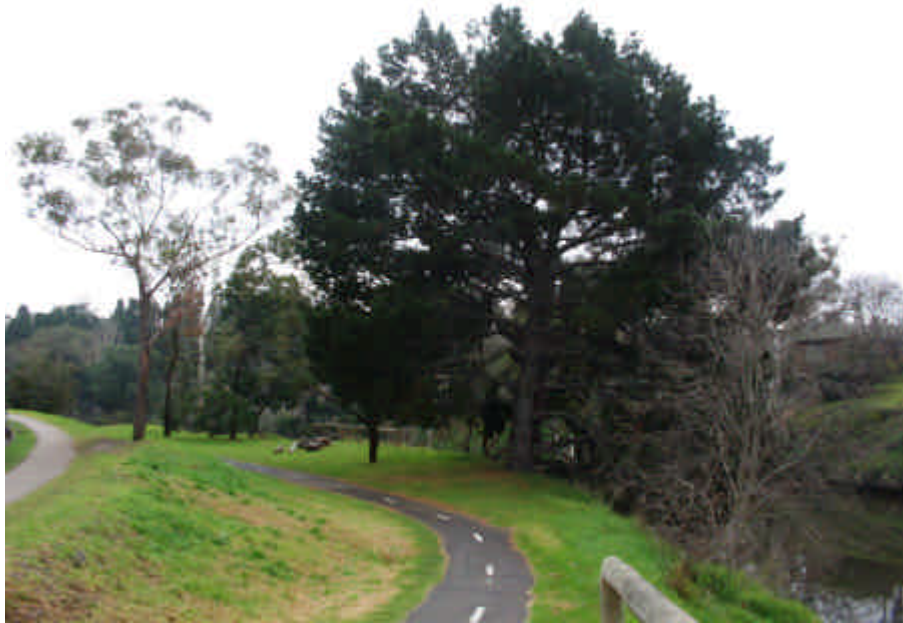
### 3.5.9 Yarra Parkland, Railway Bridge to Swan Street Bridge

This section was once part of a broader, continuous area of the Park that also included what would become the Circus Site, sandwiched between the railway line to the north and Swan Street to the south. Paths shown on the 1921 Plan of Richmond led through this area to Swan Street, opposite the entry to Burnley Horticultural College.

Replant as required, utilising a suitable palette of locally indigenous species.

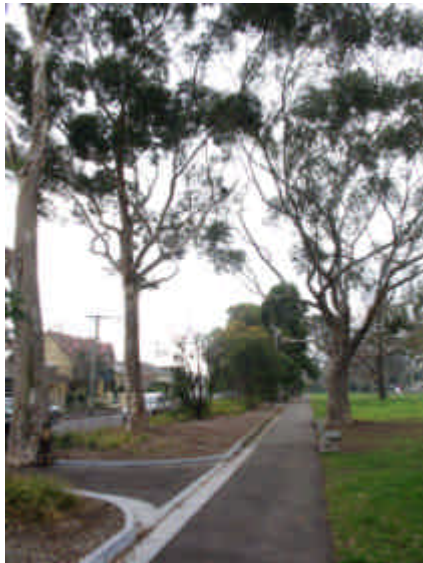
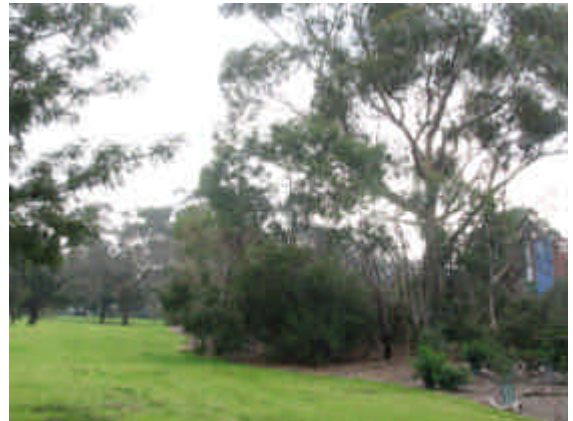
### 3.5.10 Other Garden Areas

has been extensively replanted with a palette of predominantly native species. Other beds forming part of the extensive rockeries which have retained their rock edging, are generally in poor condition, dominated by survival species and weeds.

The extensive rockery and garden beds that ran from the south western corner of the study area northwards to join with the rockeries associated with the construction of the Yarra Boulevard are much altered or are generally in poor condition. The rock edging has been removed from the southern section between Swan Street and Brooks Street and replanted in a more contemporary style utilising mass plantings of native understorey species and juvenile trees, including Eucalypts (*Eucalyptus* spp.), Brush Box (*Lophostemon confertus*), Illawarra Flame Tree (*Brachychiton acerifolius*) and White Cedar (*Melia azedarach* var *australasica*).

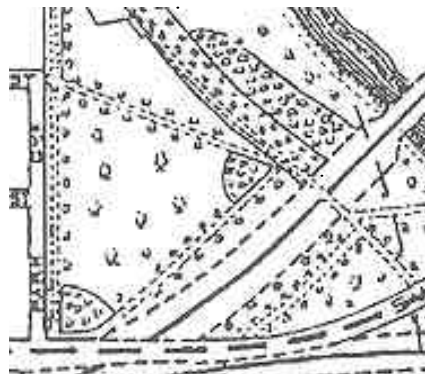
*Figure 21 Detail of 1921 Plan of Richmond showing garden beds in southern section of site.*
