Conservation Management Plan
Fernlea
75 Tuckers Road, Clyde, VIC 3978

17 SEPTEMBER 2020 – FINAL DRAFT

Prepared for Verve Projects Pty Ltd on behalf of the Owners of Fernlea

GJM Heritage

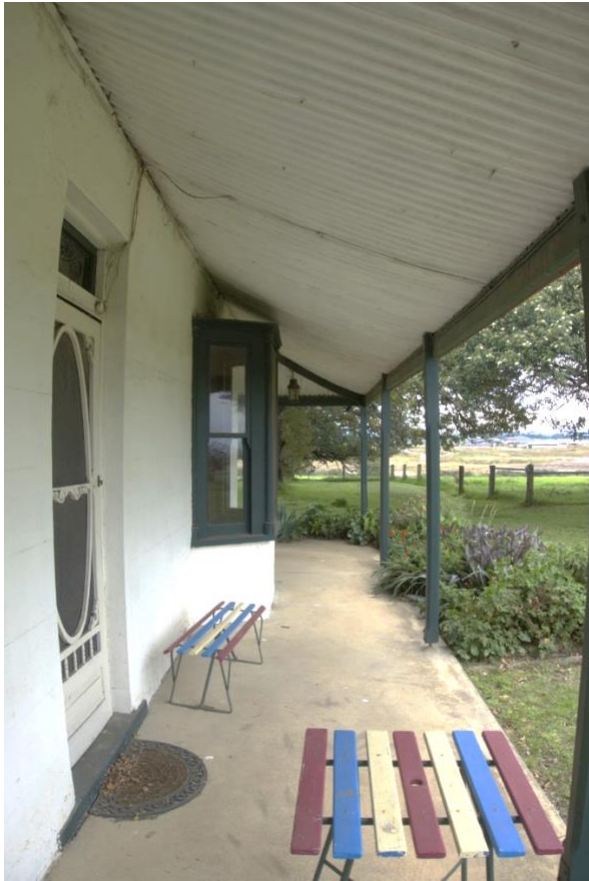
Figure 21. Detail of east (front) elevation showing convex, self-supporting verandah and bay window

The house at 'Fernlea' is a single-storey brick building with U-shaped hipped roof and concave verandah which extends around the house (Figure 20). The verandah is an extension of the main roof, forming a broken-back form, and is supported on stop-chamfered timber posts. It is a self-supporting structure of galvanised corrugated iron with rivetted laps. The verandah floor has been replaced with concrete (Figure 21).

Development of the subject site provides an opportunity to replace incompatible elements and materials, such as the concrete verandah floor, with appropriate fabric.
