# Historical archaeological site card

BENALLA RAILWAY STATION AND YARD  
H8024-0016

Place name: BENALLA RAILWAY STATION AND YARD

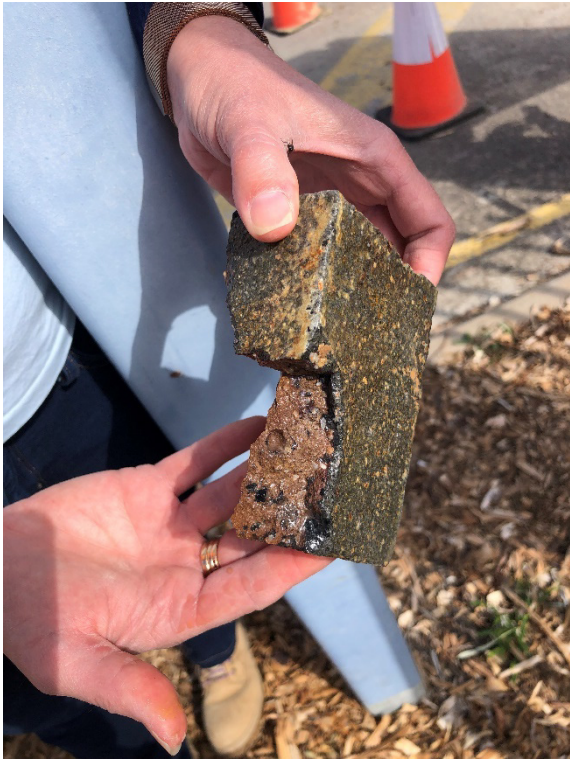
Plate 4.9 Glazed brick exposed out of context

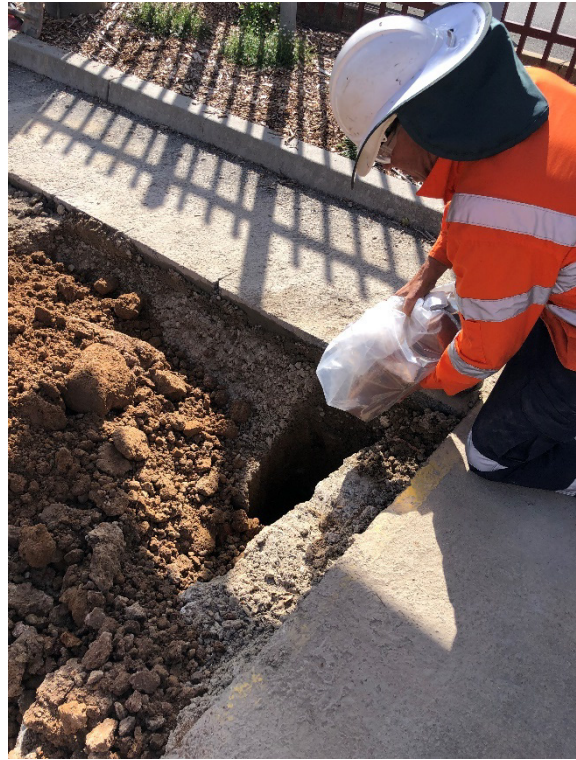
Plate 4.10 Historical artefacts bagged and placed in northern non-destructive drilling hole before reburial

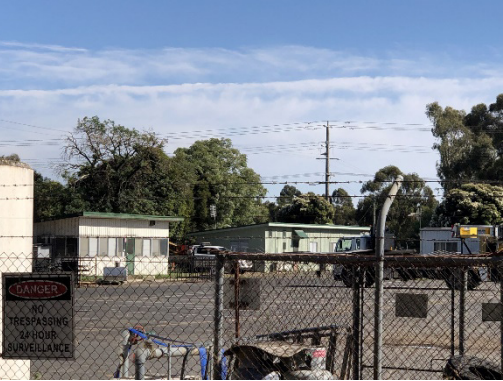
No.	Name	Description	Discussion/potential	Photo
4	Unknown	Site could not be inspected in detail as it is on privately operated land. Area has been concreted/asphalted.	It is considered the site holds limited to no archaeological potential.

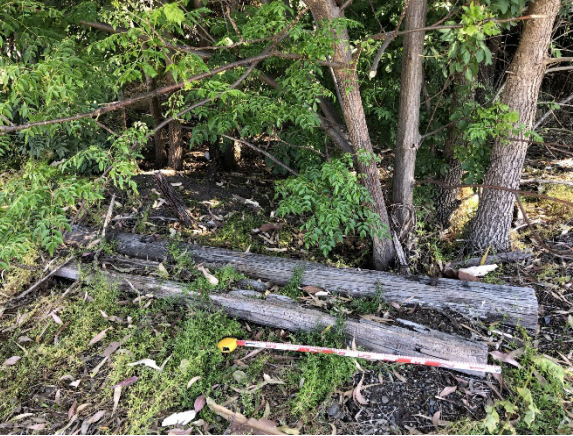
5	Unknown	Site over-grown with vegetation – heavy leaf litter reduced ground surface visibility to 0%. Two railway sleepers evident on surface.	Likely to have been a weatherboard structure set on piers. Archaeological potential likely to be limited to the building piers that are unlikely to yield information not available from other sources.

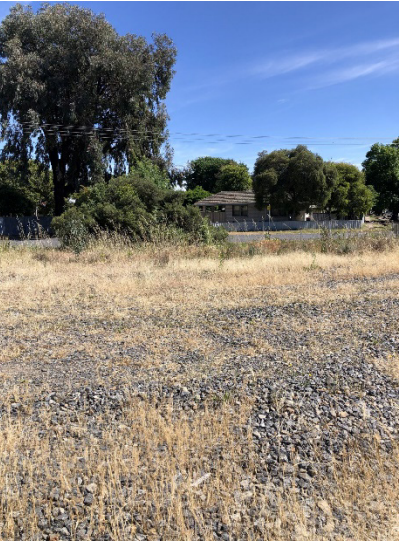
6	House?	Area is covered in ballast. No surface expression of the former structure was visible.	House is likely to have been a weatherboard structure set on piers. If extant, archaeological features would be likely to include brick piers, water tank pad, and similar domestic features. It is considered the site holds limited archaeological potential. Unlikely to yield information not available from other sources.

6	House?	Low	Archaeological deposits and features associated with the house may be extant subsurface. However, the domestic archaeology of the period has been well investigated and further archaeological investigations are unlikely to provide insights not already established.
7	Brick pit & Water Meter	Low	The archaeology of the site, if realised, is likely to be limited to the foundations/piers of a utilitarian building. Archaeological examination is unlikely to provide information that substantially enhances the historical understanding of the Benalla Railway Station.
8	2nd Victoria Rail Institute Hall	Low	The archaeology of the site, if realised, is likely to be limited to the foundations of the Institute Hall due to the subsequent ground disturbance. Archaeological examination is unlikely to provide information that substantially enhances the historical understanding of the Benalla Railway Station or the Victorian Rail Institute.

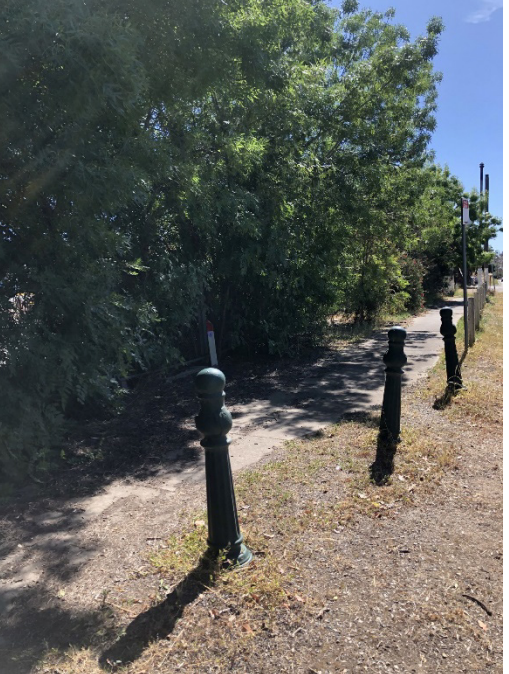
No.	Name	Description	Discussion/potential	Photo
7	Brick pit and water meter	Mapping indicates a small brick pit and water meter located near Mackellar Street, opposite the Victoria Hotel. This area is under the footpath and partially within the rail corridor. Three historical bollards may indicate the location of the pit	Pit may still be present but no surface evidence to indicate location. It is considered the site holds limited to no archaeological potential.

<p>Three historic bollards on Mackellar Street. EMM 16.11.2023</p>
8	2nd Victorian Rail Institute Hall	Mapping indicates the Rail Institute was made up of two buildings. No evidence of the main east building on surface. Concrete verandah, base of a building pier, scattered glass and painted duck-egg blue asbestos fragments noted at location of smaller building to the west	Rail Institute building constructed in 1959 or early 1960s. Plans of the buildings are available. It is considered the site holds limited to no archaeological potential.

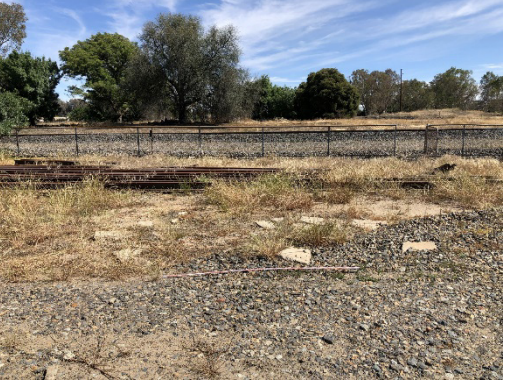
<p>View north across site of west building. EMM 16.11.2023</p>

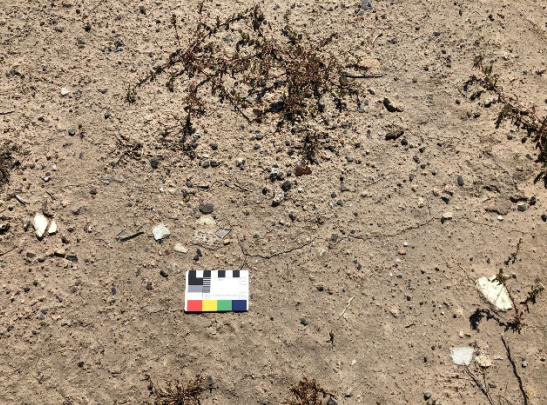
<p>Scatter of glass and asbestos. EMM 16.11.2023</p>

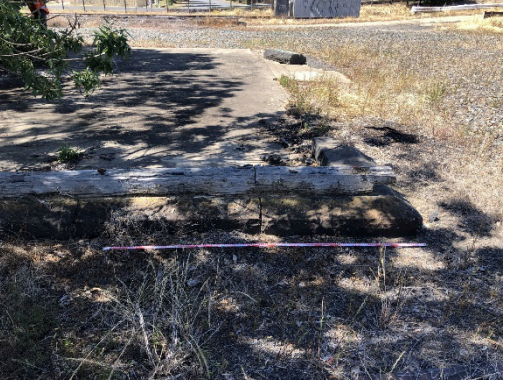
<p>View west. EMM 16.11.2023</p>
10	Locomotive workshop/ Fitters workshop / Repair shop	Bluestone foundation wall around the perimeter of the rectangular building. Set on top of the bluestone along some stretches is a timber beam. Poured concrete floor to interior. Two pits evident in the floor. Block and chain crane extant.	<p>Timber beam part of superstructure to tie the timber frame and attach the corrugated iron cladding that is visible in the historical photographs. It is considered the site holds limited to no archaeological potential.</p>

<p>View south. EMM 16.11.2023</p>

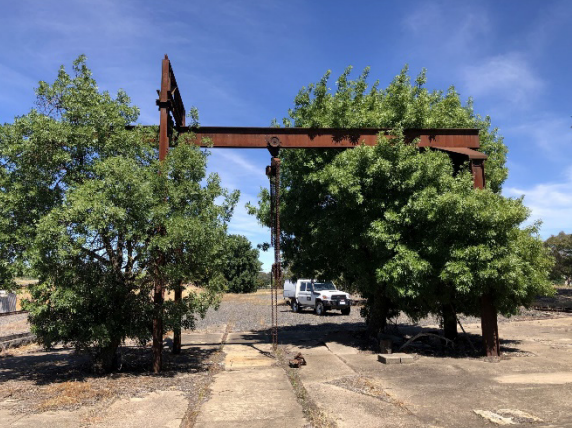
<p>Block and chain crane. View west. EMM 16.11.2023</p>

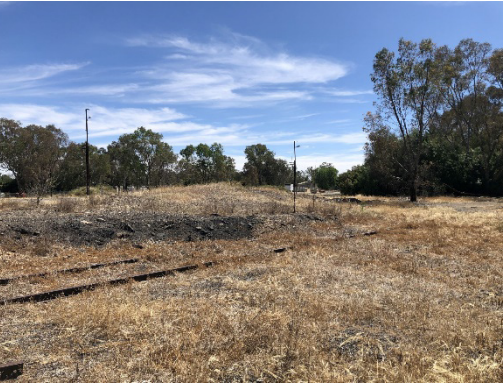
<p>View east across site. EMM 16.11.2023</p>
12	Coal loader	Earthen ramp, rising in height from the south-west to the north-east. Comparison with historical images indicates it has been reduced in height. At the northern termination of the ramp are located two concrete piers and a pile of brick rubble. No evidence of the coal loader were evident on the surface, although vegetation grown inhibited visibility.	The coal loader was in two parts: the earthen ramp and a concrete structure. No evidence of the concrete structure was evident on the surface. Further analysis of the type of coal loader facilities may elucidate an understanding of the functioning of the coal loader here. It is considered the site holds limited archaeological potential.

<p>Earthen ramp. View north. EMM 16.11.2023</p>

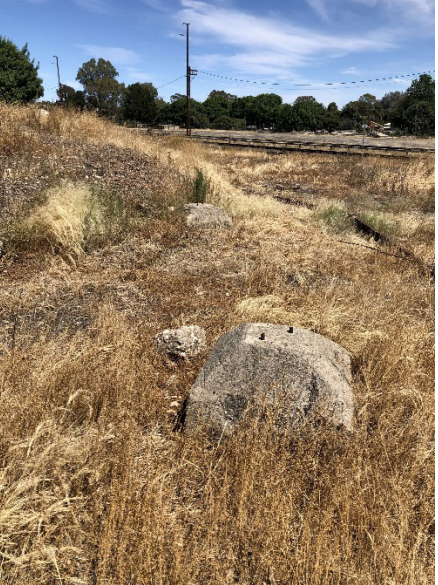
<p>Concrete piers. View west. EMM 16.11.2023</p>

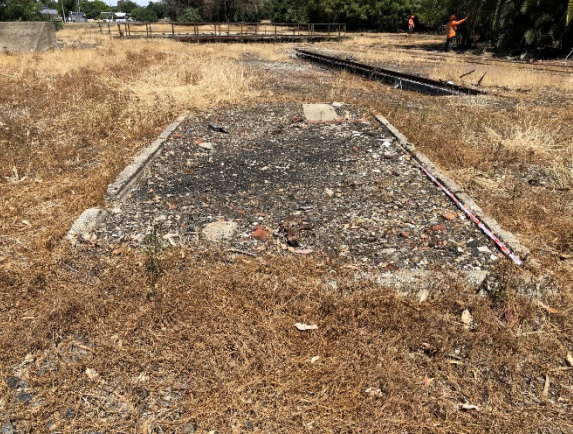
<p>Undocumented washhouse/ablutions. View NNW. EMM 16.11.2023</p>

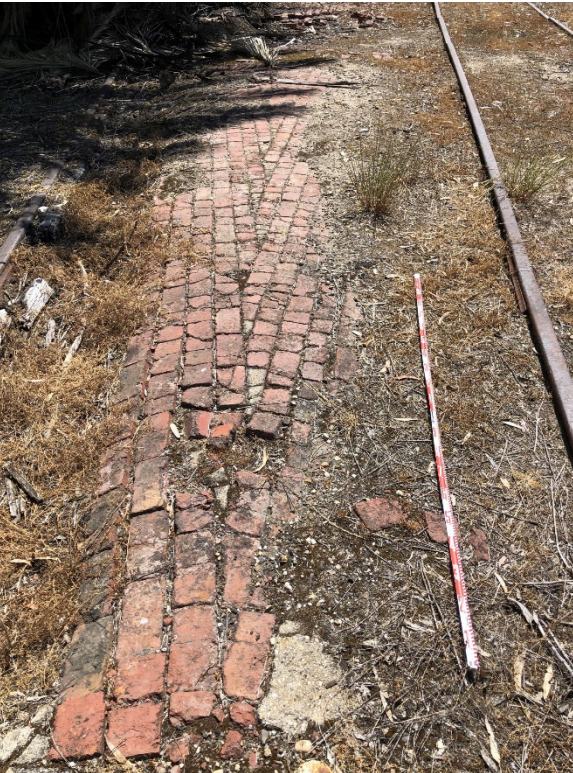
<p>Brick paving between radiating tracks. EMM 16.11.2023</p>

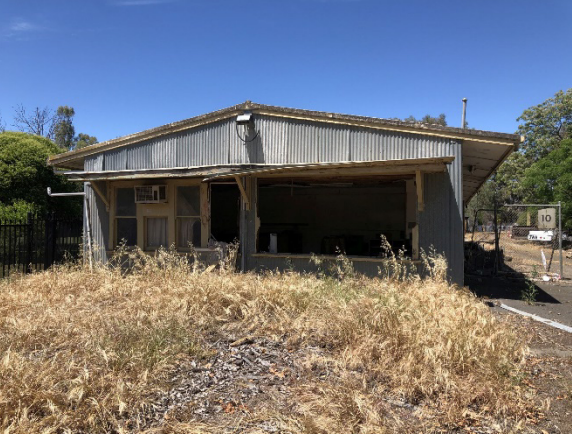
No.	Name	Description	Discussion/potential	Photo
15	New works depot, c.1960	Extant building, has been extensively vandalised, but retains similar form to that shown on plan 299/60. Concrete floor.	1960s new works depot with no archaeological potential due to concrete floor.

<p>North elevation. EMM 16.11.2023</p>
16	Gasometer	Asphalt of vehicular approach to station building. Partially within the landscaping and under a large mature eucalypt tree.	Foundations may be preserved beneath the asphalt.

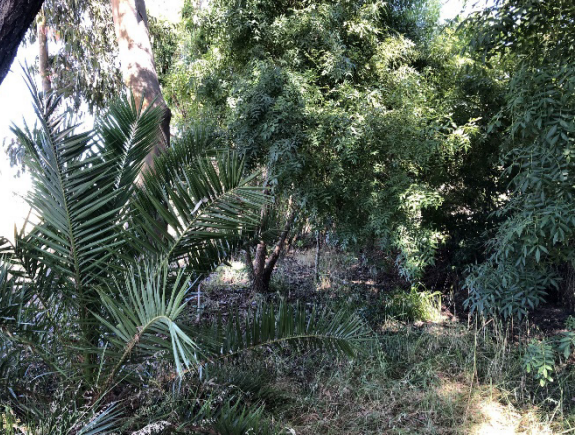
32	Unknown 1921 structure	Area has been graded, flattened and covered with ballast. There was no ground surface visibility.	Archaeological potential low to nil	
33	House?	No surface expressions were evident. Any archaeology would be heavily impacted by roots of trees and vegetation	Likely to have been a weatherboard house. Archaeological evidence anticipated to be limited to foundation squares for the piers.

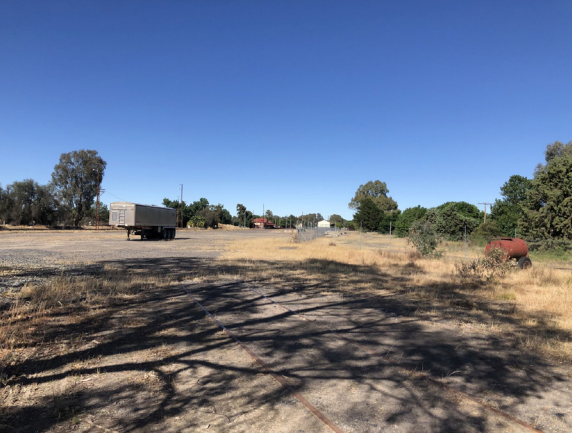
No.	Name	Description	Discussion/potential	Photo
34	Shed?	No surface expressions were evident.	The structure marked on the map may indicate the side platform located to the west of the site, visible at the right of the image. There has been substantial ground disturbance in this area, based on historical images and aerial photography. It is considered the site holds limited to no archaeological potential.

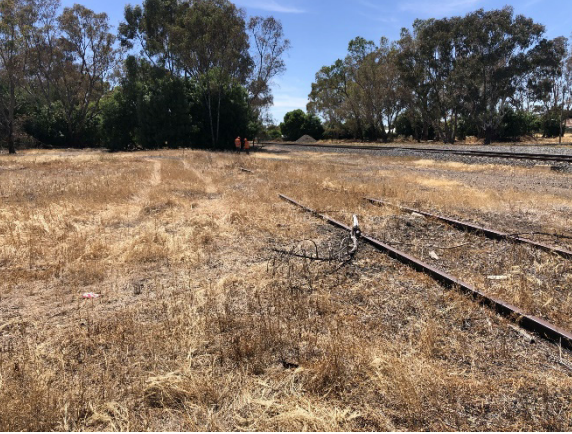
35	House?	Under the railway lines.	All archaeological evidence is expected to have been removed during the construction of the railway line.

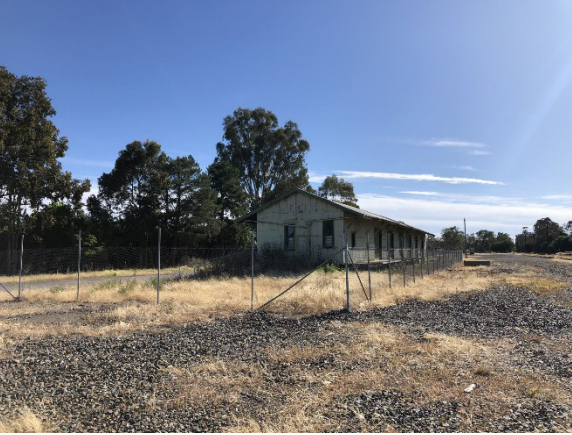
36	Brick Pit	Directly adjacent railway lines and under ballast. No surface expression evident	Investigation of structure unlikely to yield evidence not available from other sources.	
37	House?	Site was not inspected as is a private residence	Archaeological potential unknown, but unlikely to yield evidence not available from other sources	
38	Goods Shed	Corrugated iron shed with platform on south side, facing tracks.	Investigation of structure unlikely to yield evidence not available from other sources. Minimal to no subfloor deposits anticipated due to nature of use.

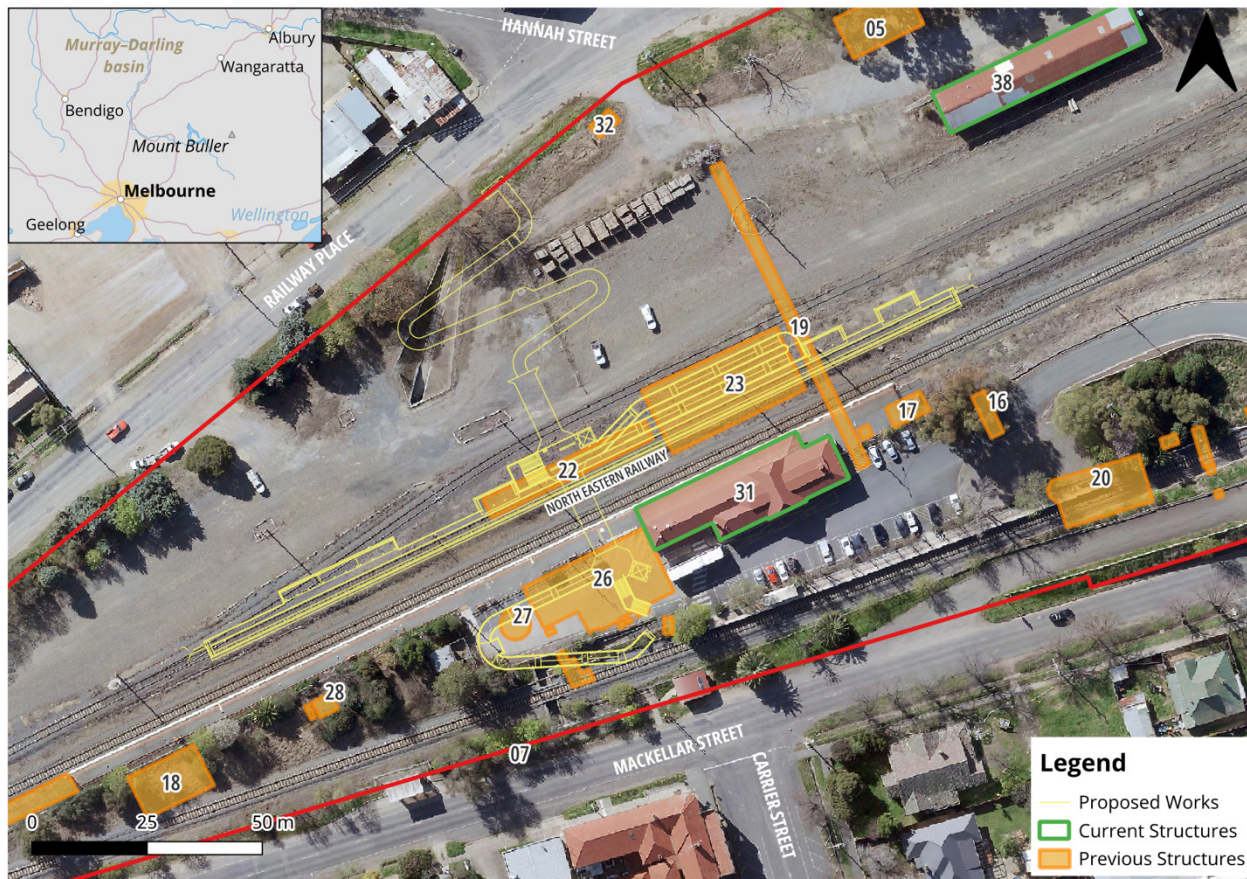
Plate 6.1 Proposed infrastructure in relation to the archaeological site

The proposed pedestrian subway access under the rail corridor would impact on the identified archaeological site (Plate 6.1).

The proposed pedestrian subway access under the rail corridor would impact on the identified archaeological site of the refreshment room (Plate 6.1). The development would not impact on the other archaeological features identified on the site.

- Under section 127 of the *Heritage Act, 2017*, the archaeological site must be reported to the Executive Director through the submission of a site card.
- There is a possibility for remnants of foundation piers, floor, remaining artefacts or structures of the refreshment room to be identified during future development activities.
- No other archaeological features would be impacted by the proposed works.
- The preliminary findings are that the archaeological resources are unlikely hold heritage significance, but further investigation and recording is warranted.
- Consultation is also recommended with Heritage Victoria to discuss the find, the archaeological interpretation, and direction regarding how to proceed. It is possible that approval under section 124 of the *Heritage Act, 2017* would be required.
