**NEWTOWN URBAN CONSERVATION STUDY. - 'C' CITATIONS. Ref: 76**  
 Richard Peterson Architect & Conservation Consultant, Daniel Catrice Historian 1996.

<b>NAME:</b> —	
<b>PREVIOUS NAME:</b> Craigeith.	
<b>ADDRESS:</b> 290 Latrobe Terrace ( North-west cnr Laurel Bank Parade).	
<b>USE:</b> House.	
<b>CONSTRUCTION DATE:</b> 1910-11	<b>SOURCE:</b> Visual & 1
<b>DESIGNER:</b> —	<b>BUILDER:</b> —
<b>CRITERIA:</b> H1, Ar1.	<b>HISTORIC THEME:</b> 2.3
<b>DESCRIPTION:</b> STYLE: Edwardian/ Californian Bungalow STORIES: 1 DETACHED.	
<b>MATERIALS:</b> WALLS Timber	ROOF Iron STRUCTURE Stud.
<b>CONDITION:</b> Very good.	INTACTNESS: Fair. THREATS: Traffic.
<b>SIGNIFICANT INTACT ELEMENTS:</b> FORM. VERANDAII. ROOF FORM. CHIMNEY. DOORS. WINDOWS. PAINTWORK SCHEME.	
<b>SIGNIFICANCE:</b>	
<b>TYPE:</b> HISTORICAL. ARCHITECTURAL.	
<b>LEVEL:</b> LOCAL.	
<b>DESIGNATION EXISTING:</b> PLANNING SCHEME.	
<b>RECOMMENDED CONTROL:</b> PLANNING SCHEME.	
<b>GRID REF:</b>	<b>SURVEY:</b> RP <b>DATE:</b> 16.3.96 <b>NEGS:</b> 3.34 & 35.

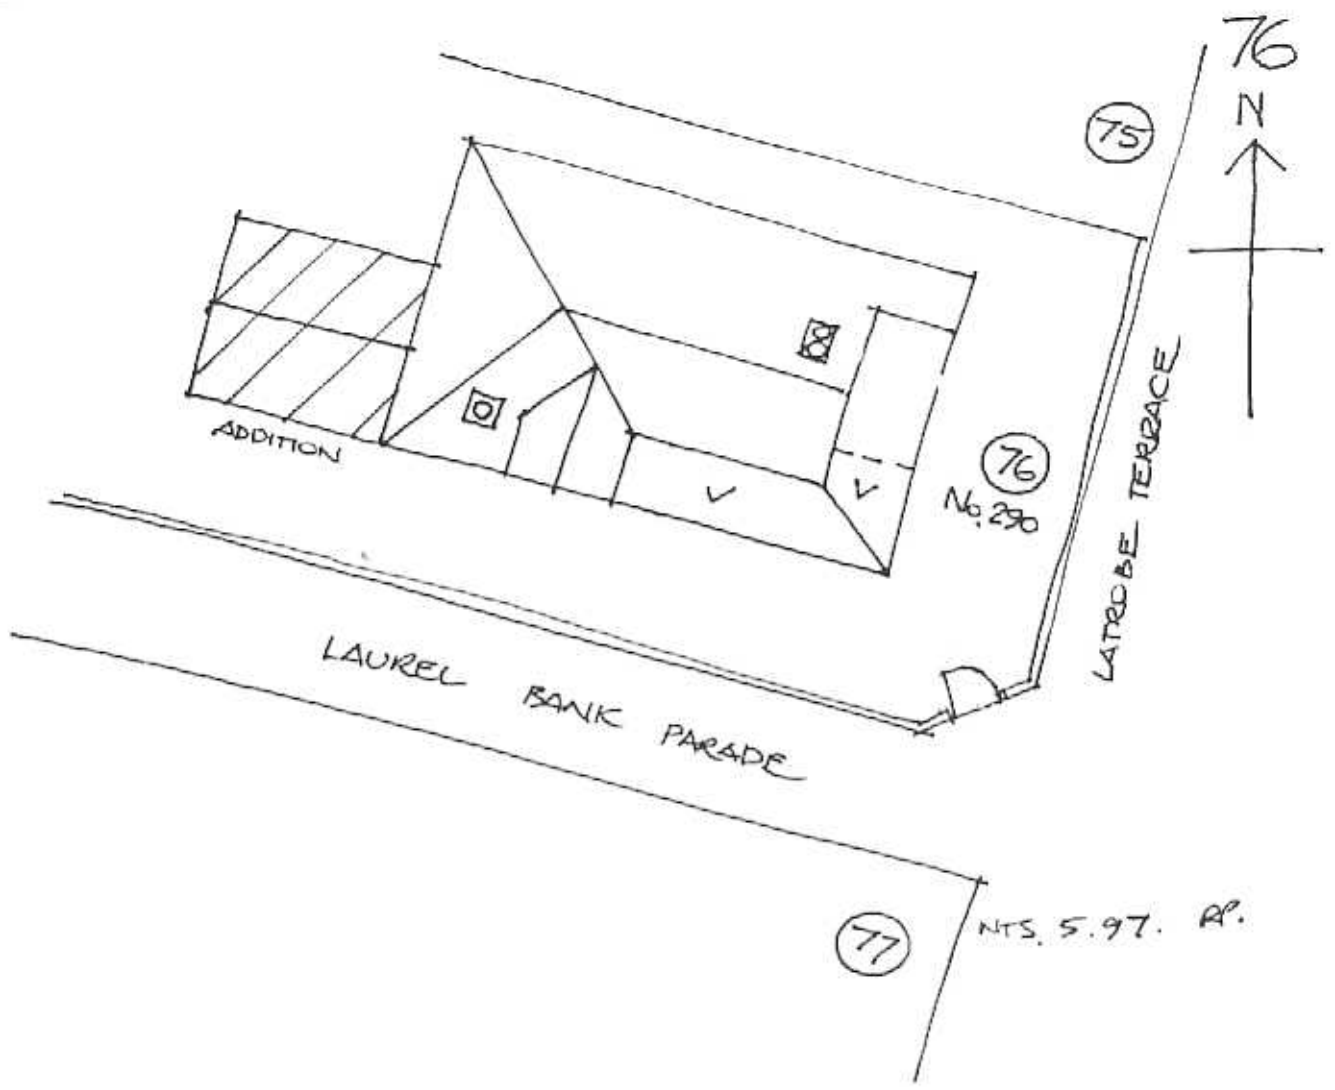
**INTACTNESS:** Fair. The verandah has been infilled, chimneys are painted. There is an inappropriate high brick fence and an addition at rear.

**CONDITION & THREATS:** Very good. Gutters are filled with leaves fallen from overhanging branches, which should be lopped. This risks blockages which may cause ceiling leaks. Traffic pollution.
