Building:	Terrace	Significance:	В
Address:	51-55 Oxford Street, Collingwood	Melway Map Ref:	2C D11
Building Type:	Residence	Construction Date:	1858-64?
Architect:	Unknown	Builder:	Unknown

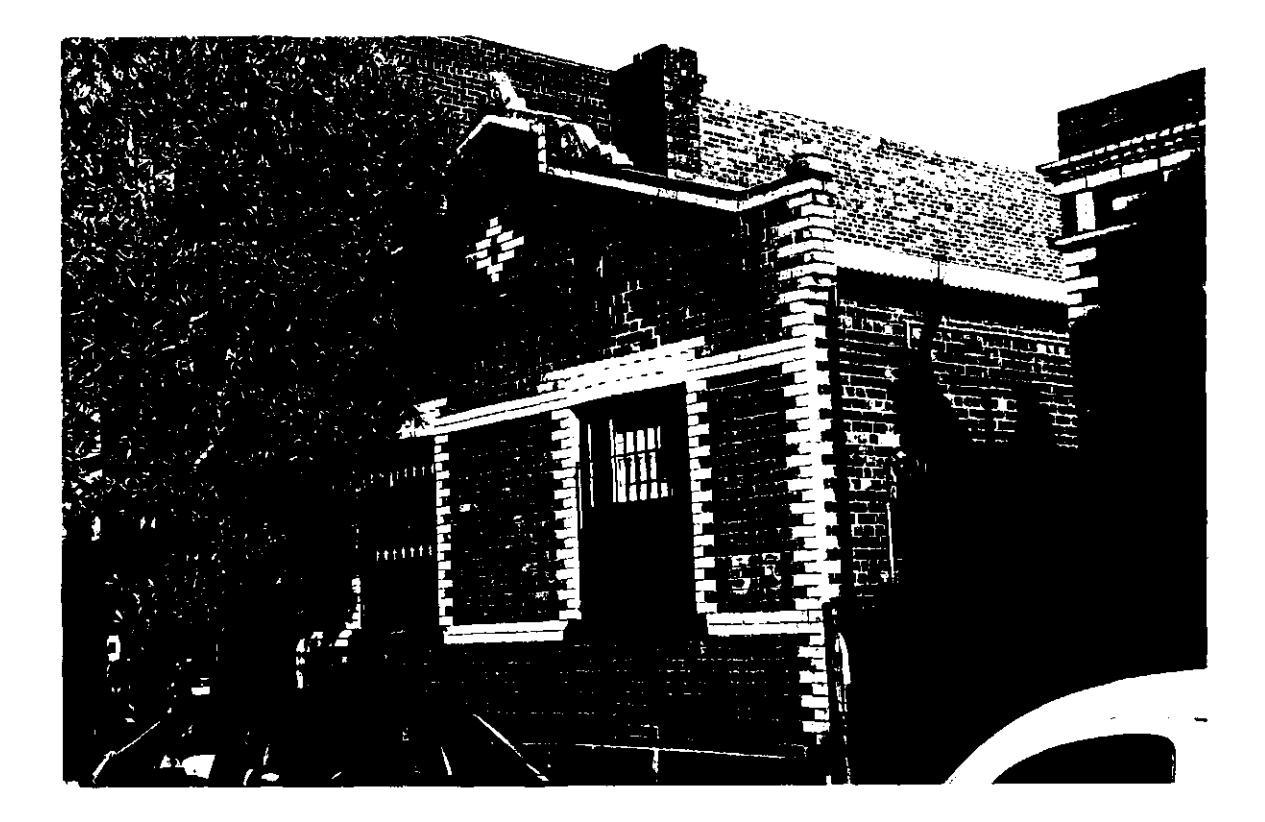
The brick building at 51-55 Oxford Street, Collingwood, is a single storey symmetrical bichromatic brick building with a gabled street facade. The east elevation, to Oxford Street, has two window openings; the entrances are via the side elevations. The walls are of red brick with a bluestone plinth, while the windows have cream brick quoining. There is also cream brick quoining at the building's corners, string courses and window head and sill level, and a small diaperwork panel in the gable-end. The gabled parapet has cream and red brick coping, and is decorated with unpainted rendered scrolls; urns (now missing) once decorated the corners. The roof is clad in corrugated iron and penetrated by a simple red brick chimney with a corbelled top.
