Boroondara Heritage Review B Graded Buildings Building Citation

Name	House	Reference No	
Address	20 Howard Street, Kew	Survey Date	16 August 2005
Building Type	Residence	Grading	В
Date	1911-12	Previous Grading	В

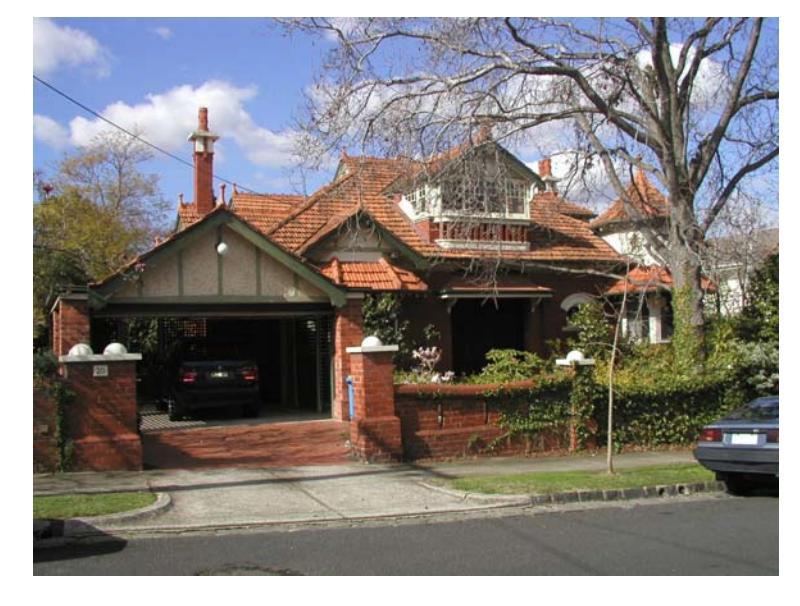
20 Howard Street, Kew, is a single-storey attic villa from the later years of the Federation period, with tuck-pointed red face brick construction. The complex gabled roofscape is clad with terracotta tiles and retains terracotta ridge cresting and finials. It is penetrated by slender red face brick chimneys which terminate in rendered caps with flat plates, brick ridging and terracotta pots. The gable ends are typically half timbered and a prominent attic dormer - which appears to have been converted from an open balcony to an enclosed room - projects from the roof above the main entrance. It contains bays of timber-framed multi-paned sashes above a ribbed brick base. A turret with roughcast rendered walls featuring pressed cement Art Nouveau motifs defines a faceted bay at the western end of the façade and the roughcast render continues around the walls of the house as a frieze. The recessed entrance porch is screened by a bracketed canopy with corrugated galvanised steel roofing and accessed via bluestone steps. A wrought iron screen obscures the main entrance door which

appears to be polished timber with leadlight glazing. Original windows typically contain timber-framed double-hung sashes with leadlight glazing, however there would appear to be some non-original windows in the side elevations at attic level.

A carport with brick piers and terracotta tile clad gabled roof to match the original building was constructed in the north-west corner of the property around 1989. This is similar in some respects to the garage at No. 10 Howard Street. While these additions have significantly altered the street reading of both houses, both can still be viewed in largely original state front on, and No. 20 retains its original brick fence with rendered caps and scalloped brick panels.⁸ The landscape contains a mature liquidambar (*Liquidambar styraciflua*).
