Name	Kirklands	Reference No	
Address	89 Union Road, Surrey Hills	Survey Date	16 September 2005
Building Type	Residence	Grading	В
Date	1888-90	Previous Grading	В

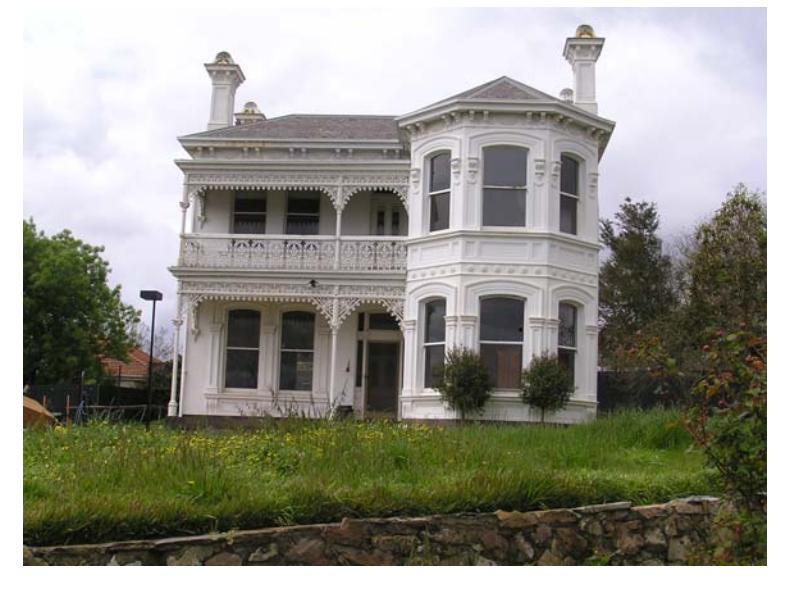
Kirklands is sited on a ridge site with commanding city views. In common with many larger suburban houses in later nineteenth century Australia, it is in a two storey double-fronted Italianate mode with a

hipped slate roof, paired eave bracketing, canted bay, segmentally arched sash windows and a twostorey verandah with cast iron columns and lace. As Graeme Butler has noted previously, the eave brackets are interspersed with garlands, and the window drip moldings, heavily accentuated, are supported with pilasters on the ground floor and brackets on the first floor.⁵ Door and window joinery appears to be original or early.

Recommended for inclusion in the Schedule to the Heritage Overlay of the Boroondara Planning Scheme.
