## NEWTOWN URBAN CONSERVATION STUDY. - 'C' CITATIONS. Ref: 207

Richard Peterson Architect & Conservation Consultant. 1997.

Gladysville **FORMER NAME:** 9 Skene Street **ADDRESS:**

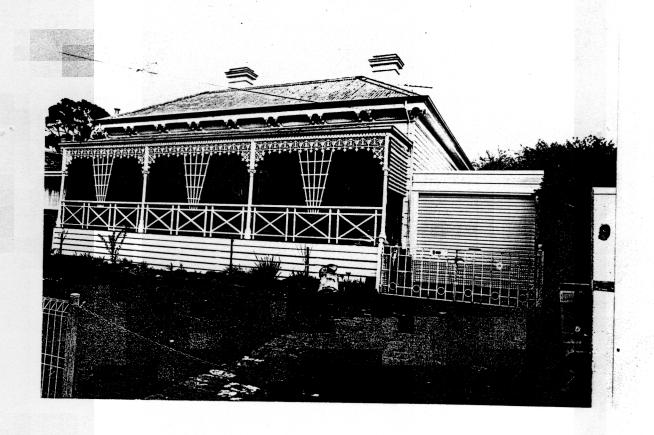
NEGS: 12.22; &1279.18 OBSCURED. SURVEY: RP **DATE:** 16.3.1997

VISUAL DESCRIPTION: An elevated double-fronted timber symmetrical Italianate house, with a high hipped roof and a verandah across. This has a shallow ogee hipped roof, with scalloped fretwork decoration over a cast-iron lace valance and brackets and cast-iron Composite posts, with coin-mould decoration. Chimneys are rendered with fine Classical mouldings. Eaves are shaped to turn down as a valance to turned spindle ogee brackets, between roundels and round-ended panels. Windows are tripartite and the entrance has side and fan lights(?).

INTACTNESS: Very good. The balustrade may be recent.

CONDITIONS & THREATS: Very good.
