GEELONG CITY 'C' CITATIONS

Site Name: Shelter (Rotunda)

Address: Eastern Park Geelong 3220

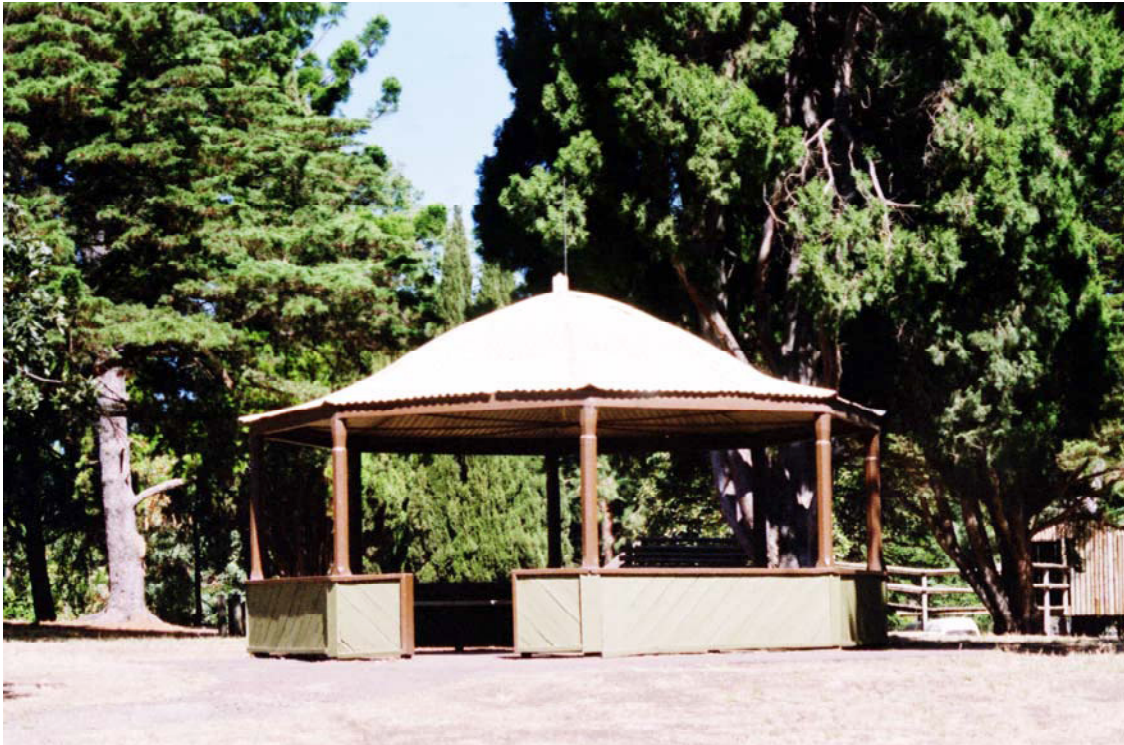
Photograph No: 11a.22

The small shelter is characterised by an octagonal plan with fixed timber seating on all sides except for two doorways. The unusual ogee form roof is clad in galvanised corrugated iron and is supported by heavy stop chamfered timber columns. The roof is also steel framed and steel tie rods are attached to the top of the columns to support the centre of the roof.

The small shelter has experienced some changes. The early timber finial at the apex of the roof is missing, as are brackets at the top of the columns. The capped timber balustrading - forming a herringbone pattern - has replaced an earlier timber capped vertical boarded balustrade.

The shelter (rotunda) in Eastern Park, Geelong, has significance as a moderately intact example of an early 20th century garden structure within a well-treed landscape and with views to Corio Bay. Built before 1916, the shelter appears to be in fair condition.
