# BUILDING IDENTIFICATION FORM

RICHMOND CONSERVATION STUDY

BUILDING ADDRESS 96 BENDIGO ST

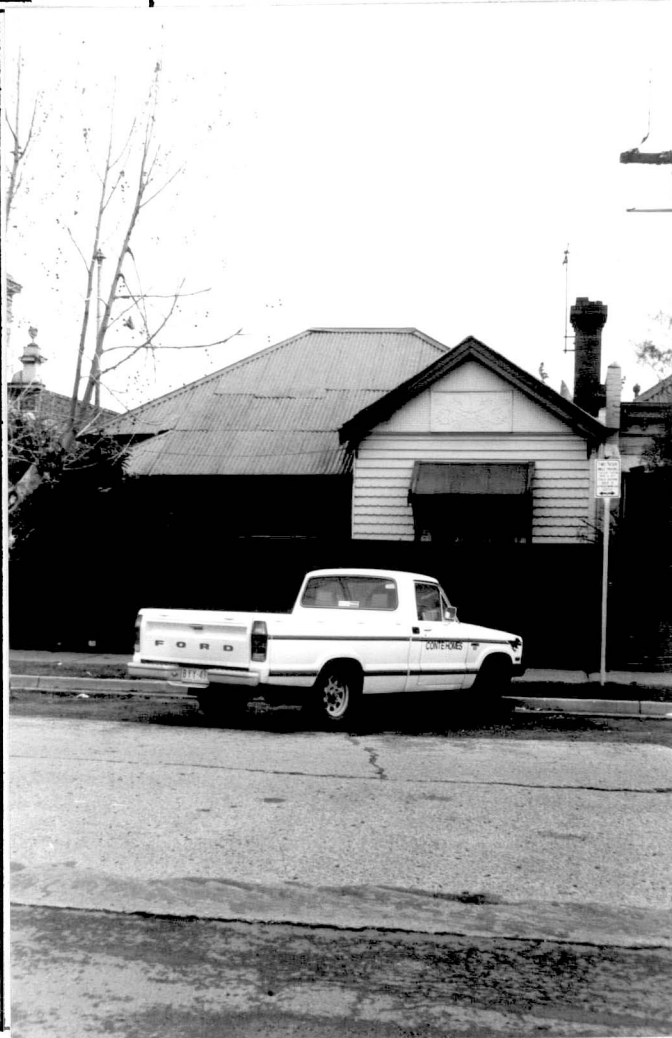
Edwardian cottage with attractive facade detailing, including pressed metal gable and notched timber boards.

| | | | | | <u>FENCE</u> | <u>S</u> |
