# BUILDING IDENTIFICATION FORM

RICHMOND CONSERVATION STUDY

BUILDING ADDRESS *Cnr Bridge Road / Rink Road*

BUILDING TITLE *"Napier Hotel"*

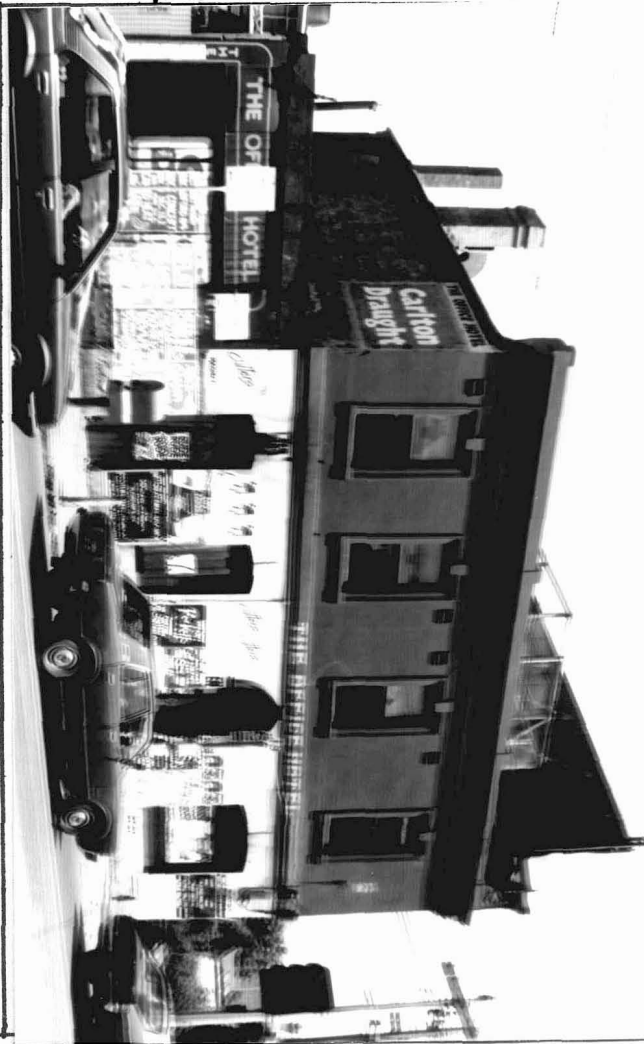
SURVEY DATE *12/11/04* NEG. FILE *109-15*

Walls *Brick/Render* Roof *Cor. Iron*

| ornamental wall detailing | <input checked="" type="checkbox"/> | early fence | <input type="checkbox"/> |
| original doors/windows | <input checked="" type="checkbox"/> | early garden | <input type="checkbox"/> |
| original parapet | <input checked="" type="checkbox"/> | | <input type="checkbox"/> |
| original roof form & finish | <input checked="" type="checkbox"/> | | <input type="checkbox"/> |
| original chimneys | <input checked="" type="checkbox"/> | | <input type="checkbox"/> |

INTEGRITY RATING excellent ☐ good ☒ fair ☐ poor ☐

COMMENTS *AN UNUSUALLY INTACT PRE 1855 HOTEL, IMPORTANTLY LOCATED AT THE ENTRY TO RICHMOND. WINDOWS WERE ORIGINALLY MULTI-PANED.*

| No. | Sympathetic | S.G. | Inappropriate | S.G. | Extremely Inappropriate | S.G. |
|---|---|---|---|---|---|---|
| | | | <i>Harding</i> | <i>R.</i> | | |
| | <i>WINDOW SASHES</i> | <i>O</i> | | | | |
| | | | <i>DOORS</i> | <i>O</i> | | |
