BUILDING IDENTIFICATION FORM

RICHMOND CONSERVATION STUDY

65 BRIDGE RD

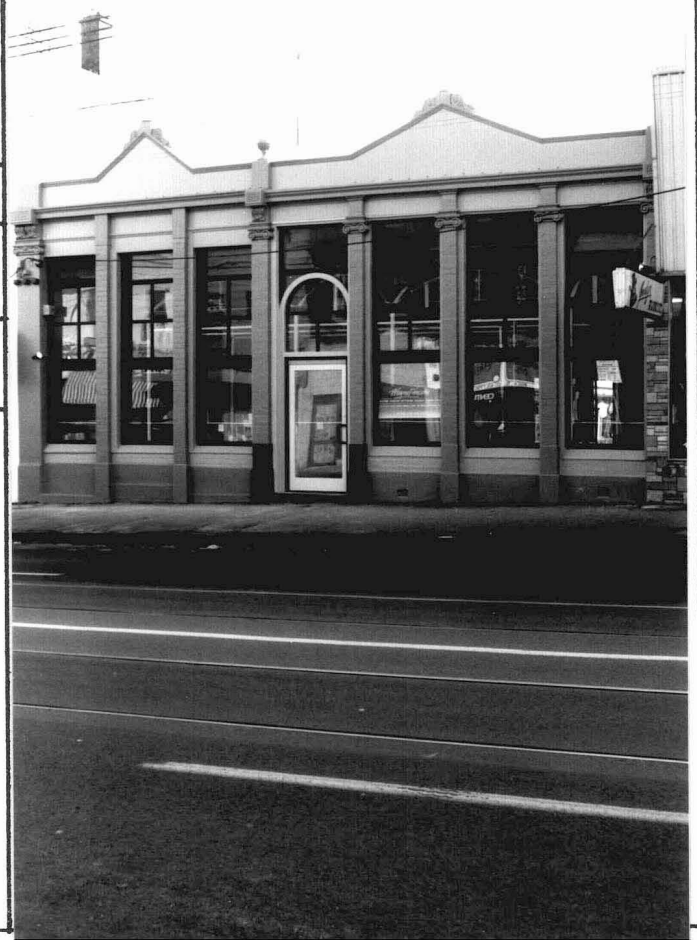
No.	Sympathetic	S.G.	Inappropriate	S.G.	Extremely Inappropriate	S.G.
	3 WINDOWS WEST END		DOOR & FRAME	S		
	WINDOW SUBSTITUTED		PAINT OVER			
	FOR DOOR WEST END		PILASTER EXTEND	R		
			PAINTED BRICKW'K	R

SOME PARAPET URNS MISSING.

SOME PILASTER CAPITALS MISSING.

Substantial Edwardian commercial building, with interesting pilaster decoration.
