BUILDING IDENTIFICATION FORM

RICHMOND CONSERVATION STUDY

BUILDING ADDRESS *314 - 328 BRIDGE RD.*

BUILDING TITLE *STANFORD BLOCK*

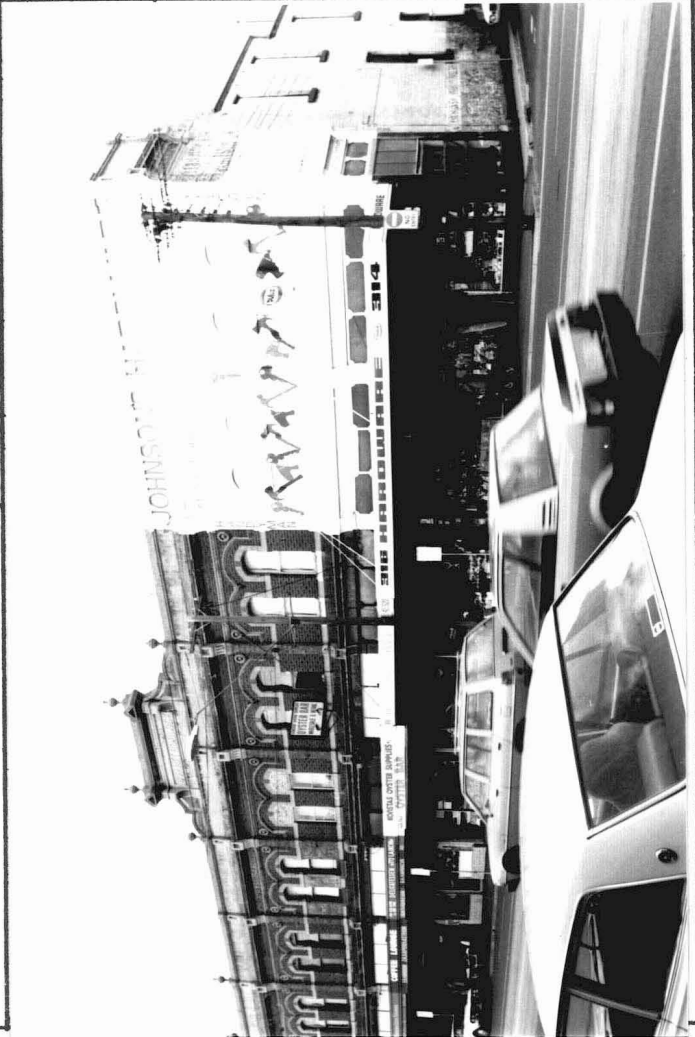
COMMENTS *IMPOSING BLOCK OF SHOPS BUILT FOR THOMAS STANFORD & CO. MERCHANTS, BY A. PAYNTER IN 1900. UPPER FLOOR OF TWO SHOPS DEFACTED BY PAINTING. ORIGINAL VERANDAH'S MISSING. SHOPFRONTS TO 314, 316 DATES FROM 1920'S.*

| No. | Sympathetic | S.G. | Inappropriate | S.G. | Extremely Inappropriate | S.G. |
|---|---|---|---|---|---|---|
| <i>314</i> <i>316</i> | | | <i>PAINTED BRICKW/IK</i> | <i>R</i> | <i>SIGNS</i> | <i>R</i> |
| <i>318</i> <i>320</i> <i>322</i> <i>324</i> <i>328</i> | | | <i>SHOPFRONTS</i> | | | |
| | | | | | <i>VERANDAH'S</i> | <i>S</i> |
