BUILDING IDENTIFICATION FORM

RICHMOND CONSERVATION STUDY

BUILDING ADDRESS 394, 396 BRIDGE RP.

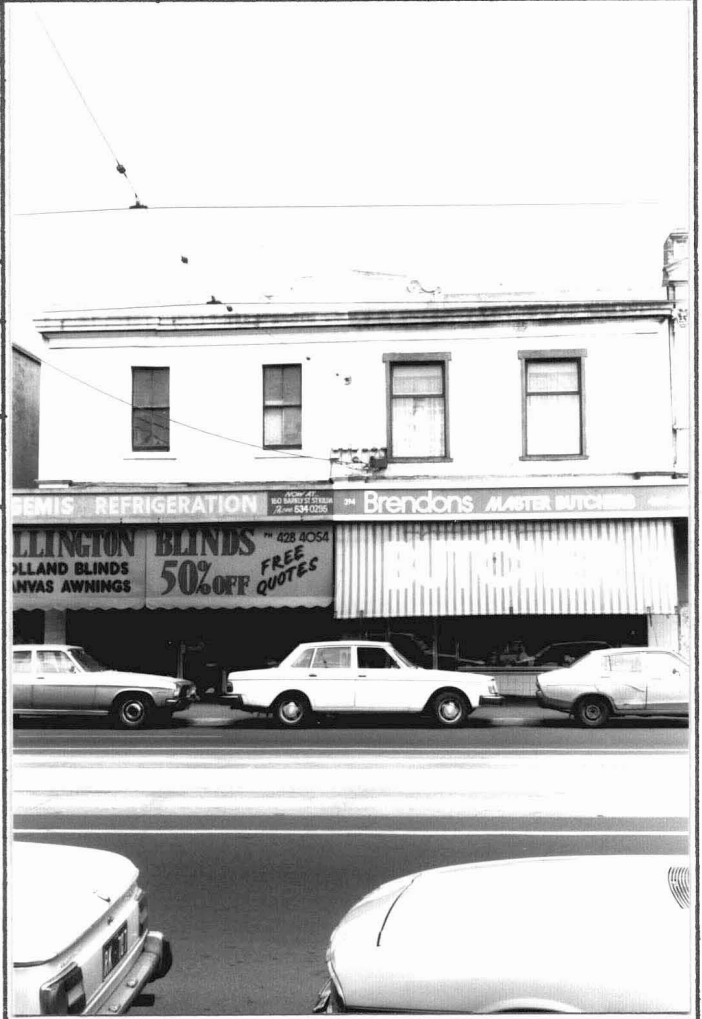
excellent good fair poor
396 *394*

This early Victorian commercial building was possibly constructed sometime prior to 1855 and retains fair integrity at first floor level with several surviving windows, simple cornice and pediment.

No.	Sympathetic	S.G.	Inappropriate	S.G.	Extremely Inappropriate	S.G.
					<i>SHOPFRONTS</i>	<i>S</i>
					<i>VERANDAH'S</i>	<i>S</i>
<i>394</i>			<i>WINDOWS 1st FLR</i>	<i>O</i>
