# BUILDING IDENTIFICATION FORM

## RICHMOND CONSERVATION STUDY

BUILDING ADDRESS *450, 452, 454 BRIDGE RD.*

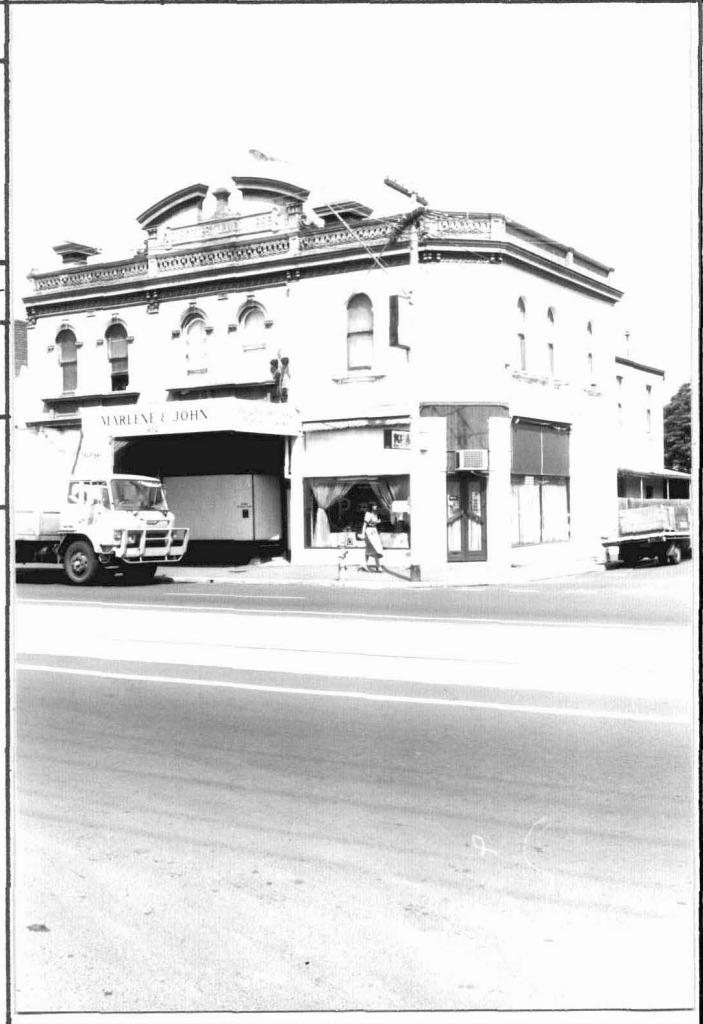
Walls *RULED RENDER* Roof *IRON*

early paint colour scheme <input type="checkbox"/>	eaves, roof or gable decoration <input type="checkbox"/>
original unpainted wall finish <i>452 454</i> <input checked="" type="checkbox"/>	intact verandah decoration <input type="checkbox"/>
ornamental wall detailing <input checked="" type="checkbox"/>	early fence <input type="checkbox"/>
original <i>1st FLR.</i> doors/windows <input checked="" type="checkbox"/>	early garden <input type="checkbox"/>
intact verandah structure <input type="checkbox"/>	other prominent contrib. elevations <i>450</i> <input checked="" type="checkbox"/>
original parapet <input checked="" type="checkbox"/>	<i>EARLY SHOPFRONTS 452 454</i> <input checked="" type="checkbox"/>
original roof form & finish <input checked="" type="checkbox"/>	<input type="checkbox"/>
original chimneys <input checked="" type="checkbox"/>	<input type="checkbox"/>

*Prominent Victorian commercial buildings with large central broken pediment, and intact parapet balustrading.*

No.	Sympathetic	S.G.	Inappropriate	S.G.	Extremely Inappropriate	S.G.
<i>450</i>			<i>PAINTED RENDER</i>	<i>RAM</i>	<i>MISSING VERANDAH</i>	<i>?</i>
<i>450</i>			<i>SHOPFRONT</i>	<i>O</i>		
<i>452, 454</i>					<i>VERANDAH</i>	<i>S</i>
