# CITY OF GEELONG WEST

URBAN CONSERVATION STUDY: BUILDING IDENTIFICATION FORM.

BUILDING ADDRESS 42 Villamanka Street

42 VILLAMANTA STREET

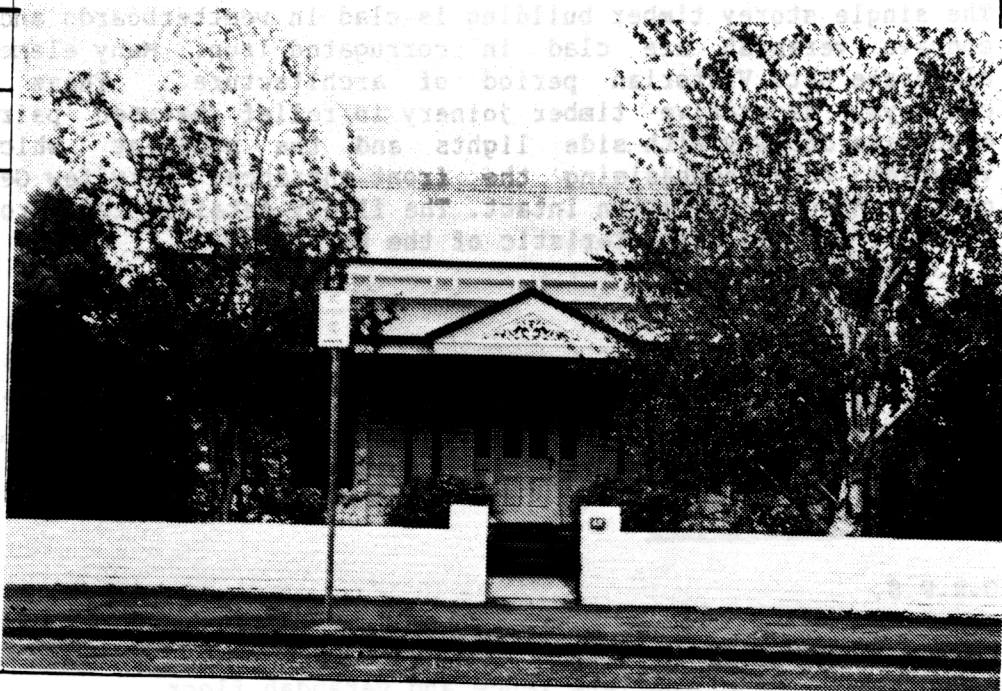
The single storey timber building is clad in weatherboards and the hipped roof and concave verandah are clad in corrugated iron. Many elements are typical of the elaborate Late Victorian period of architecture. These include the stuccoed chimneys, decorative timber joinery in relief between paired eaves brackets, the elaborate doorway with side lights and the pediment which projects from the verandah thus emphasising the front entrance. Very few Geelong West houses have cast iron roof decoration intact. The finely detailed cast iron lace on the verandah and roof is also characteristic of the period.

42 Villamanta Street is a very good example of a Late Victorian timber house in Geelong West. It is of local significance.

More appropriate paint colours would greatly enhance the character of this building as would a more appropriate fence and verandah floor.
