BUILDING IDENTIFICATION FORM

RICHMOND CONSERVATION STUDY

BUILDING ADDRESS 11-15 CLIFTON ST

BUILDING TITLE 'GRANBY'

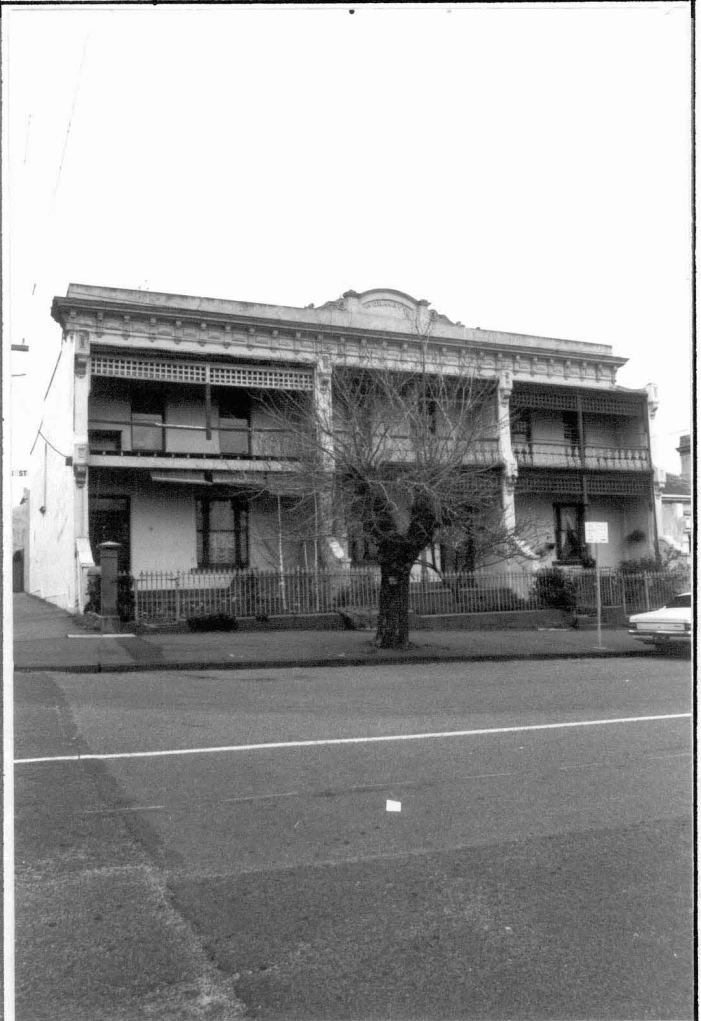
No.	Sympathetic	S.G.	Inappropriate	S.G.	Extremely Inappropriate	S.G.
			PAINTED RENDER	RAM		
			VALANCE & BALUSTRADE			
			REMOVAL O

Substantial terrace retaining accentuating parapet detailing and consoles. This group retains its early cast iron fencing with elaborate corner post.

O = reinstate original designs S = reinstate sympathetic alternative R = remove RAM = Remove by approved method
