BUILDING IDENTIFICATION FORM

RICHMOND CONSERVATION STUDY

BUILDING ADDRESS *26 CLIFTON ST*

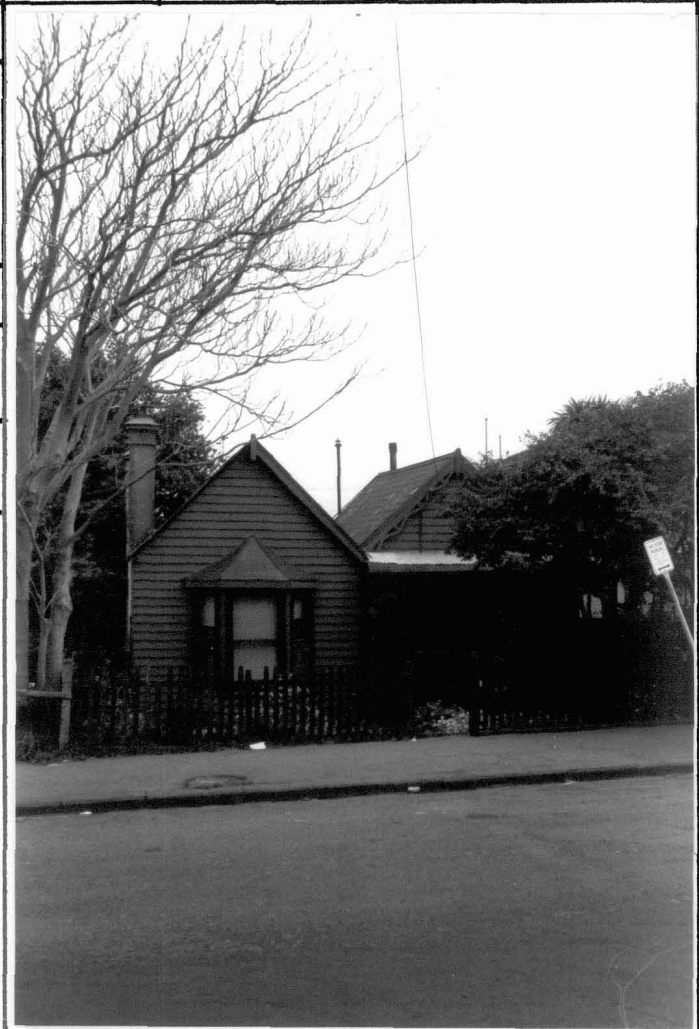
Walls *WEATHERBOARD*

Roof *SLATE*

Unusual Neo-gothic style Victorian dwelling retaining curved barge boards, evidence of finials, and unusually conceived bay window projection with flat sheet iron roof.
