BUILDING IDENTIFICATION FORM

RICHMOND CONSERVATION STUDY

BUILDING ADDRESS 1 EGAN ST

BUILDING TITLE PERSEVERANCE

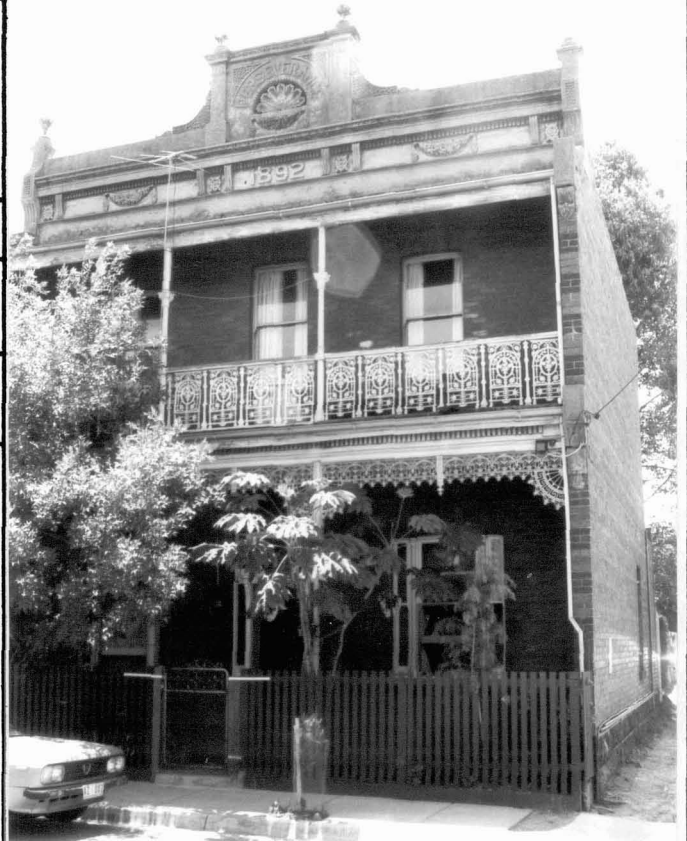
early paint colour scheme <input type="checkbox"/>	eaves, roof or gable decoration <input type="checkbox"/>
original unpainted wall finish <input checked="" type="checkbox"/>	intact verandah decoration <input checked="" type="checkbox"/> <i>partial</i>
ornamental wall detailing <input checked="" type="checkbox"/>	early fence <input type="checkbox"/>
original doors/windows <input checked="" type="checkbox"/>	early garden <input type="checkbox"/>
intact verandah structure <input checked="" type="checkbox"/>	other prominent contrib. elevations <input type="checkbox"/>
original parapet <input checked="" type="checkbox"/>	<i>Verandah + Path Tiling</i> <input type="checkbox"/>
original roof form & finish <input checked="" type="checkbox"/>	<input type="checkbox"/>
original chimneys <input checked="" type="checkbox"/>	<input type="checkbox"/>

INTEGRITY RATING excellent ☐ good ☒ fair ☐ poor ☐

Substantial intact Victorian residence which features elaborate parapet detailing and original unpainted wall surface.

No.	Sympathetic	S.G.	Inappropriate	S.G.	Extremely Inappropriate	S.G.
			MISSING VERANDAH DECORATION 0			
	FENCE
