**BACCHUS MARSH HERITAGE STUDY.****Ref:** 320

**NAME:** Merrimu Reservoir.**PREVIOUS NAME:** Coimadai Town.**ADDRESS:** Bennetts Lane, Coimadai.**TITLE DETAILS:****USE:** Water storage.**PREVIOUS USE:** Town, lime kilns, quarry etc.**SIGNIFICANT DATE:** c1990? **CONSTRUCTION DATE:** 1850s **SOURCE:** 1**CRITERIA:** H1,2,6; Ar 1.**HISTORIC THEME:** Mining & quarrying.**CONDITION:** **INTACTNESS:** Under water**SIGNIFICANT INTACT ELEMENTS:**

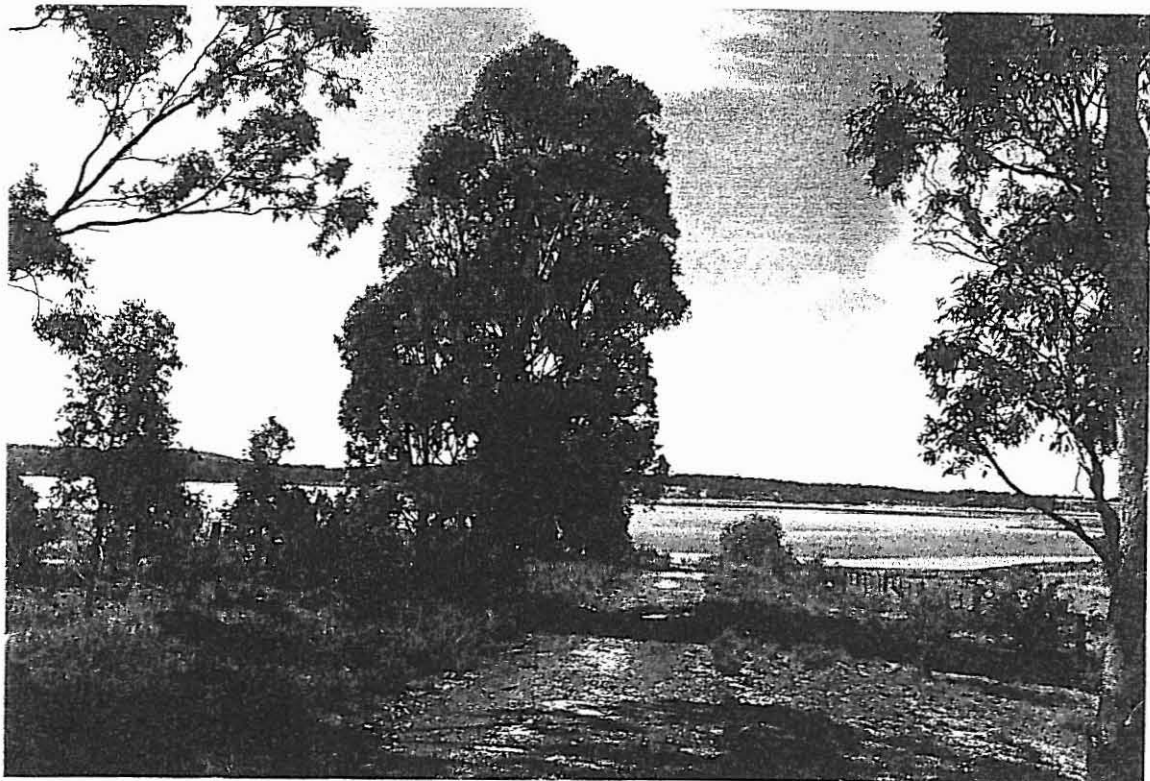
1. Hopgood's lime kiln and quarry. (Operating 1850s-1875). Possible remains of two early kilns: a circular random rubble stone wall, 3.5-4m diameter and .4m height.<sup>1</sup>

2. Alkemade's lime-burning kilns and lime extraction quarries. (Operating c1886-1953-4). Lime was quarried here loaded into the kilns which were fired. The burnt lime was unloaded, crushed, sieved, bagged, transported to market and sold. The fuel was always timber, cut locally. Lime was transported from quarry to kiln on cable tramway trolleys, prior to 1930s, after that horses were used. The Tramway was then relocated to the antimony mines. Alkemade's lime was highly regarded and particularly by architects. The site includes:

- two groups of two (western) and three kilns, 4m diameter of squared rubble; brick-lined.
  - quarry
  - rail sections including turntable, water tanks, remains of a trolley, etc.Note: machinery and storage sheds, engine, well, tramway, track viaduct turntable, winch-house etc had all be demolished.<sup>2</sup>

3. Dibleys Kilns, workings and quarry. (Operating 1872-1893). These kilns were constructed in 1886. Three kilns of squared random rubble, lined with bricks and red brick corner dressings, 8m. high, with battered walls with round headed stoke holes. The western kiln is a square, flare kiln, the other two continuous process kilns. A loading ramp, tramway, drawing and crushing shed, and storage shed had been removed.<sup>3</sup> The Alkemades extracted lime to be sold unburnt from near here in 1943 and 1953-69.<sup>4</sup>

4. Burnip/Coopers lime kilns. (Operating 1865 - resited to Antimony Mine Road, site, ref: 334). There are the shafts of two kilns, internal diameter 2.5m.<sup>5</sup>

5. Hjorth's Quarry. (Operating C1867-1923). Low grade limestone was quarried by blasting and transported by dray to Alkemade's kilns.<sup>6</sup>

The area was flooded c1990.
